# National Transportation Safety Board

CEN22FA405

## **SURVIVAL FACTORS**

Specialist's Factual Report

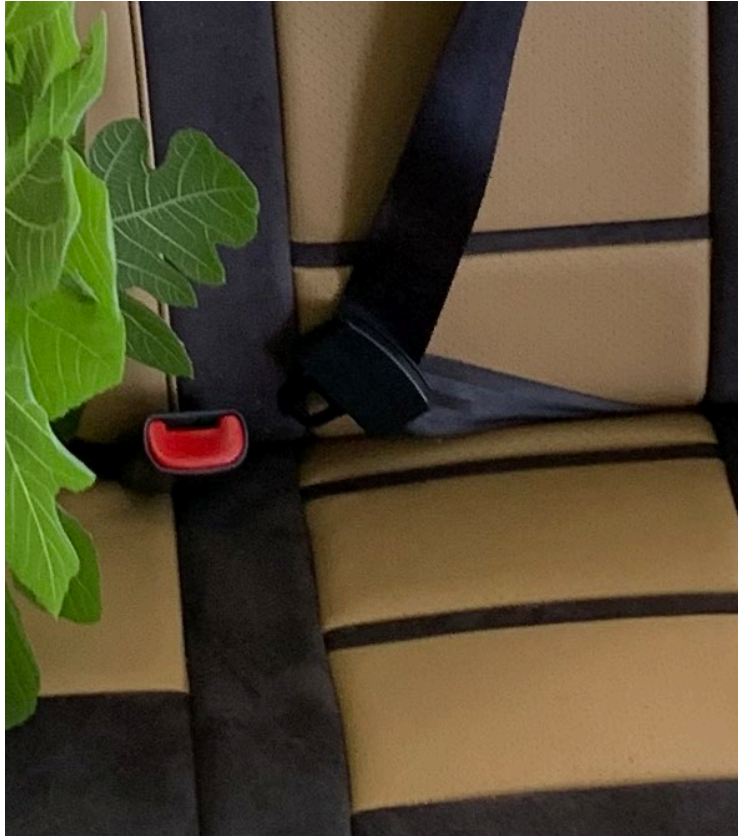
The left portion measured 21.2 inches from the webbing attachment point to the center of the load bar. The push button buckle (see figure 16) functioned, and no anomalies or damage was noted. The torso webbing label noted that it was manufactured by AmSafe (PNR: 3228-2-011-2396, MFR: 35FB9, DMF: A0522, S/A: 3228-2070112396, S/O: S457335-16, C/PNR: 39684-002-2396, conforms to FAA TSO-C114, rated 3000 pounds, to be repaired by AmSafe only). The buckle webbing label noted the following: PNR: 3228-2-011-2396, MFR: 35FB9, DMF: A0422, S/A: 3228-2010112396, S/O: S457335-6, C/PNR: 39684-001-2396, conforms to FAA TSO-C114, rated 3000 pounds, to be repaired by AmSafe only.

**Figure 16.** The push button buckle for the rear seat positions.
