## The National Transportation Safety Board

Office of Aviation Safety  
Central Region  
Memorandum for the Record  
Engine Examination Findings  
CEN22LA144  
Minot, North Dakota  
March 11, 2022

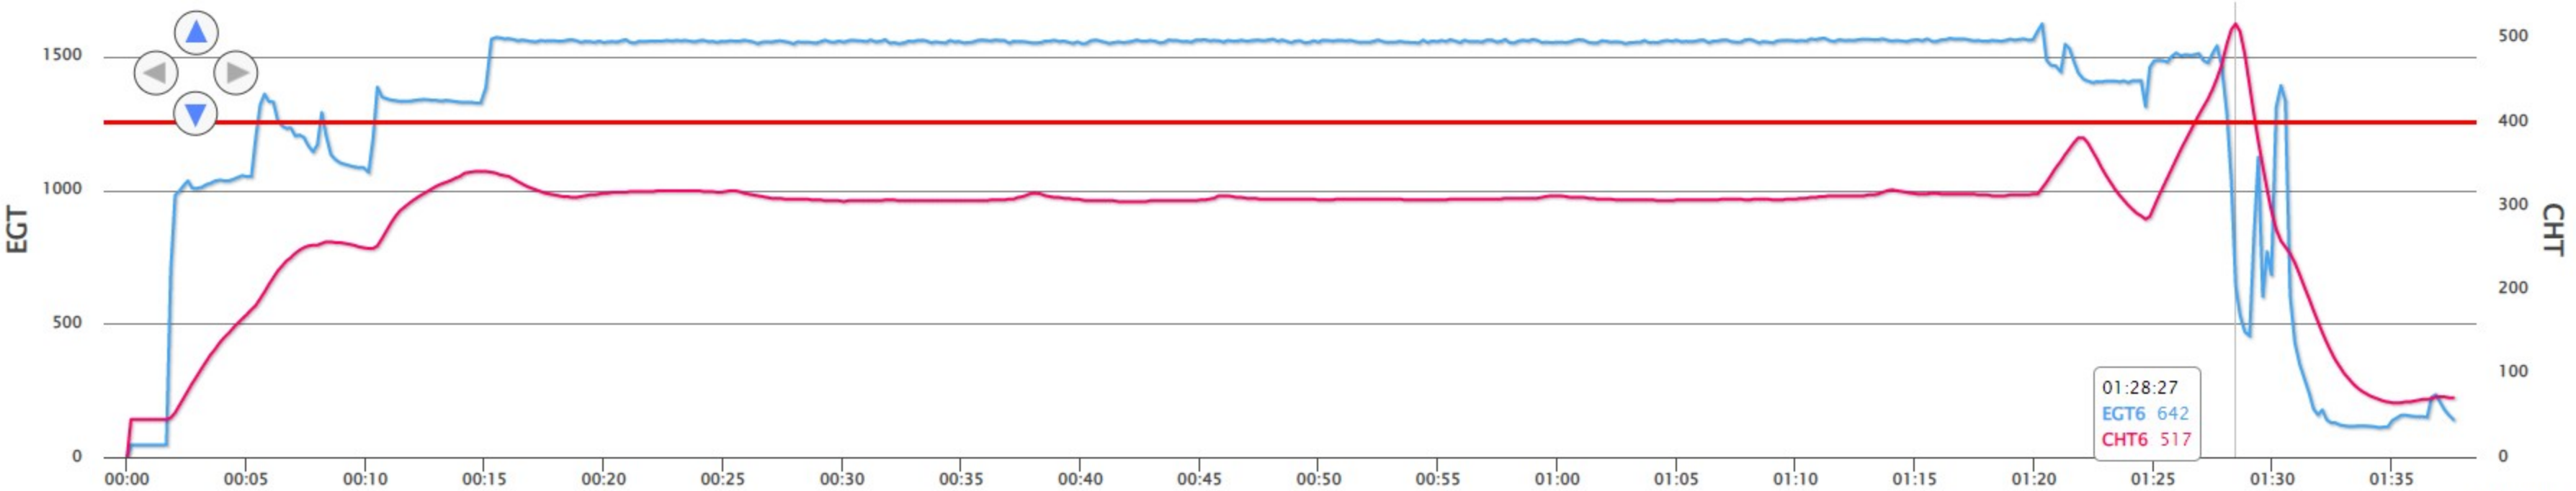
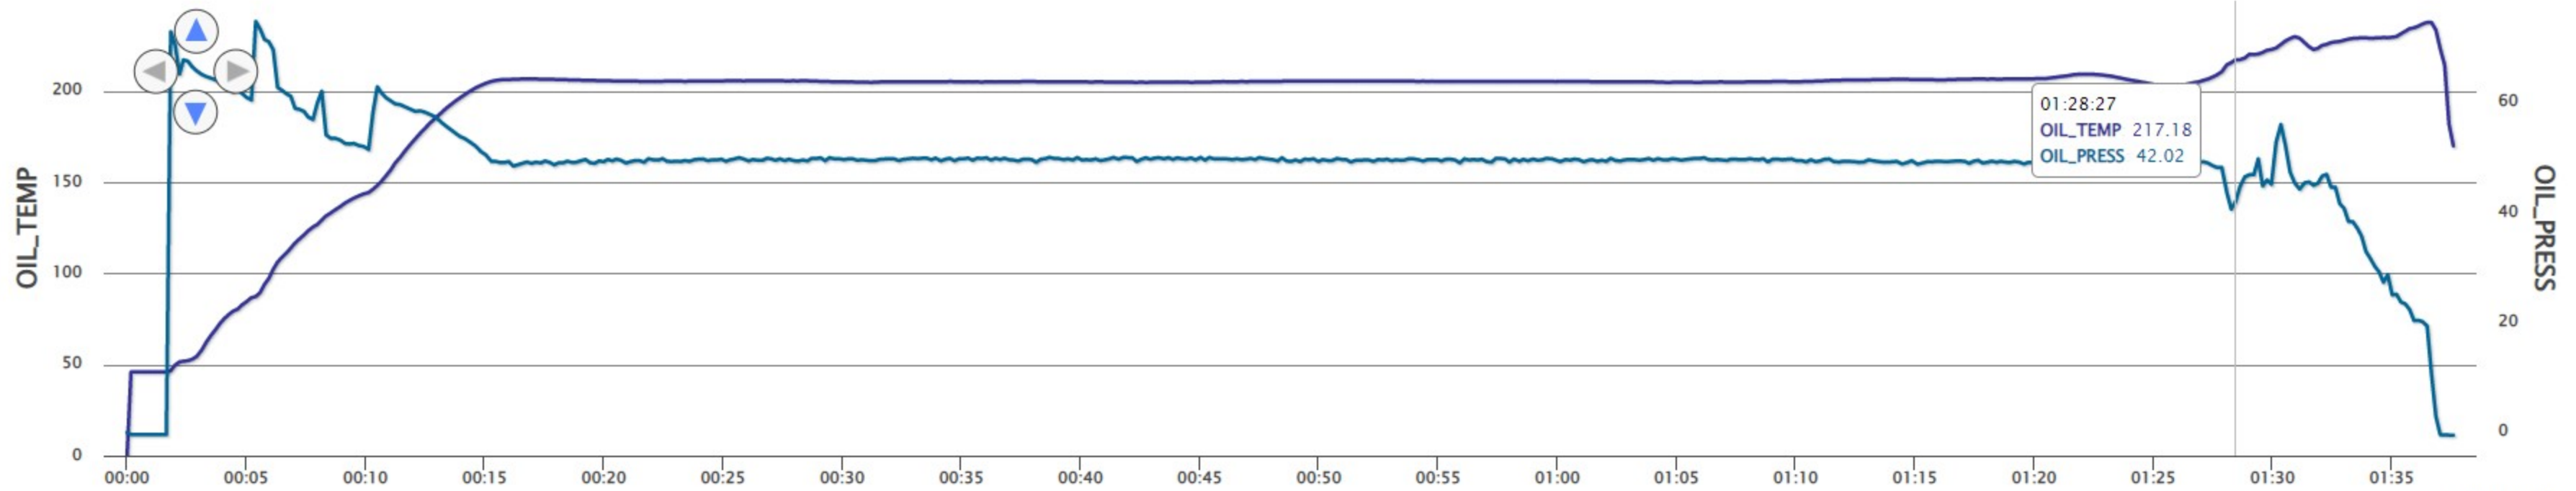
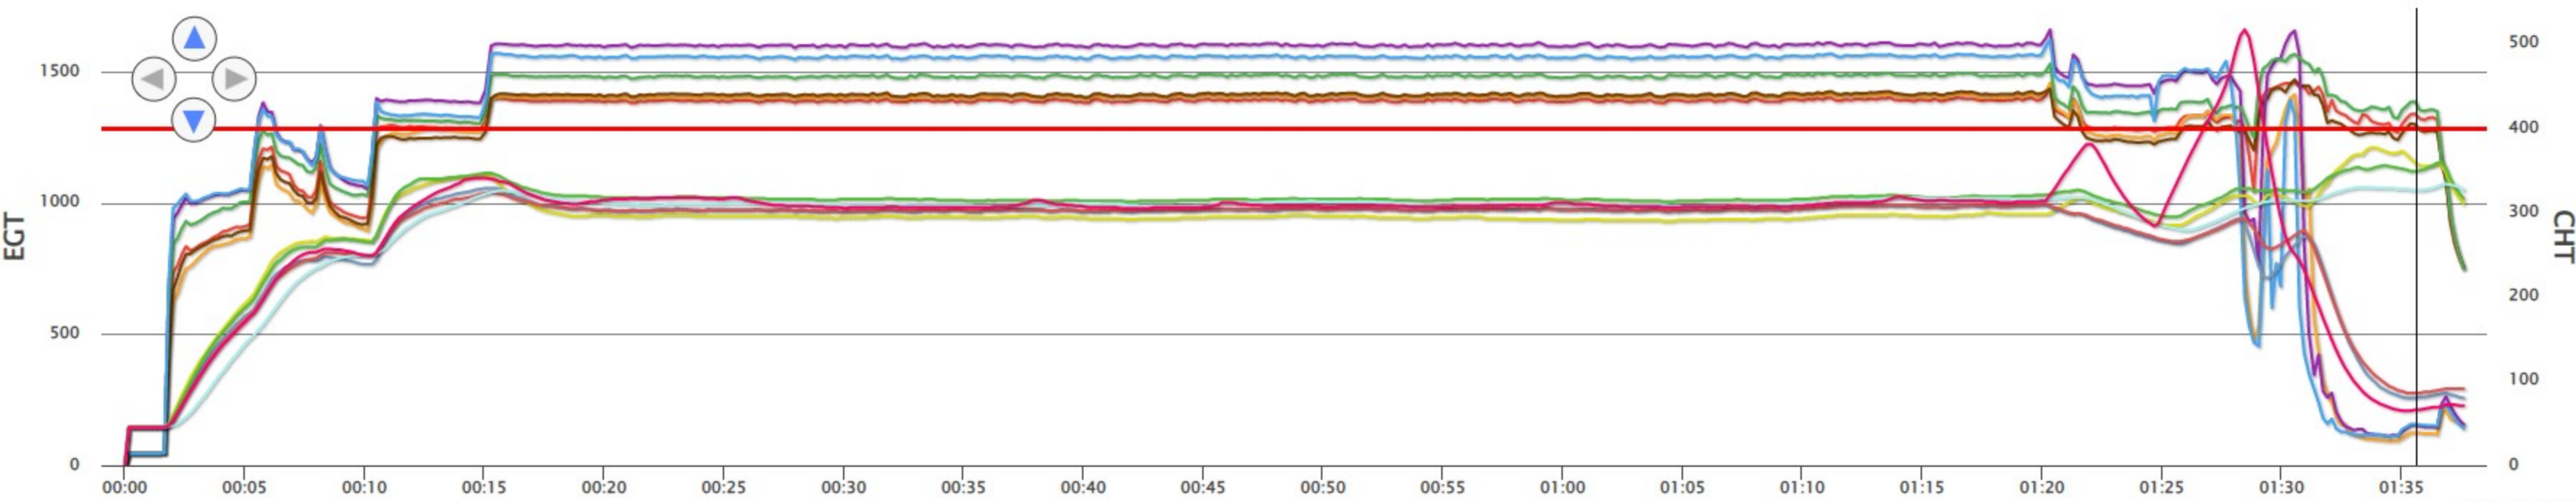
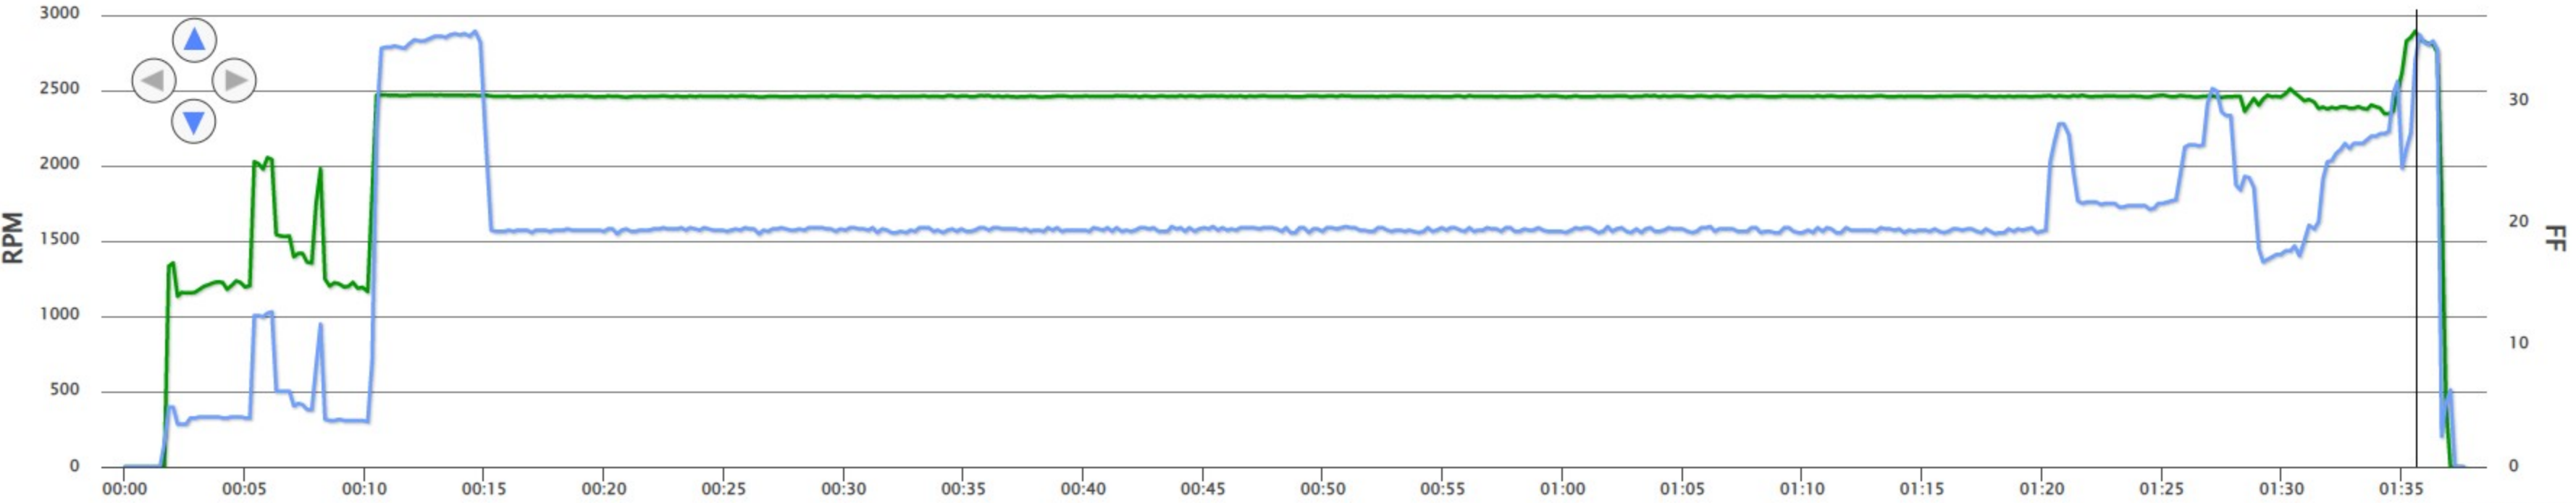
Downloaded engine monitoring data showed that cylinder #6 failed in flight. The data also shows cylinder's #2 & #4 failing shortly after, resulting power to be reduced drastically. The data plots are attached to this memorandum.
