## **CEN22LA146 - N500MZ NTSB Examination Report**

## **Engine Investigation Report**

**Rolls-Royce Corporation  
Model 250-C20R/2  
Engine CAE-295832**

**Accident date: 17 March 2022  
Wreckage exam date: 5 April 2022  
Engine exam date: 20 April 2022  
Report date: 29 April 2022  
NTSB Case: CEN22LA146**

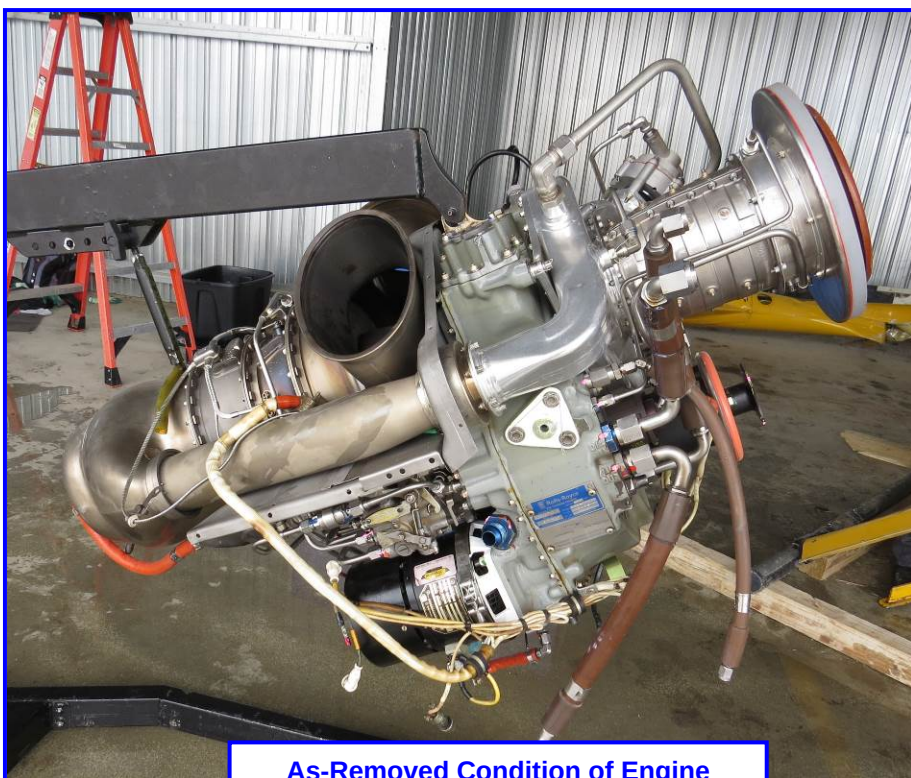
As-Removed Condition of Engine

The 4th-stage turbine blades appeared undamaged when inspected as did the surrounding turbine sections and exhaust plenum. The compressor inlet was also undamaged and exhibited no indication of FOD ingestion.

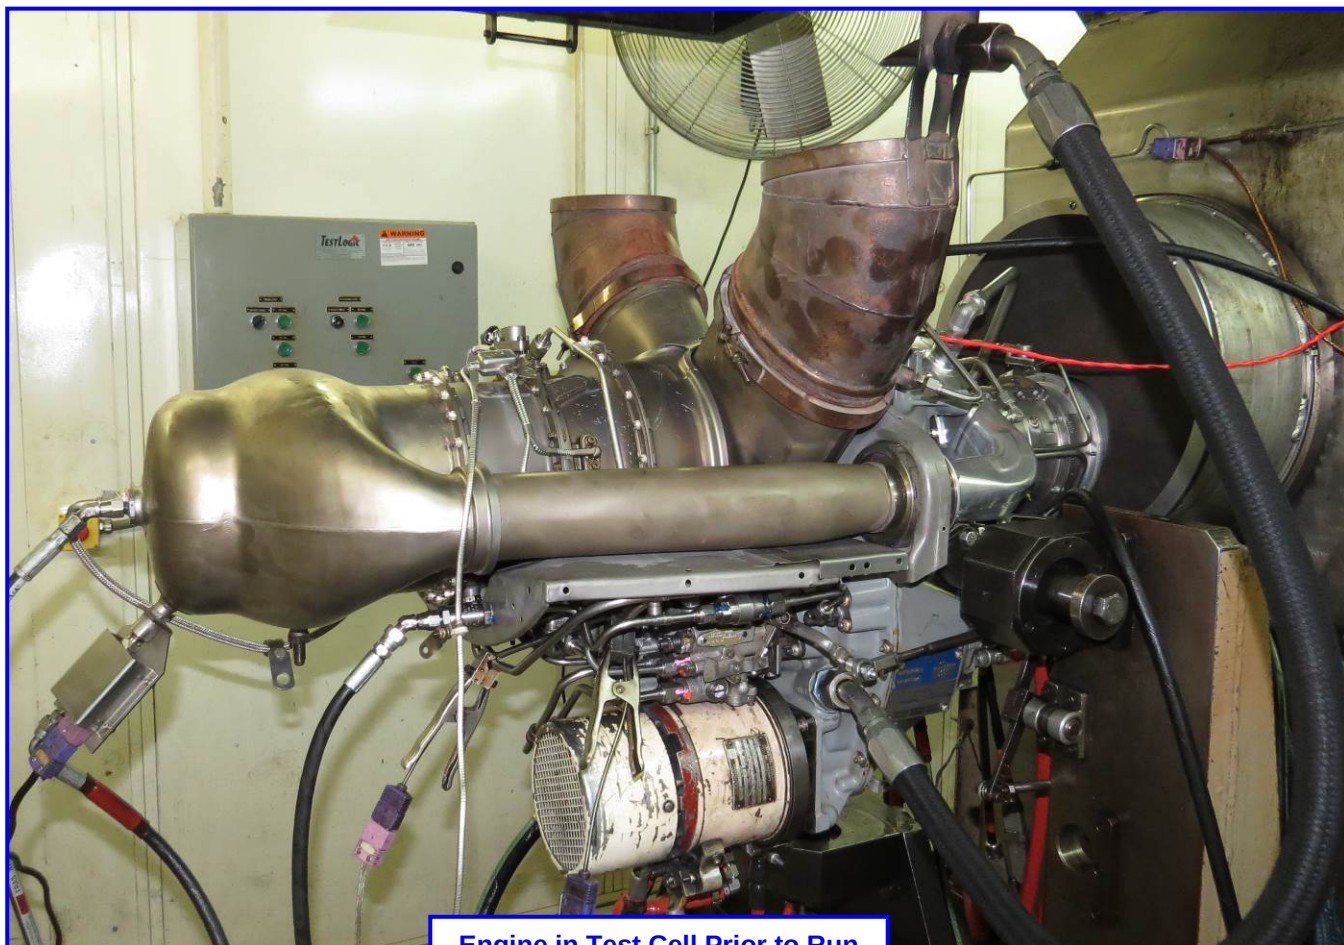
Engine in Test Cell Prior to Run

Prior to performing the standard performance test, the Pc tube B-nut was run down to the same position shown previously in Figure 2. This was intended to replicate its position following the FCU replacement on the aircraft. The engine started & during acceleration, with the starter still engaged, the engine abruptly went to an idle/sub-idle condition. Examination revealed the subject B-nut connection had separated (backed off) at the FCU presenting a similar scenario as that during the mishap flight. The B-nut was refitted & tightened using the OMM specified P/N 23083893 B-nut torque adapter wrench. The engine subsequently performed satisfactorily on the test cell.
