# National Transportation Safety Board

CEN22LA153

## **PIPER PA46 RUNWAY EXCURSIONS STUDY**

April 20, 2026

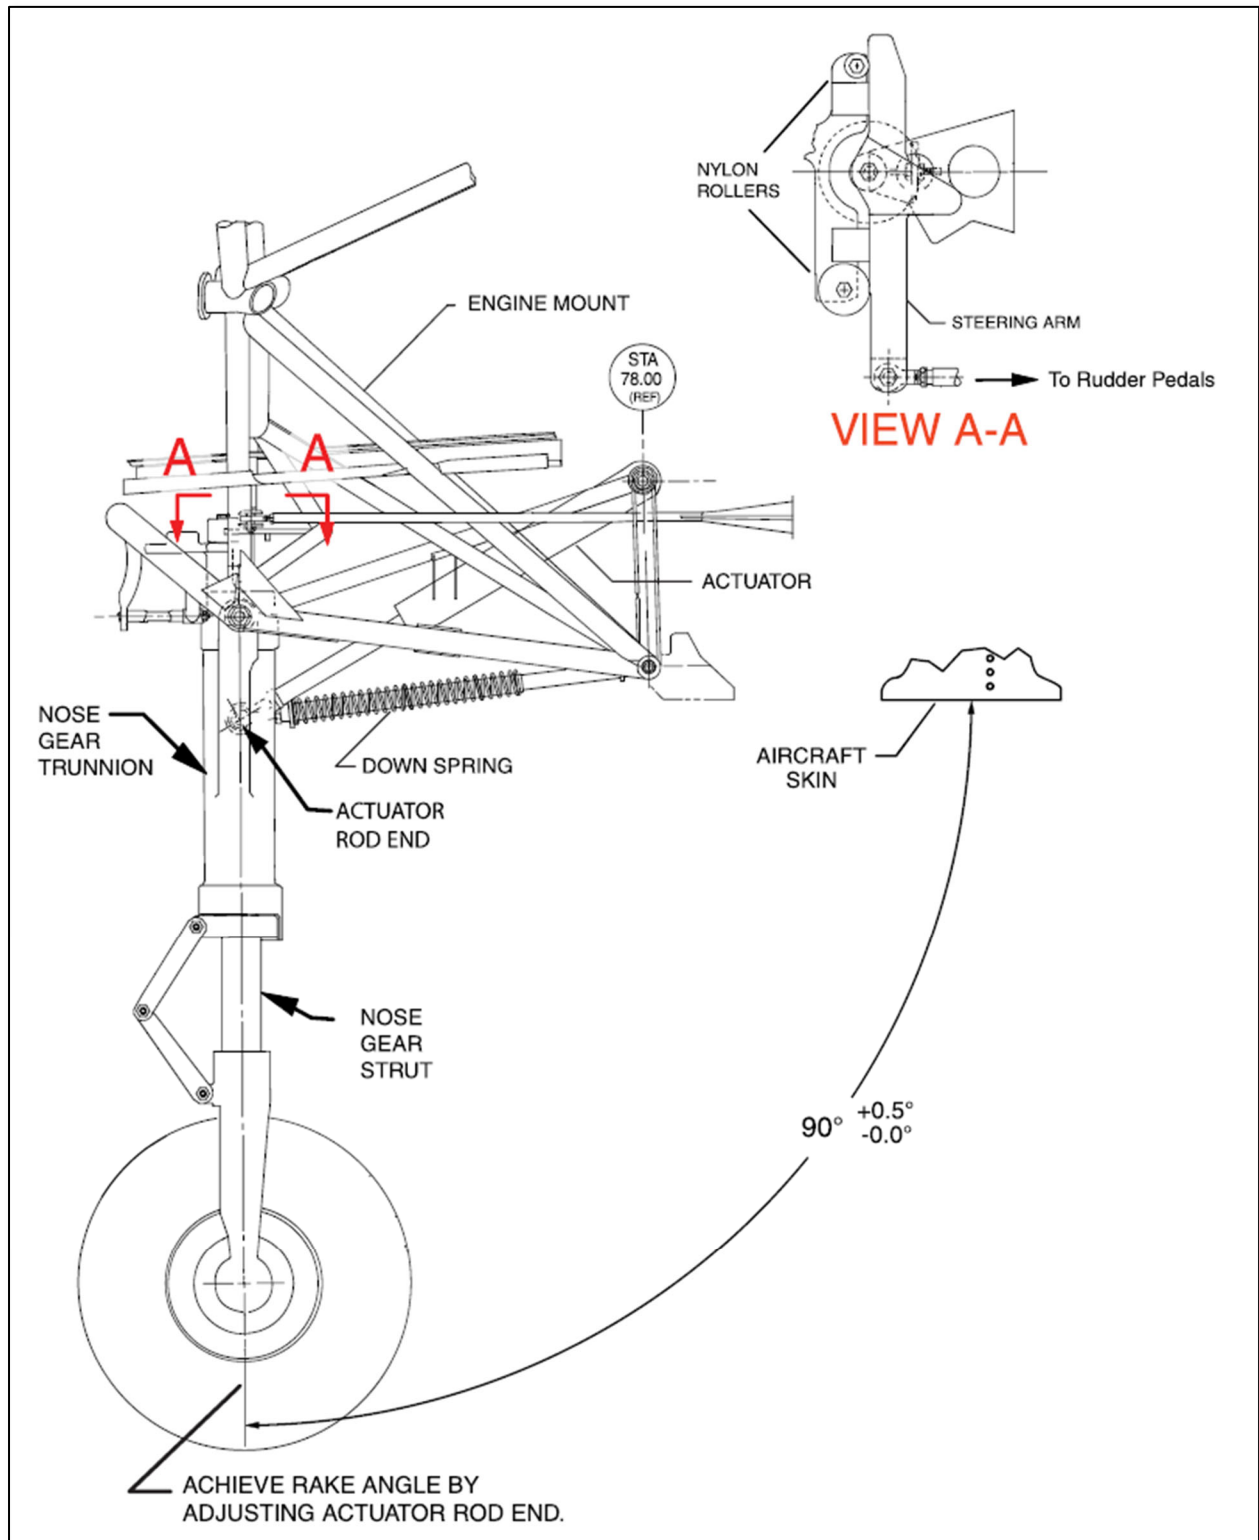
The instructor then goes through a detailed description of the PA46 NLG system with several illustrations and photographs, including those presented in Figures 3 and 4, paying particular attention to the importance of the proper NLG rake angle, steering horn roller gaps, and compliance with SB 1286D. The instructor also mentions the CEN22LA153 accident and the NTSB's investigation of that case, along with the NTSB final report (Reference 1). The instructor provides a description of neutral, positive, and negative stability using the example of a ball bearing on a flat, concave, and convex surface. He discusses the effect of rake angle on the NLG directional stability, but like the CEN22LA153 final report, does not refer to the effects of pneumatic or dynamic trail.

**Figure 4.** PA46 nose landing gear rake angle drawing from Piper Customer Information Letter dated 3/27/2008 (Reference 10).

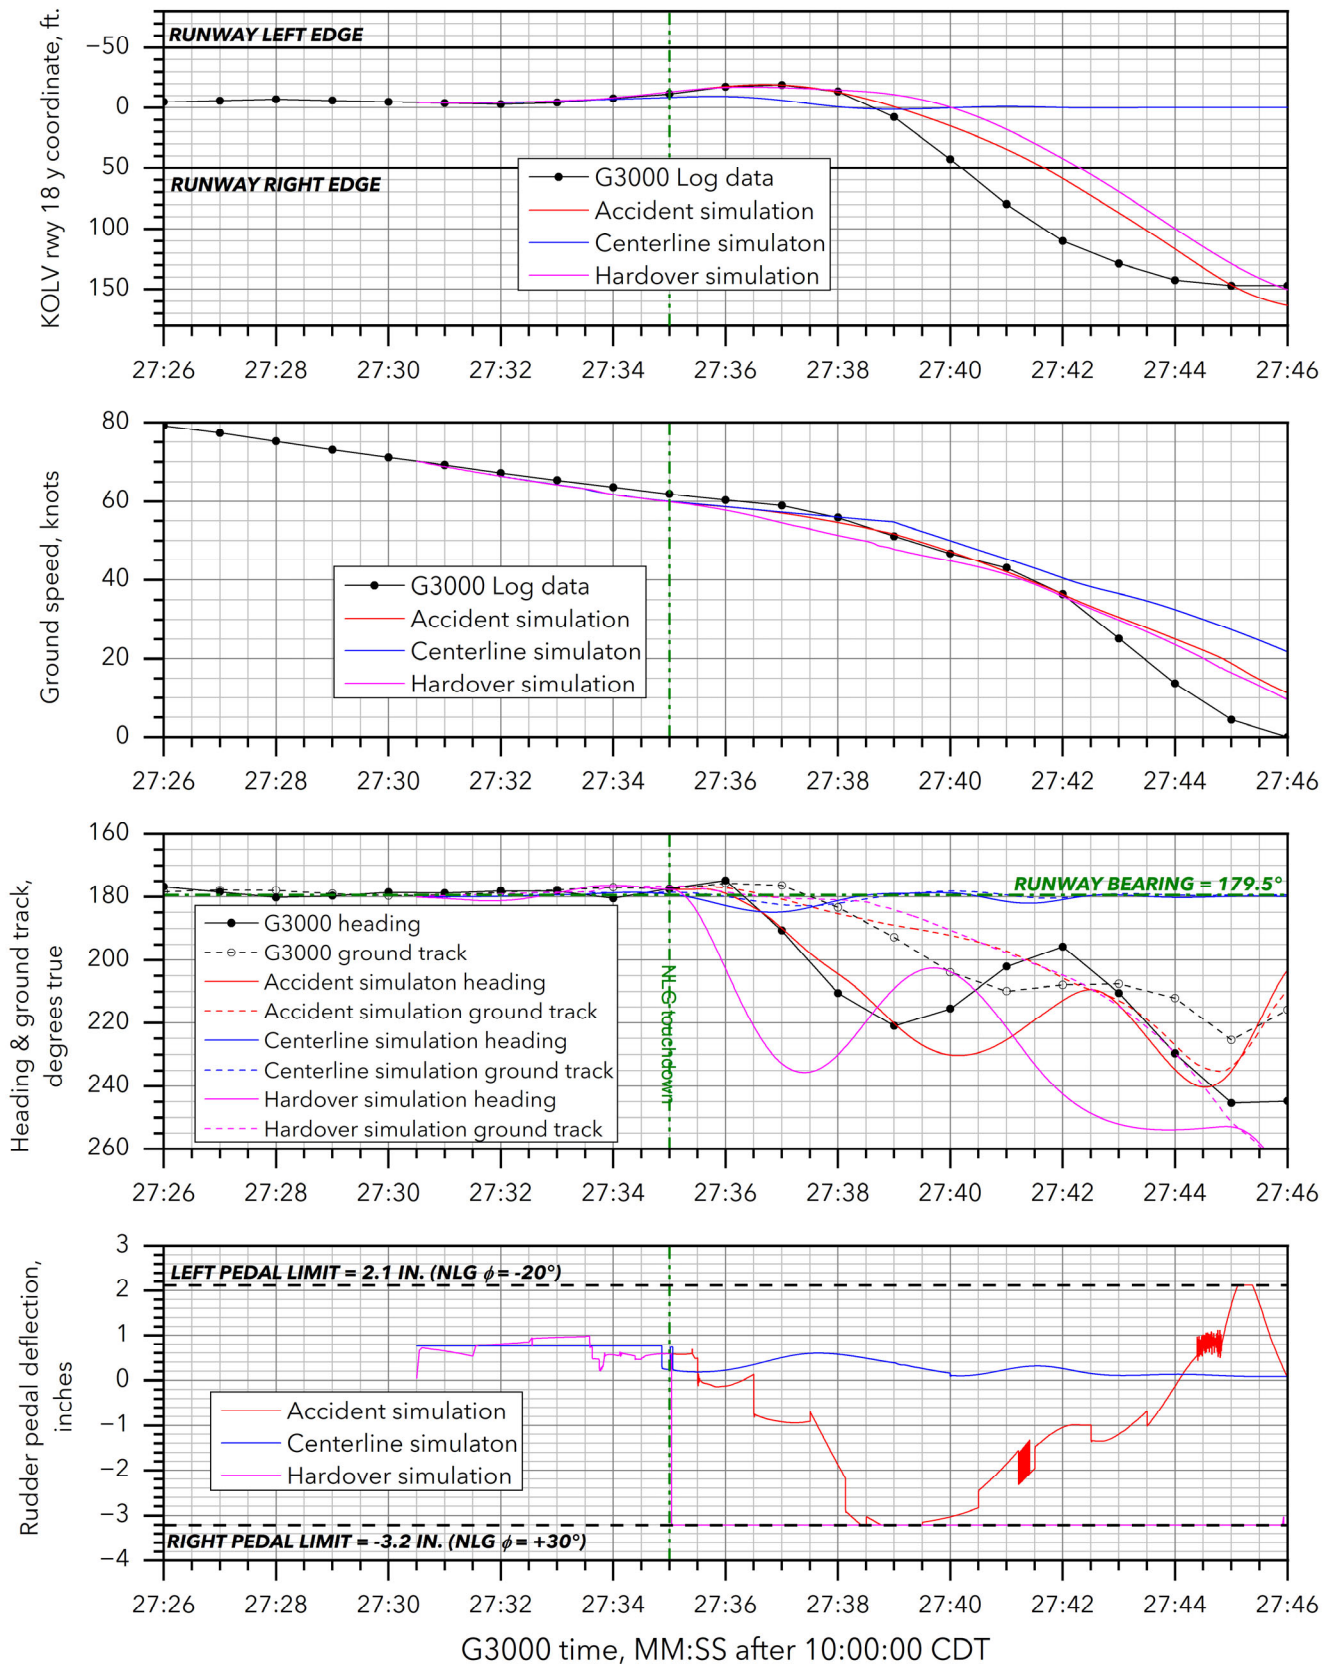
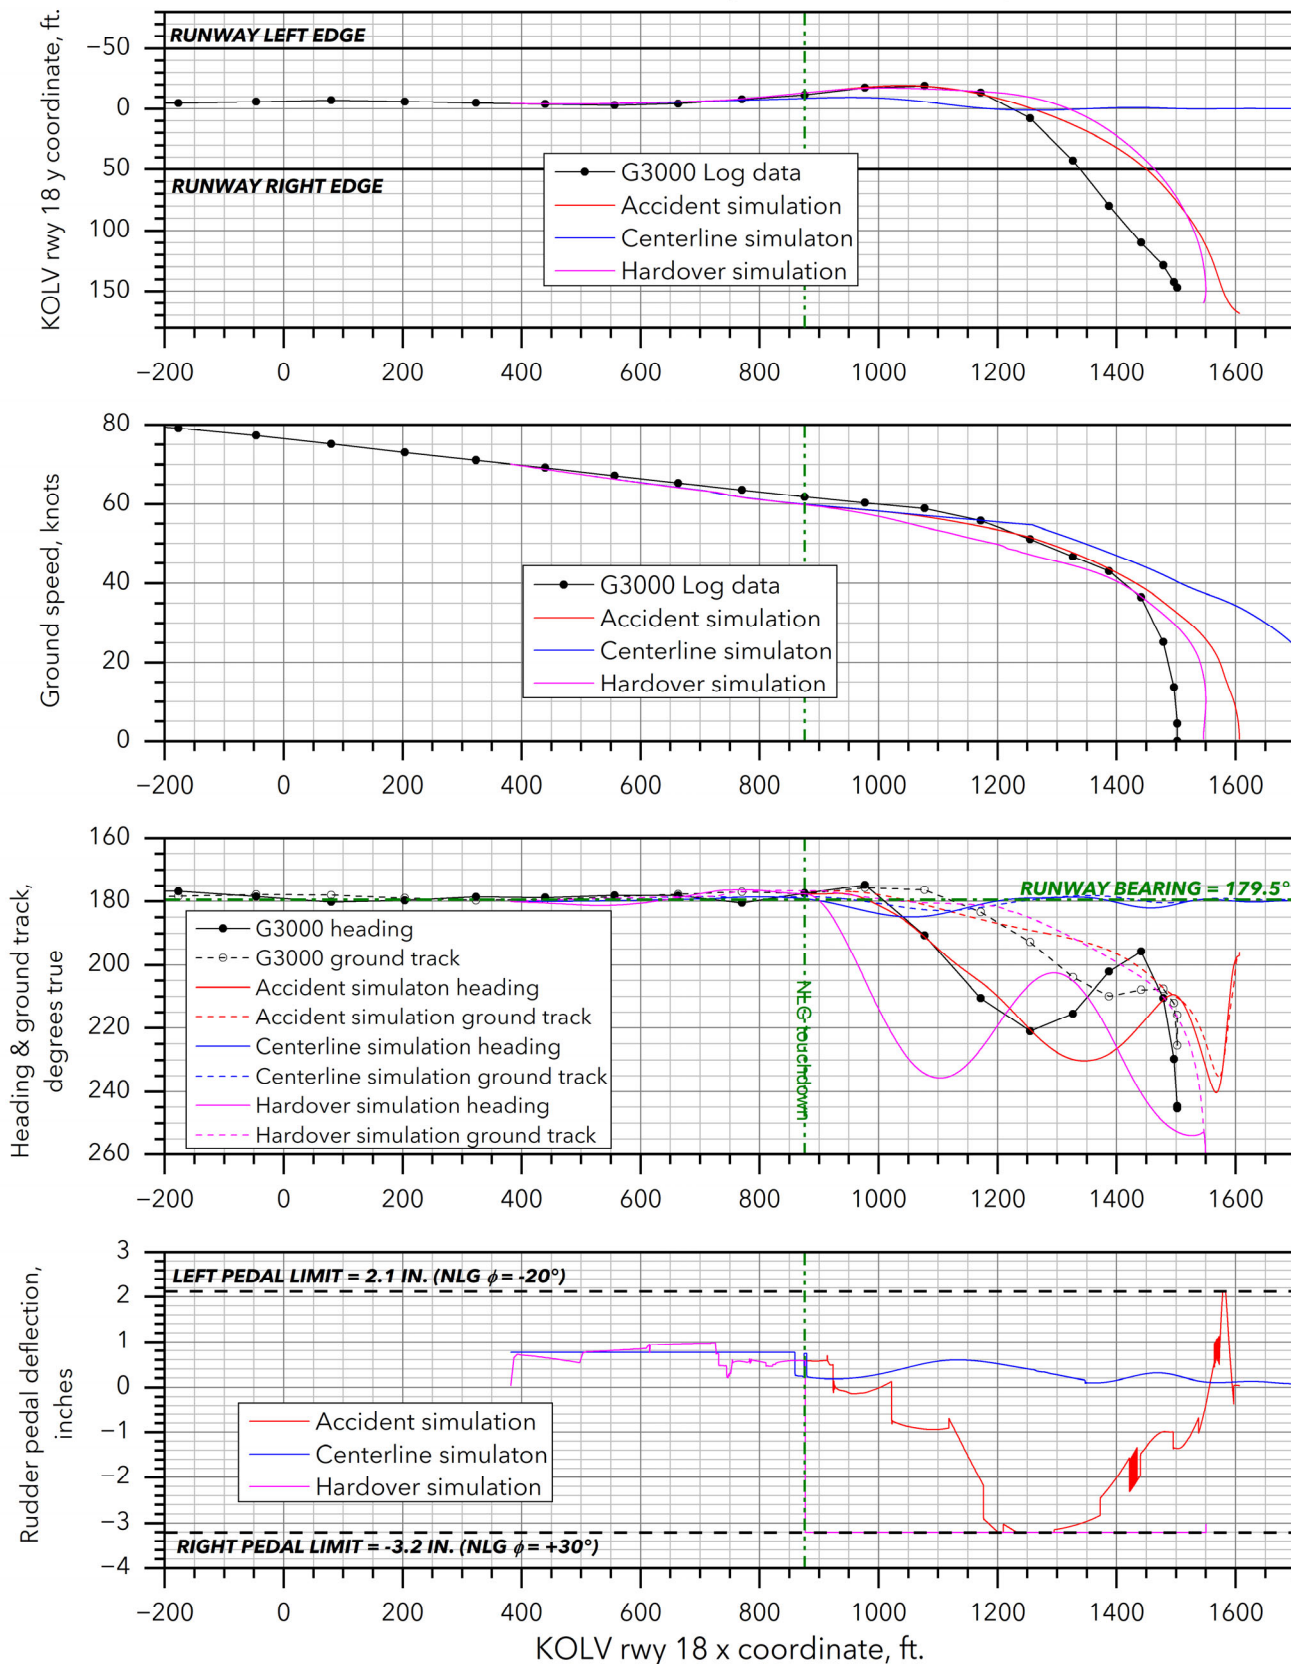
The match of the CEN22LA153 accident in Figure 20 (the “accident simulation”) is far from perfect, even with the math pilot driving the rudder pedals in an attempt to duplicate the recorded ground track, indicating that the simulation gear model does not account fully for all of the physics involved. However, the simulation does match the recorded data fairly well during the initial seconds of the veer to the right, and indicates that while full nose-right deflection of the NLG is required to approximately match the dynamics recorded in the CEN22LA153 data, a better match is obtained if the NLG rotates from centered to full-right over about 3 seconds (the “accident simulation”), instead of snapping to full-right almost instantly after NLG touchdown (the “hardover simulation”).

The sudden jumps and ringing in the “accident simulation” rudder pedal data in Figure 20 are artifacts of the logic of the math pilot. Similar results could be obtained with a rudder pedal trace that “smooths” through the jumps shown in Figure 20.

Figure 20 also indicates that the math pilot can track the runway centerline with relatively small rudder pedal inputs (the “centerline simulation”).

Because the G3000 data does not include rudder pedal force, rudder pedal position, rudder surface position, or NLG steering angle parameters, the actual value of these parameters during the CEN22LA153 accident landing cannot be determined. However, the “accident simulation” shown in Figure 20 indicates that a substantial right rudder pedal input is required shortly after NLG touchdown in order to approximately match the heading and track data that the G3000 does record. Further, the magnitude and suddenness of the veer are hard to explain without a substantial deviation of the NLG steering angle. The similarity of the CEN22LA153 event with the other M600 veer events plotted in Figures 17 and 18 suggests that the NLG steering angle likely deviated shortly after NLG touchdown in those events as well (with the exception, perhaps, of case CEN23LA137\_N13HL). Granting that the NLG steering angle (and rudder pedals) in the CEN22LA157 case did behave approximately as depicted in the “accident simulation” scenario plotted in Figure 20, it is of interest to consider whether the rudder pedal movements could have been the result of forces applied by the pilot with his feet, or of a destabilizing  $M_z$  on the NLG that “drove” the pedals through the mechanical linkage to the NLG, or of a combination of these factors.

The "accident simulation" scenario in Figure 20 indicates that the pilot's application of "incorrect braking and steering technique," per the PFR's assertion, must have been egregious indeed, since it indicates that full-right rudder deflection (and not simply a non-centered NLG at touchdown) is required to approximately match the G3000 data.

**Figure 20a.** Accident and simulation data comparisons vs. time.

**Figure 20b.** Accident and simulation data comparisons vs. runway x coordinate.

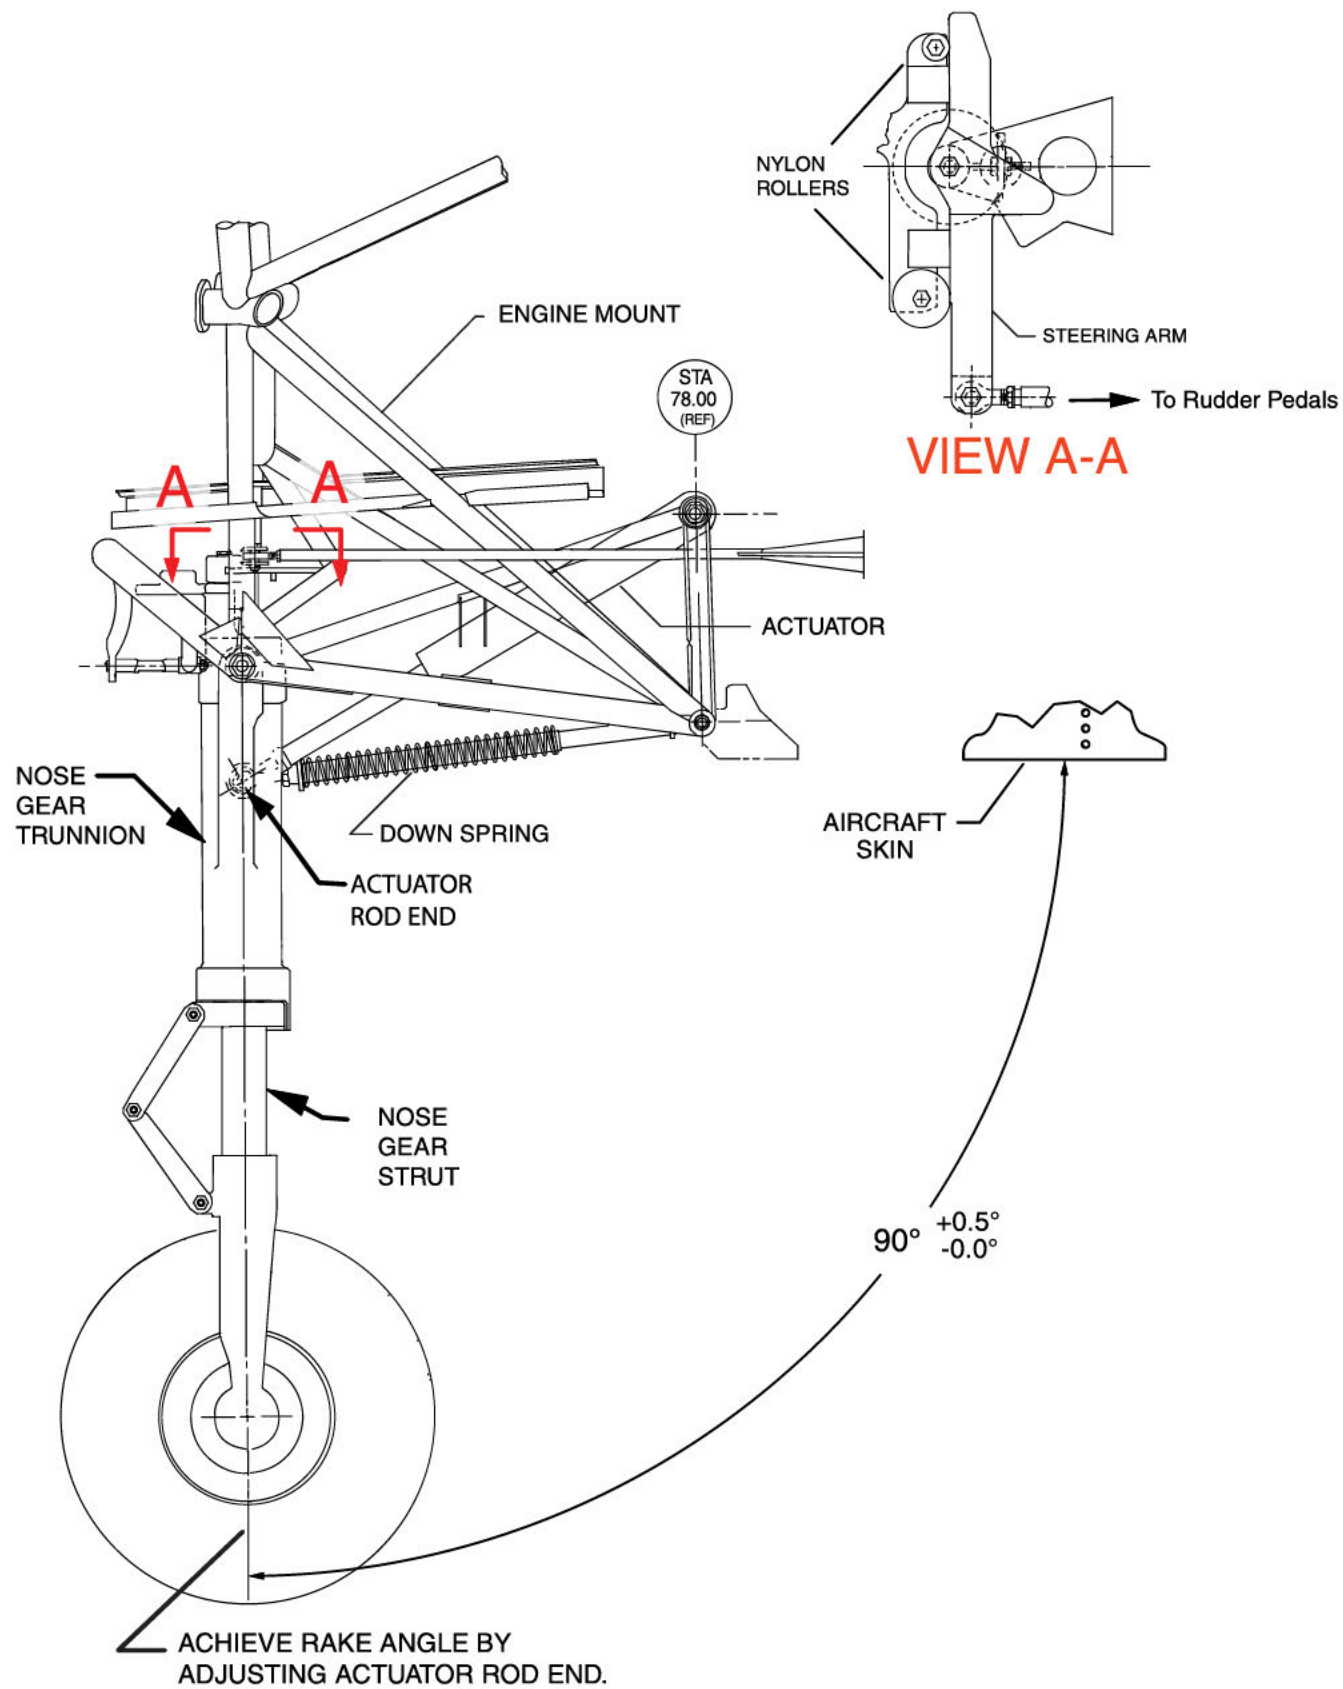
Figure 1

The proper nose gear rake angle for all Malibu models is zero to one-half degree forward from vertical, measured using the airframe lower skin just aft of the nose gear doors as a horizontal datum with the aircraft on jacks. In other words, the relative angle between the lower (belly) skin and the nose gear strut should range from 90.0 degrees to 90.5 degrees. See figure 1.

The nose gear rake angle is properly adjusted and verified at the factory and should be inspected and/or adjusted by an FAA-licensed mechanic according to the schedule and instructions in the maintenance manual, any time the pilot experiences poor steering, or there is replacement or service to the nose gear trunnion, the nose gear actuator, or the engine mount.

Left side view of Malibu Nose Gear
