RE: Petition for Reconsideration NTSB Accident Number CEN22LA153

**Re: Piper Aircraft, Inc. Petition for Reconsideration and Modification of Findings, Analysis and Determination of Probable Cause, and Request for Oral Presentation: Accident Number CEN22LA153, Olive Branch, Mississippi, March 23, 2022, Aviation Investigation Final Report with Probable Cause and Findings, (the "NTSB Report").**

| Title : | REVIEW OF NTSB REPORT CEN22LA153 | |

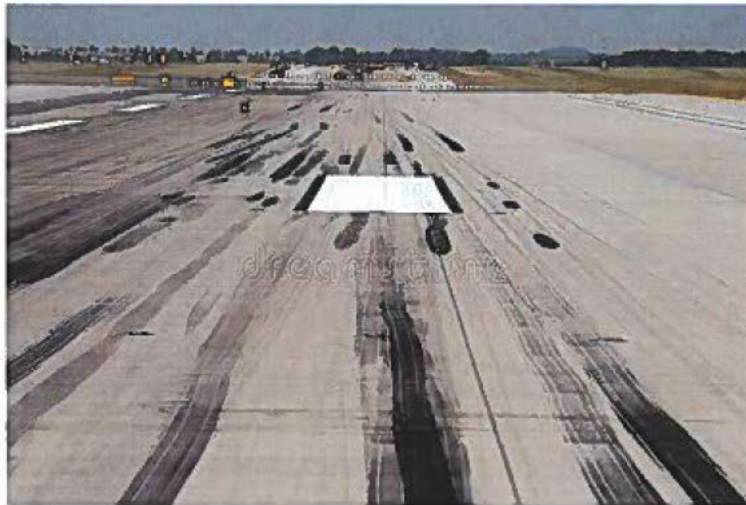
Examples of tire marks showing sudden directional changes are shown in Figure 6 and Figure 7. For the NLG's dynamic instability to be significant enough to change the aircraft's direction requires: (1) the NLG must be in ground contact. (2) The tire marks must show sudden directional change preceding any

significant heading change. No such evidence is visible in the photographs presented in reference [1]. Therefore, the claim that dynamic instability contributed to the accident is not supported.

**Figure 6: Examples of tire marks showing rapid lateral change of the tire direction (close to bottom of photo). (NOT the accident scene.)**

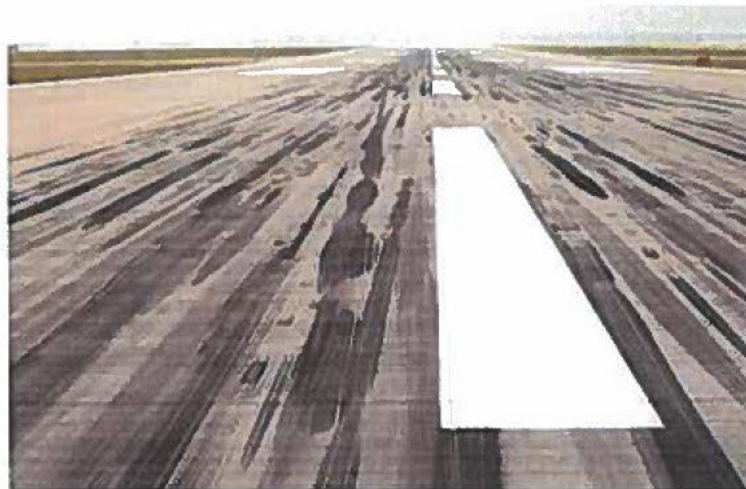
Figure 7 shows signs of vertical oscillation (bouncing) of an aircraft after landing. The asymmetric contact pattern indicates it landed slightly skidded, perhaps due to crosswind. Per paragraph 2.4.5 of reference [7], the length of the centerline stripe should be 120 ft. The instability is seen to last between 90 to 120 ft. In aircraft, the damped oscillation is usually highly transient, lasting less than a second. If it is not, it is called *shimmy*. Shimmy is not alleged in reference [1] and, thus, beyond the scope of this report. The main point is that reference [1] does not state how the tire marks confirm dynamic instability.

**Figure 7: Example of tire marks showing rapid vertical oscillation of a tire (just left of runway centerline). (NOT the accident scene.)**
