**NATIONAL TRANSPORTATION SAFETY BOARD**

**INVESTIGATION SUMMARY**

**CEN22LA156**

## **B. ACCIDENT SUMMARY**

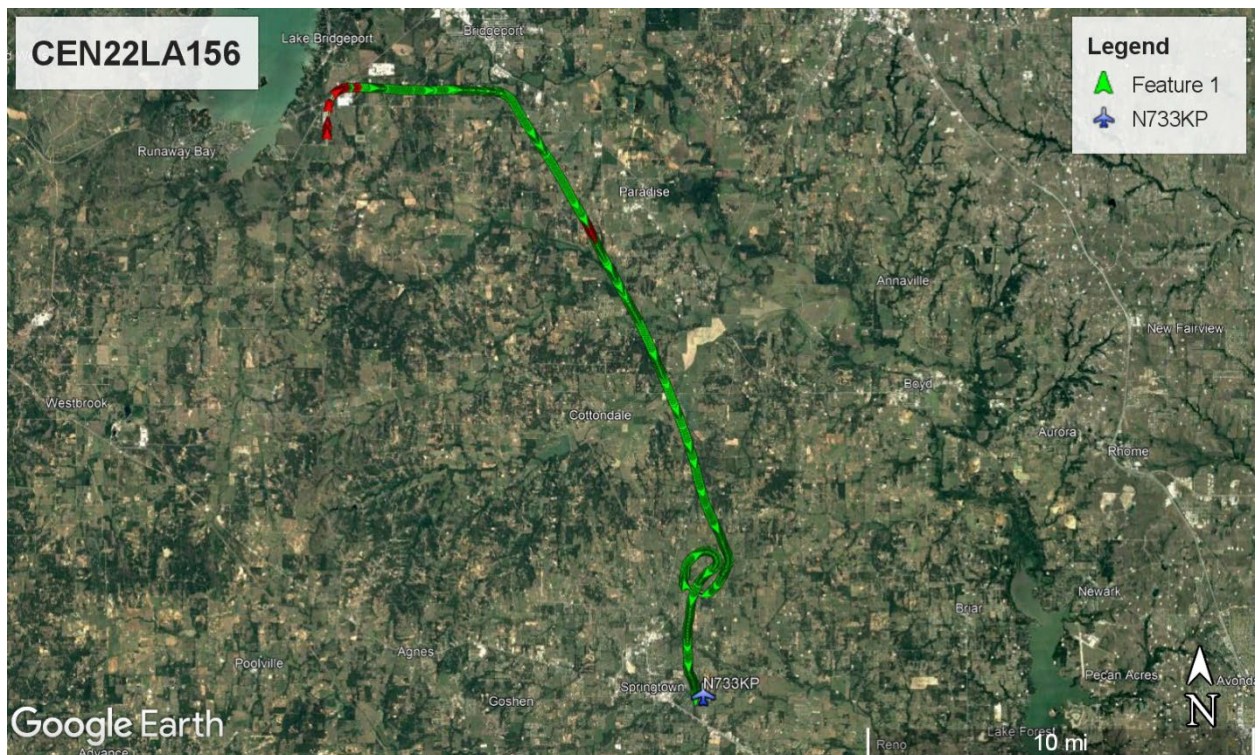
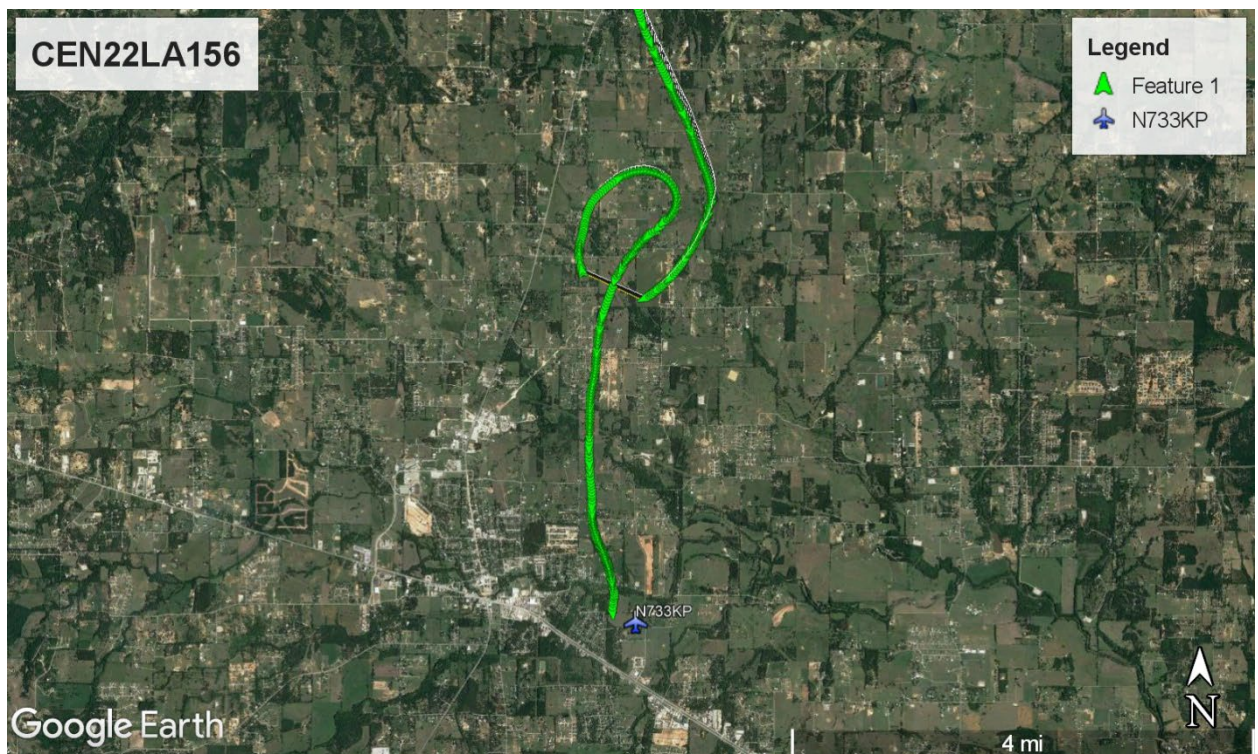
Max glide distance from 2,000 ft is 3 nm. Airplane actually traveled 2.75 nm.  
 Max glide distance from 3,000 ft is 5 nm. Airplane traveled 5.62 nm and made a right turning descent near at the beginning of the event.

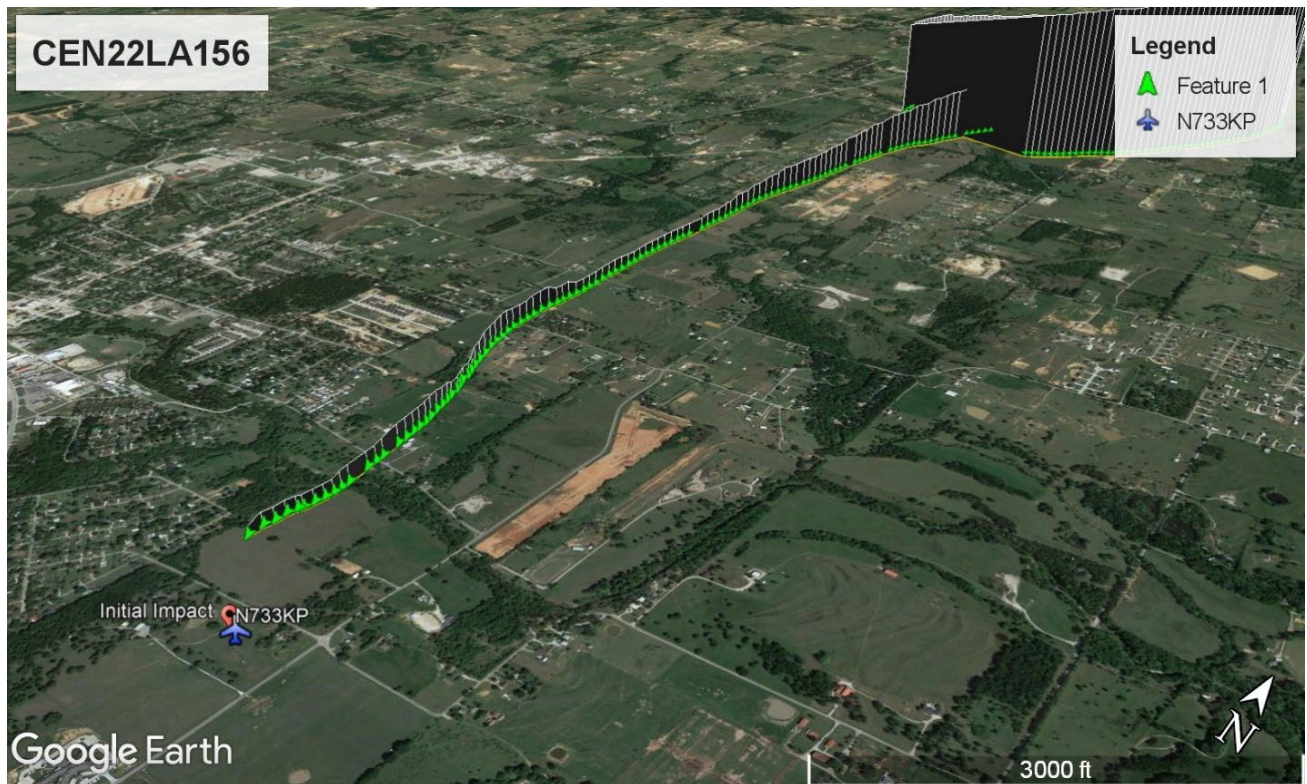
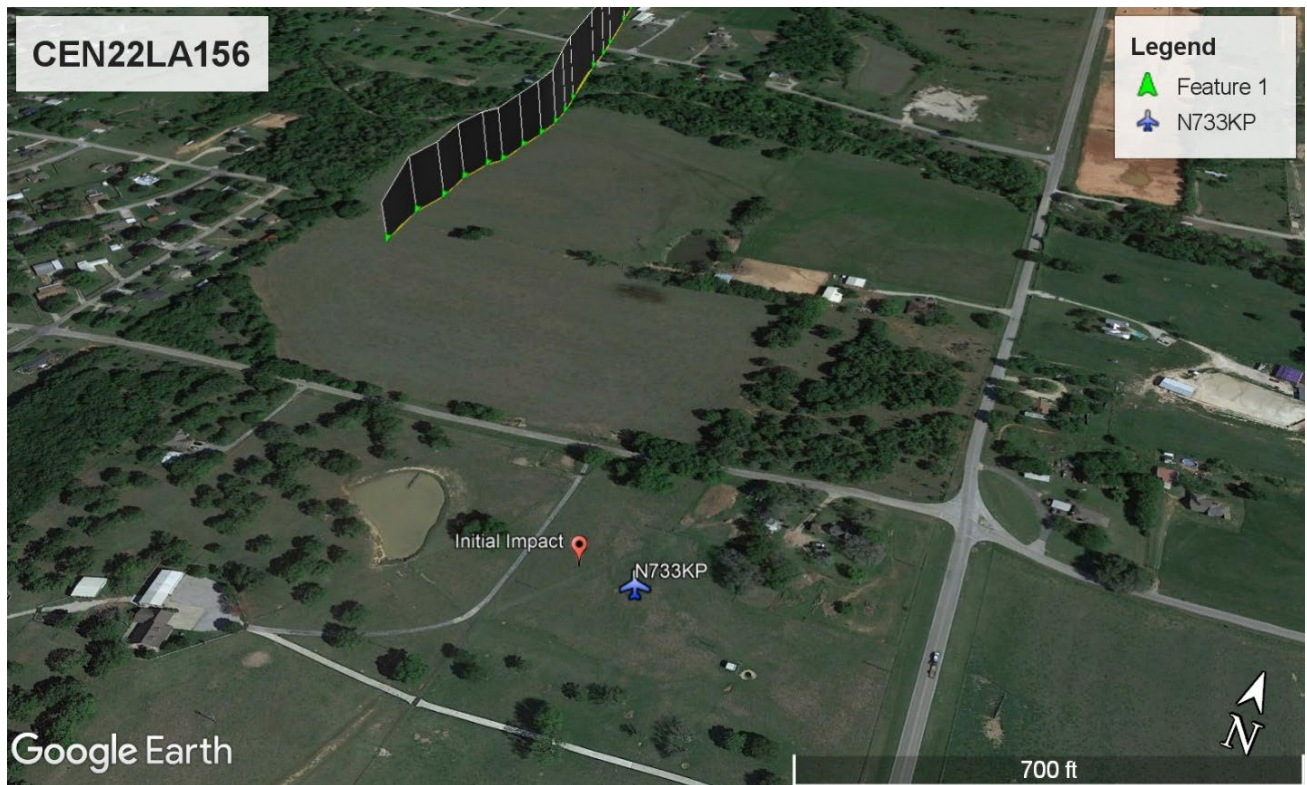
Airplane gained altitude two times during the final descent to the accident site.
