# National Transportation Safety Board

CEN22LA312

## **POWERPLANTS**

Group Chair's Factual Report

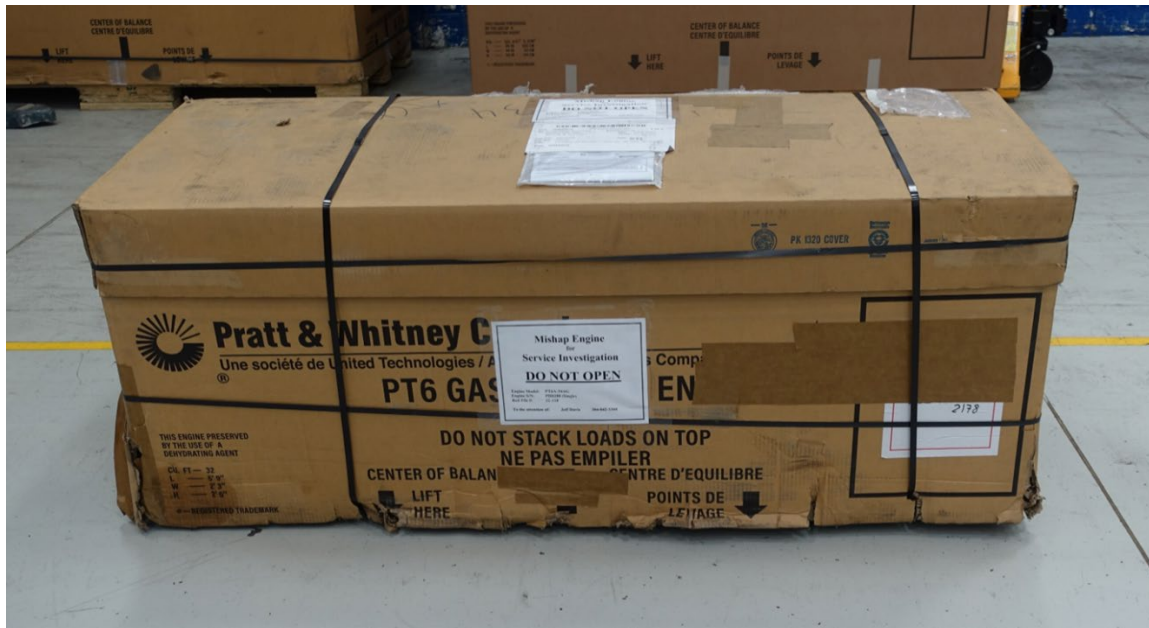
**Photo 3- Engine Shipping Container, as Received**

The engine was secured in a banded cardboard shipping container when the investigation team arrived at PWC-Bridgeport, West Virginia (**Photo 3**). There was no evidence of engine fire damage or radial uncontainment (**Photos 4, 5, and 6**). The exhaust case had deformation around the engine circumference. Loose metal fragments were collected in the exhaust duct at the 6 o'clock position aft of the PT blades (**Photo 7**). All PT rotor blades were broken at varying spanwise locations.

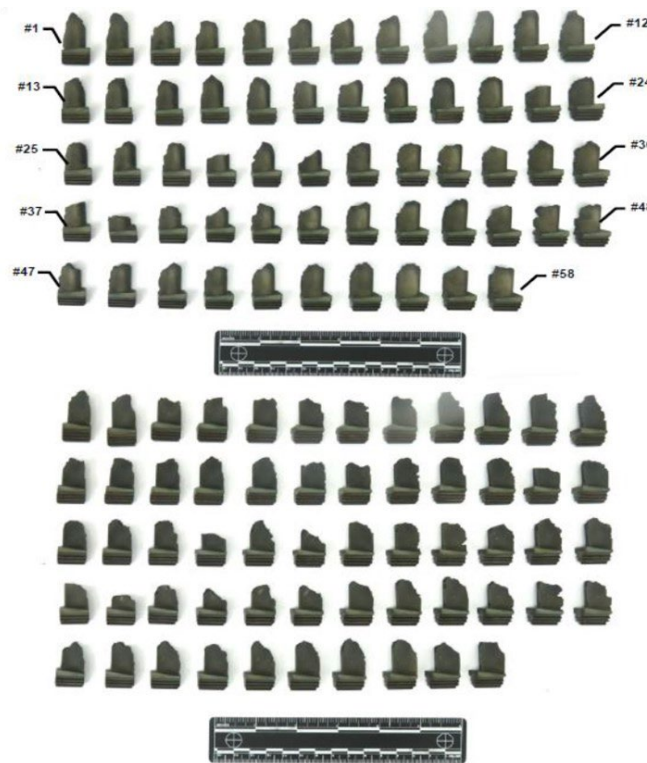
The complete set of 58 CT rotor blades were shipped to the PWC Materials Laboratory in Montreal, Québec, Canada for failure analysis (**Photo 20**). Blades No. 1 and No. 20 were sectioned to evaluate microstructure. Both blades exhibited solutioning of the gamma prime<sup>6</sup> (**Photo 21**). The PWC Materials Laboratory was unable to determine maximum temperature exposure or duration but stated that the solutioning observed in the microstructure occurs at temperatures above the published operating limits. A cross section of Blade No. 20 was examined 0.25 inches from the trailing edge with a scanning electron microscope. Micro-voids were observed perpendicular to the airfoil axis at the material grain boundaries (**Photo 22**). Micro-voids along the grain boundaries suggest creep<sup>7</sup>. Similar voids along the material grain boundary were observed when a cross section of blade No. 39 was viewed under the scanning electron microscope (SEM).

**Photo 20- Compressor Turbine Blade Set, as Received at the PWC Materials Laboratory, (Top) Suction Side, (Bottom) Pressure Side (Photos Courtesy of PWC)**
