**From:** Howell, William J (FAA) <[REDACTED]>  
**Sent:** Thursday, July 14, 2022 2:35 PM  
**To:** Williams Shaun  
**Subject:** Fuel Sump results- N478WT accident aircraft Rapid City, SD PA24-260.  
**Attachments:** 20220714\_075407.jpg; 20220714\_075355.jpg; IMG\_2132.JPG

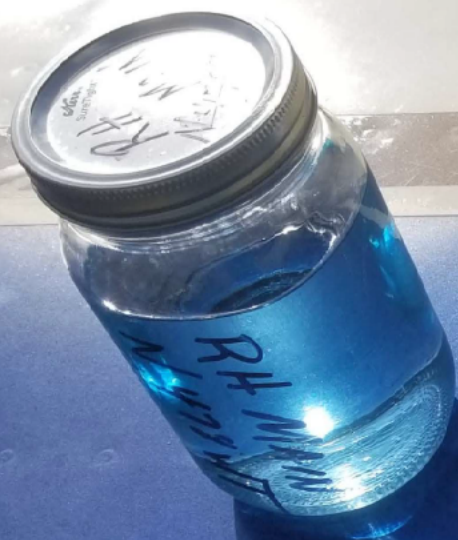
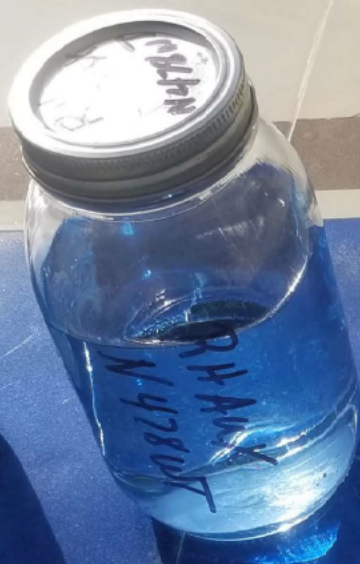
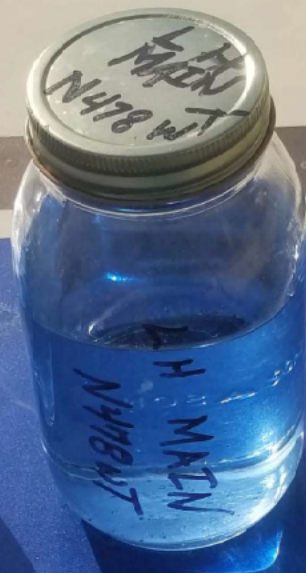
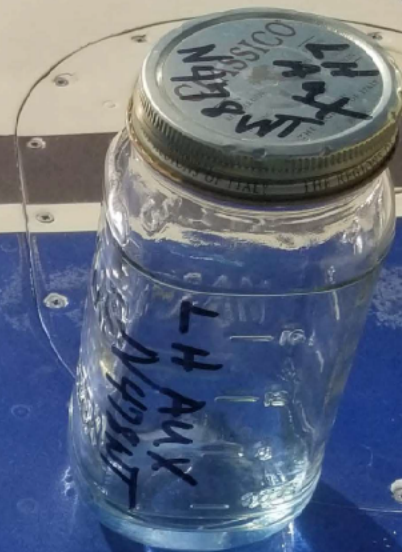
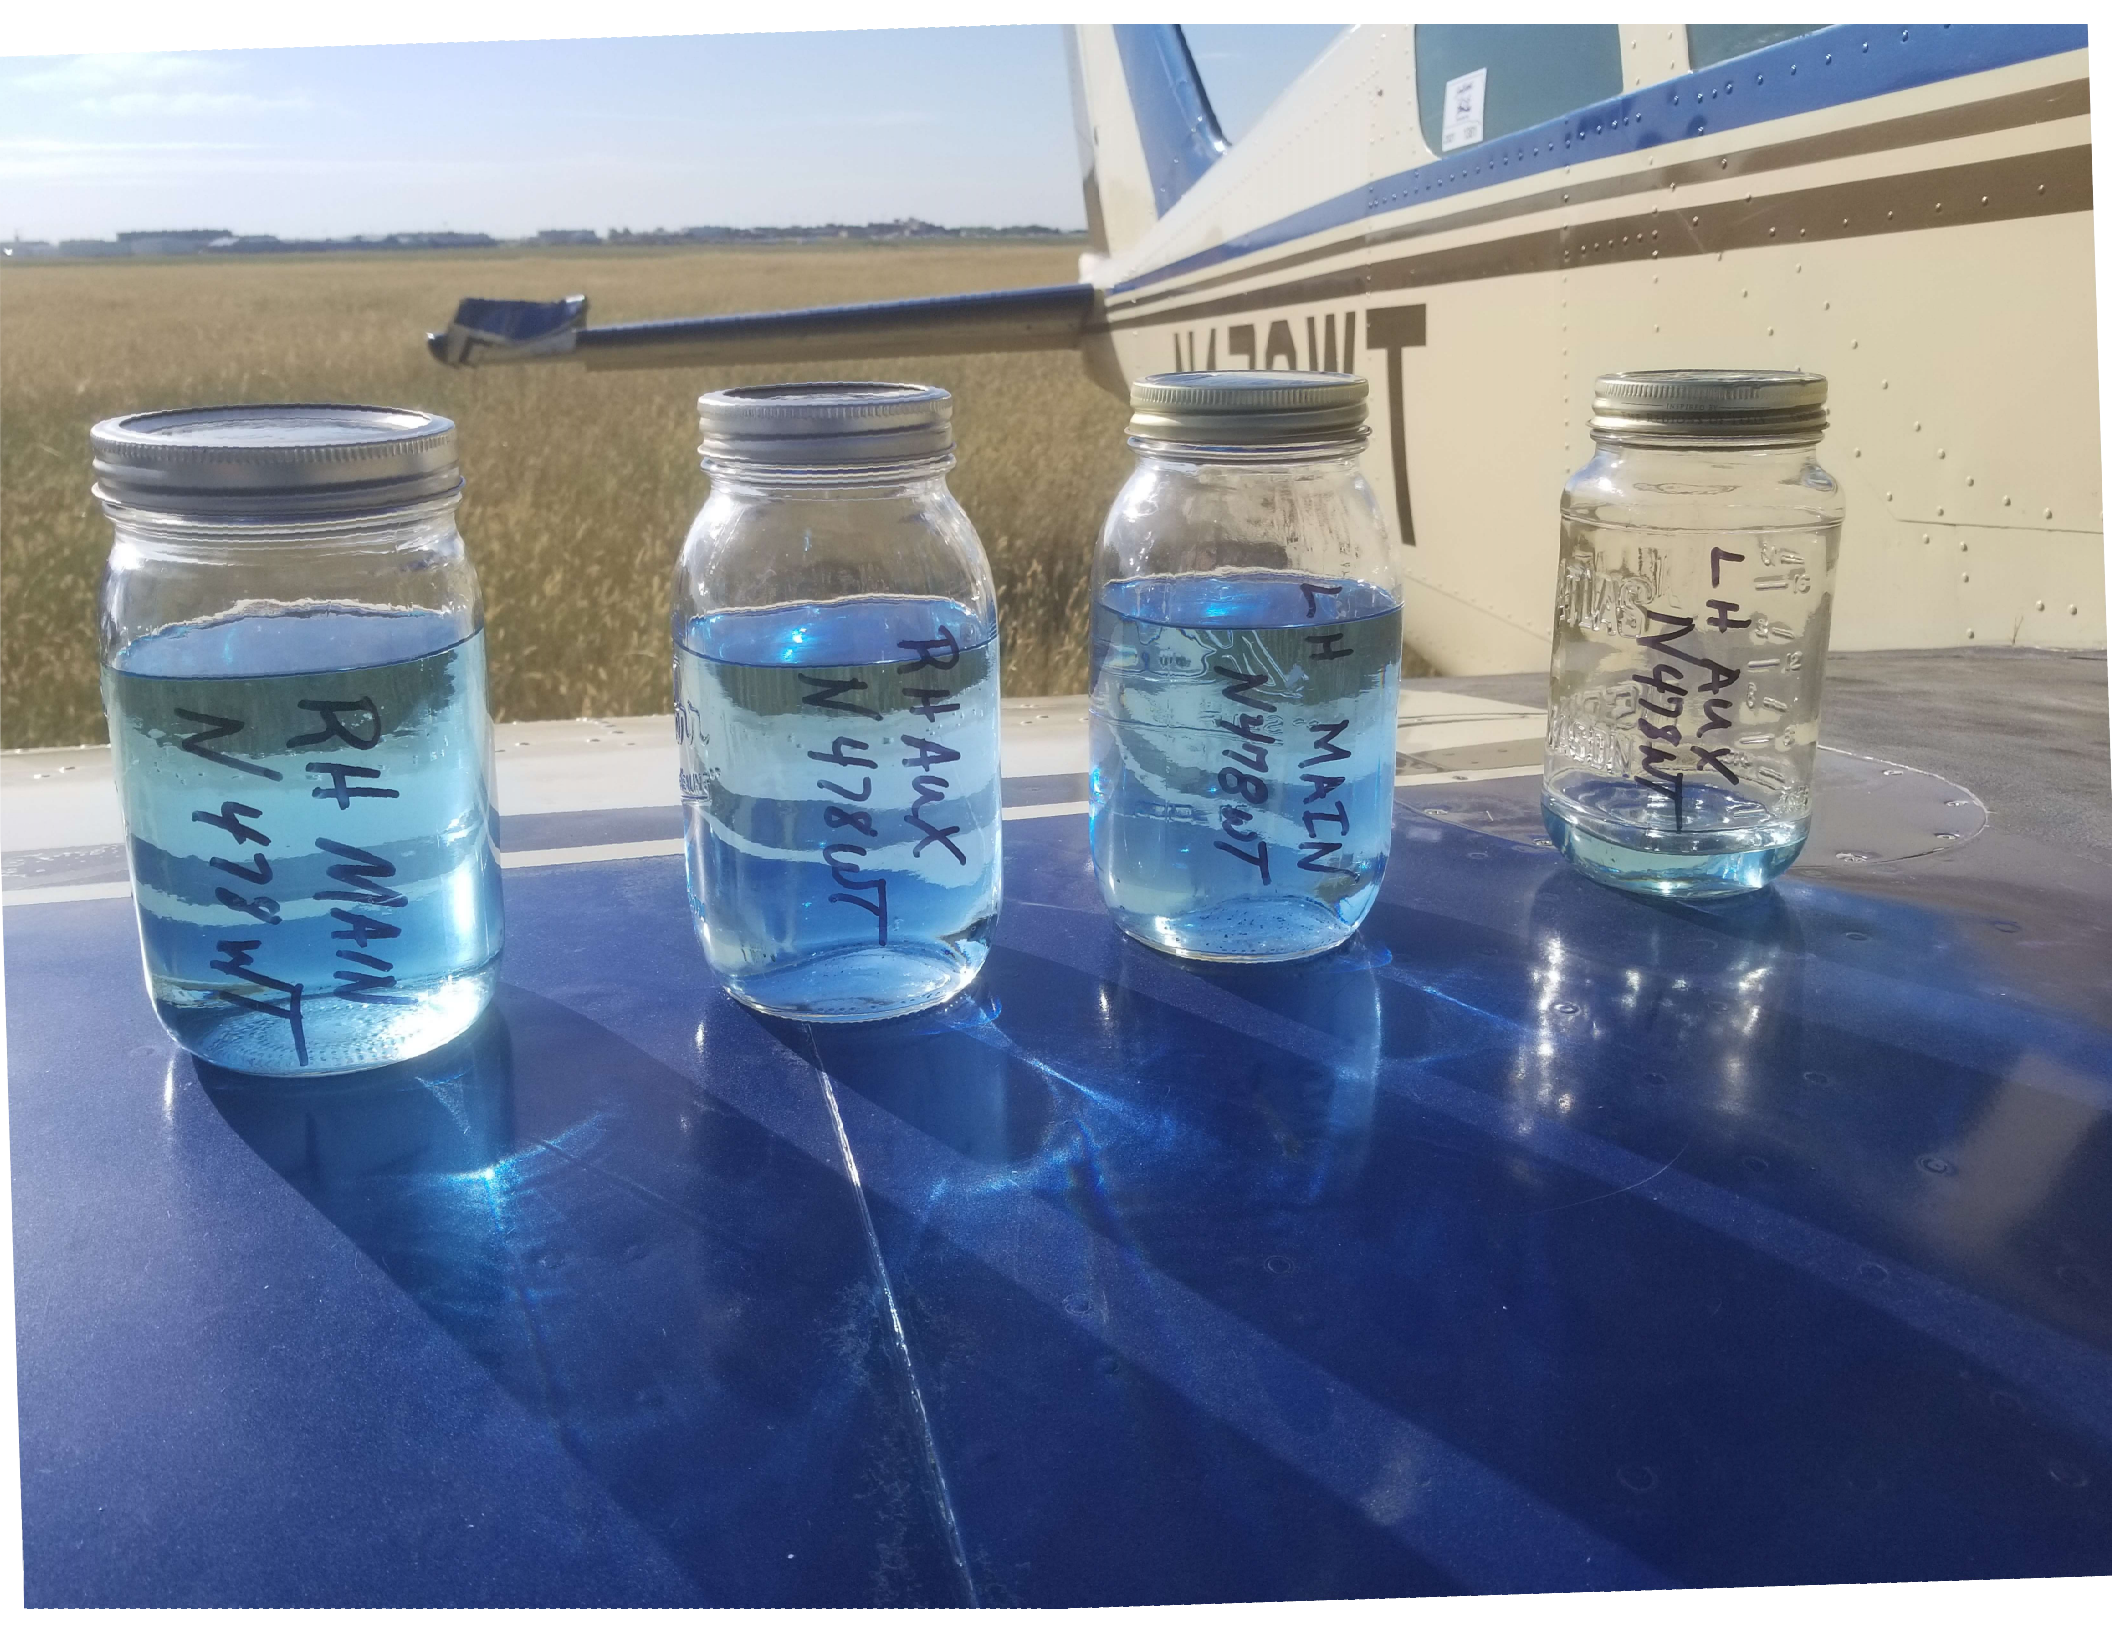
Last night, (Wednesday 13, 2022) Beegles Aircraft arrived at the accident aircraft and lifted it up onto styrofoam blocks. Early this morning (Thursday, July 14) I took my Avionics counterpart (Todd Obritsch) out to assist in the sump draining of the 4 fuel tanks, through the center strainer drain. This Comanche has (left to right) an outboard Left Aux Tank, inboard Left Main Tank, inboard Right Main Tank, outboard Right Aux Tank. I pulled the belly panel at the fuel strainer drain from under the aircraft. Todd was in the cockpit and we verbally agreed on which tanks was selected so I could use the proper previously marked (per tank) quart mason jar. We agreed to start with the LH aux tank, Todd moved the fuel selector to LH Aux, I positioned the mason jar under the drain. Todd pulled the strainer drain to reveal no fuel at all. (bone dry) nothing even drained out from the strainer bowl. (maybe 2 ounce capacity). This tank reads under ¼ tank of fuel on the quantity gauge. We proceeded to LH Main, I held the jar and left main flowed blue 100 LL fuel normally. No water noted in the glass jar. We filled the jar over ¾ full. We moved to RH Main, pulled the strainer drain and pure blue 100LL filled the jar, no sign of water. Last tank is RH Aux, we pulled the drain and pure blue 100LL flowed into the jar with no signs of water. Three tanks drained normal. We returned to the LH Aux tank and pulled the drain and acquired maybe 2 ounces that had filled the strainer from the other tanks. But after maybe 2 ounces, it quit flowing any fuel.

Fortunately we were lucky enough to start with the dry LH AUX and proved there was not one drip of fuel in the LH aux tank and associated tubing. I took a bar and placed it in the LH tank as deep as I could reach and found no traces of fuel. The 3<sup>rd</sup> attachment to this email is the fuel quantity indication when selecting LH AUX.
