# National Transportation Safety Board

CEN22LA421

## **AIRPLANE EXAMINATION**

Location: Broomfield, Colorado  
Date: September 14, 2022  
Time: 1140 (Local)  
1740 UTC  
Airplane: Piper PA28R-180

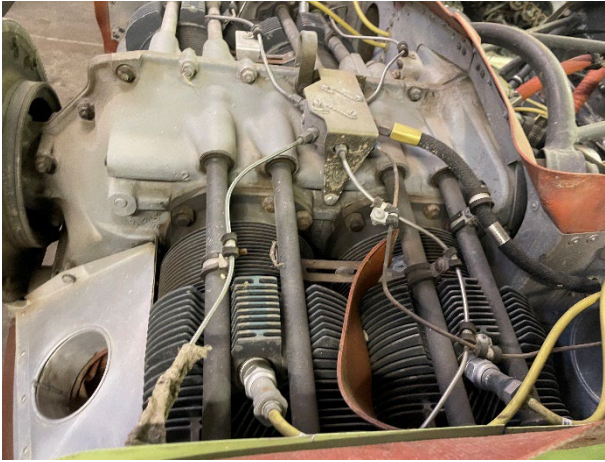
**Figure 3 Left Side of Engine**

The engine was visually examined to ensure all lines and hoses remained properly attached. The engine mounts were not damaged. All engine accessories remained attached to the engine. Engine control continuity was established from the cockpit controls to the throttle body where they appeared to move full travel. The fuel screen was removed and was unobstructed.
