# National Transportation Safety Board

CEN23FA084

## **SURVIVAL FACTORS**

Specialist's Factual Report

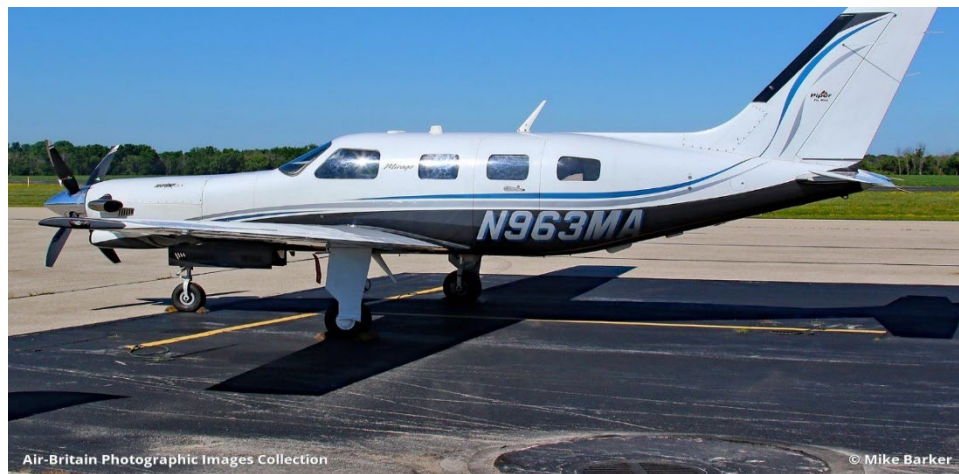
**Figure 1.** Photograph from of the accident airplane. (Source: Ai-Britain Photographic Images)

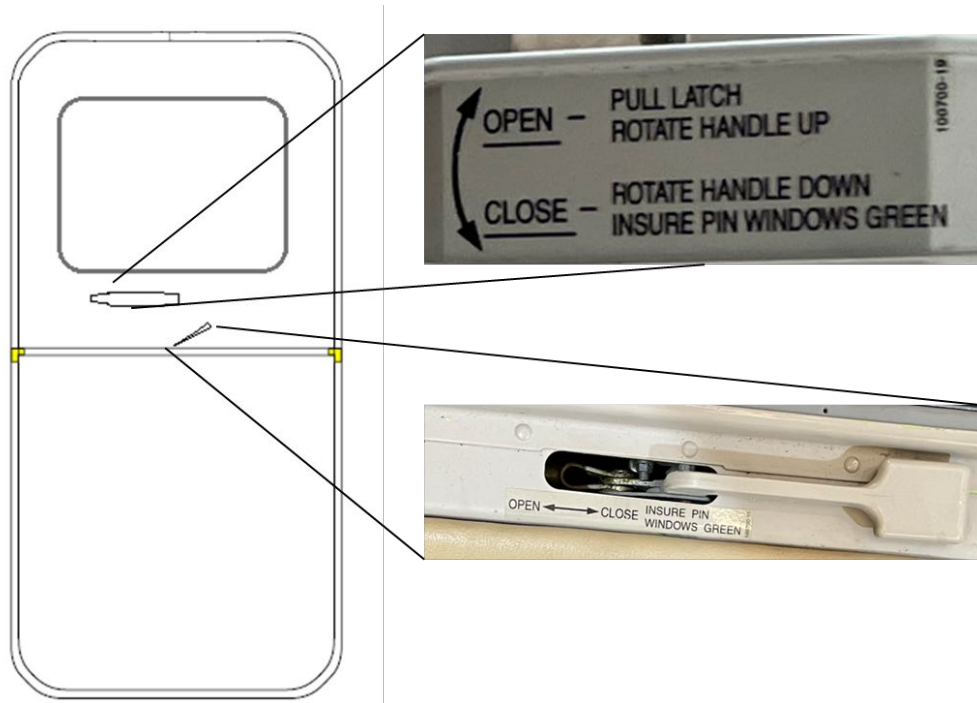
During normal operation, the airplane interior was accessed by a clam shell-type, two-piece door located adjacent to seat 5. The door was operated from the interior by rotating a lever clockwise, which released the top portion, allowing it to open with an outward push and its pneumatic assists. The bottom portion was opened by pulling up on a lever located on the top of the bottom half structure (see figure 5). According to a statement provided by the survivor, the door popped open during the accident sequence. First responders found the door open upon arrival (see figure 6).

**Figure 5.** Diagram depicting the internal operation of the door. The top portion is opened first followed by the bottom section.

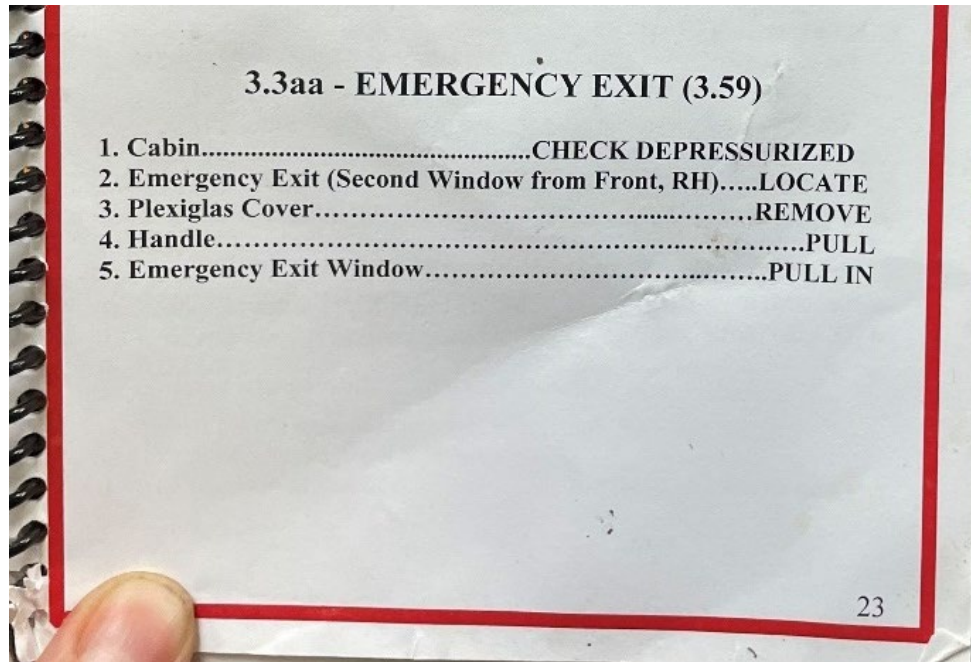
No passenger safety information briefing cards were found at the accident site, nor in the debris at the salvage facility. There was an entry in the pilot's emergency procedures checklist that described how to open the emergency hatch (see figure 15). According to the survivor, the pilot provided a safety briefing to the passengers to include seat belt and door operation.

**Figure 15.** Page 23 of the pilot's emergency procedures checklist that described the emergency exit operation.
