# National Transportation Safety Board

CEN23FA113

## **AIRCRAFT PERFORMANCE**

Location: Little Rock, Arkansas  
Date: February 22, 2023  
Time: 11:56 central standard time  
17:56 UTC  
Airplane: Beech B200, N55PC

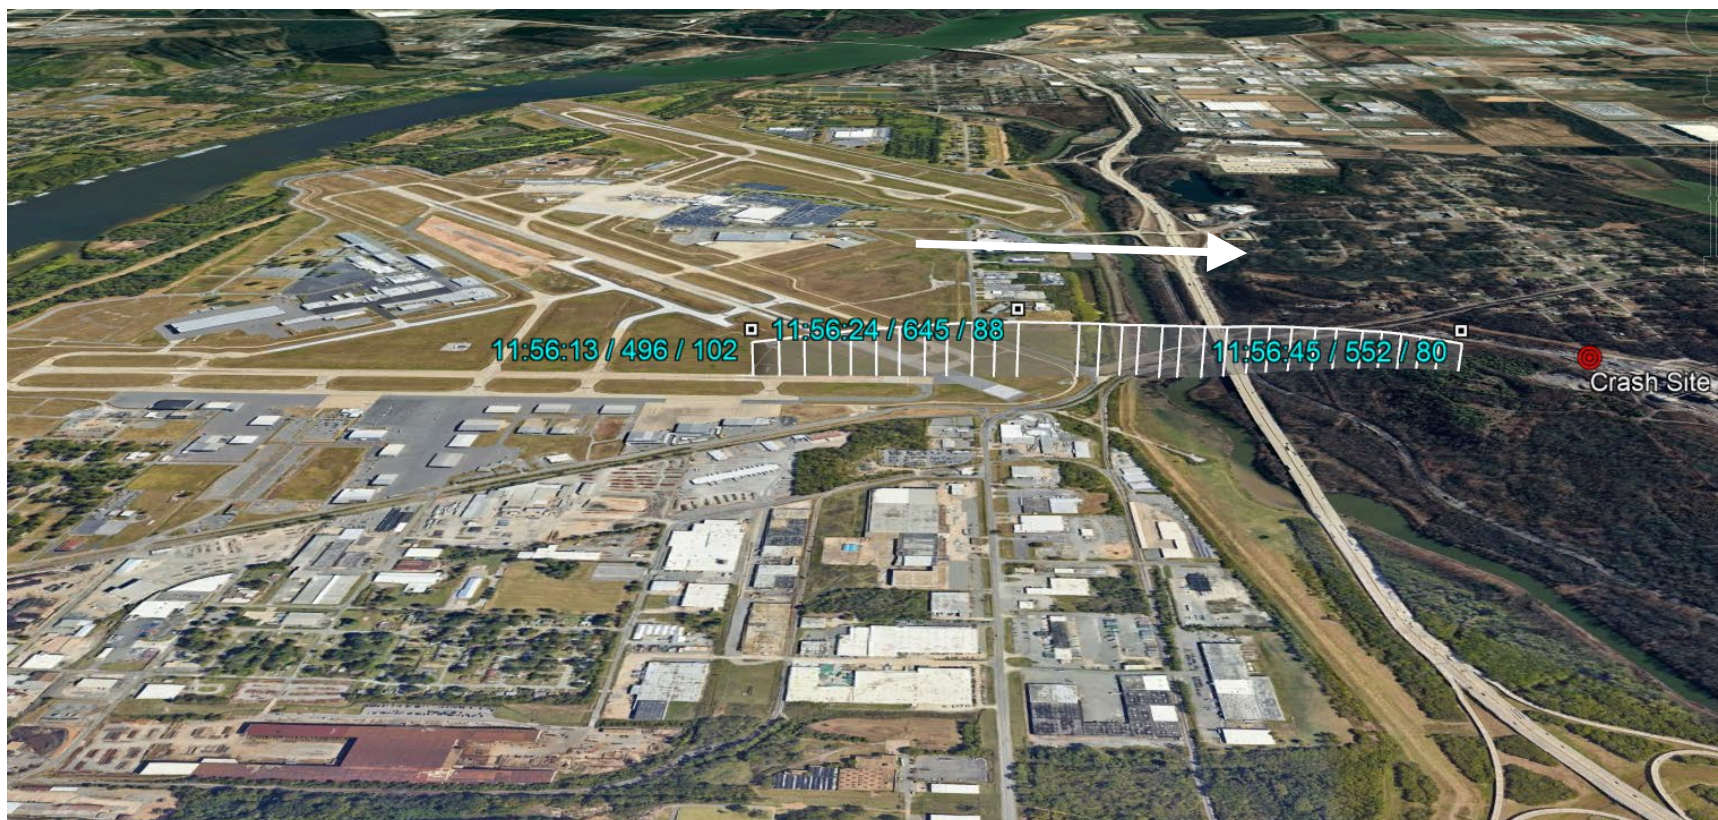
Figure 3 shows a profile view of the flight path on a Google Earth background. Figure 4 shows an overhead view of the flight path on a Google Earth background.

**Figure 3. Profile view of the accident flight path. Annotations indicate the time, altitude msl and groundspeed. North is to the left.**

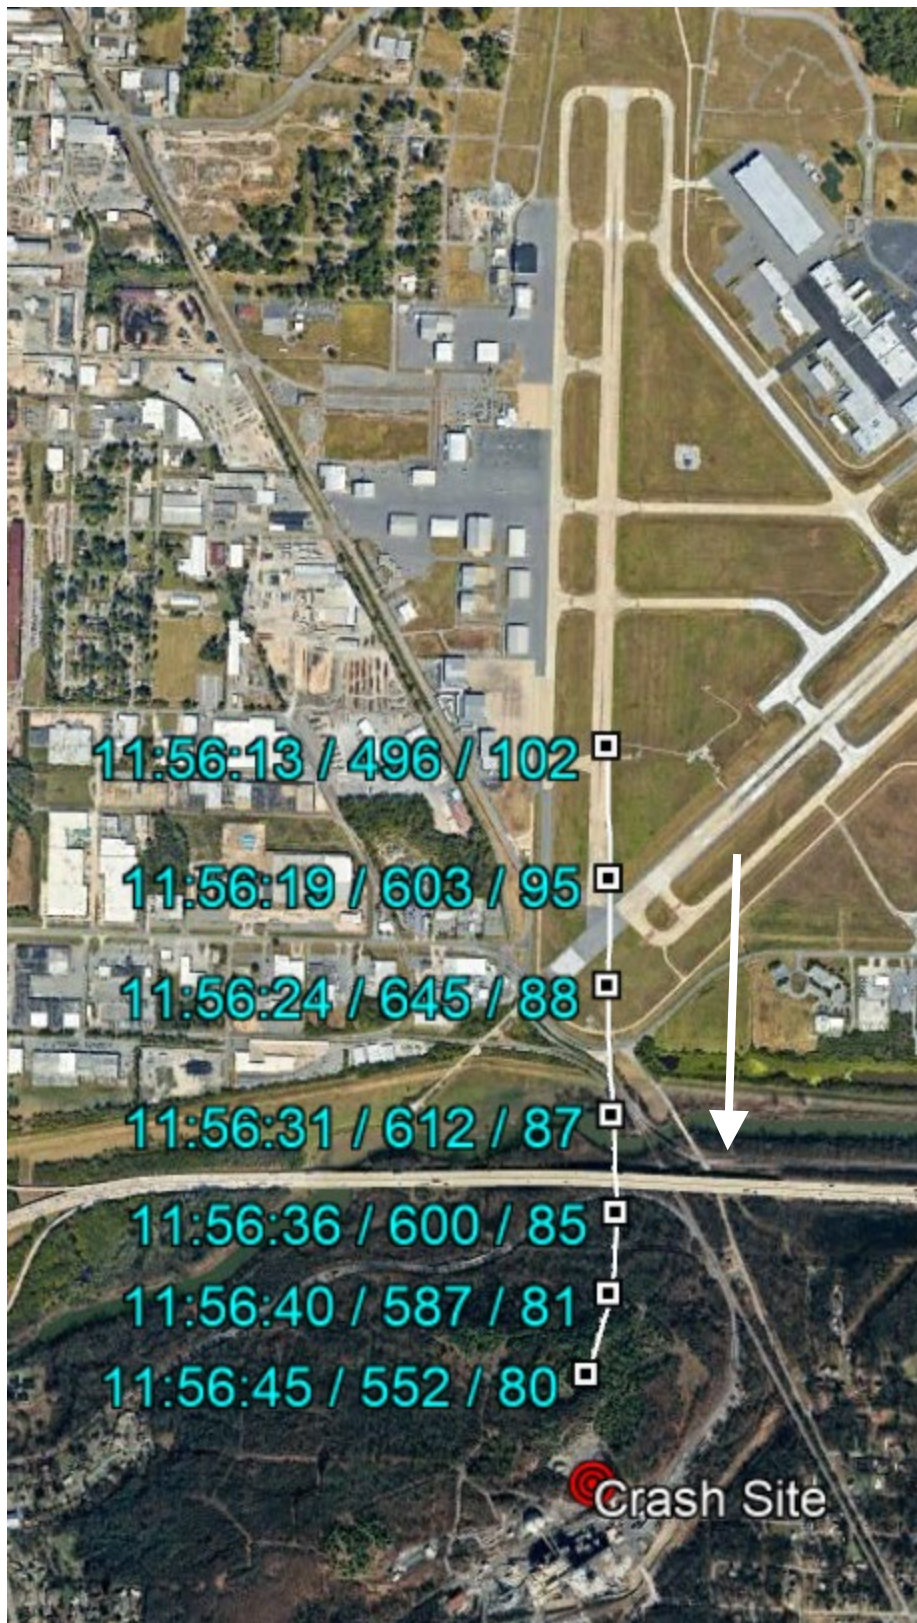
**Figure 4. Overhead view of the accident flight path. Annotations indicate the time, altitude msl and groundspeed. North is at the top.**

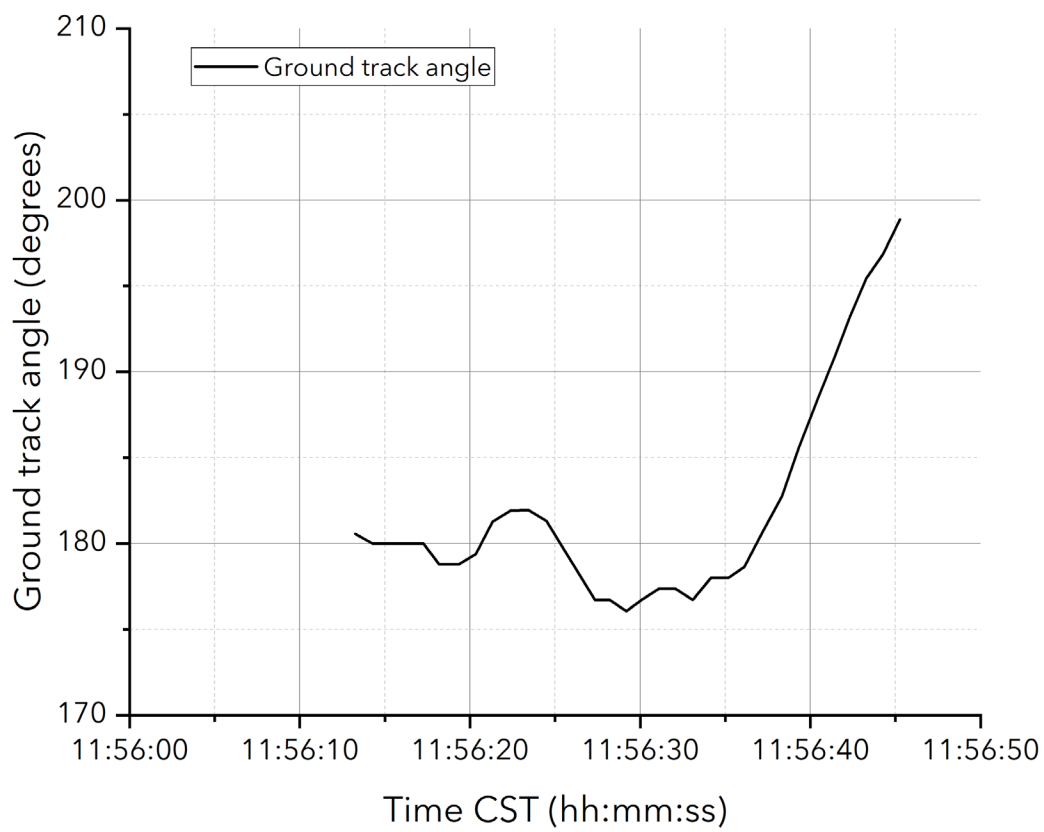
The ground track angle for the flight is shown in Figure 6.

**Figure 6. Ground track angle for the accident flight.**

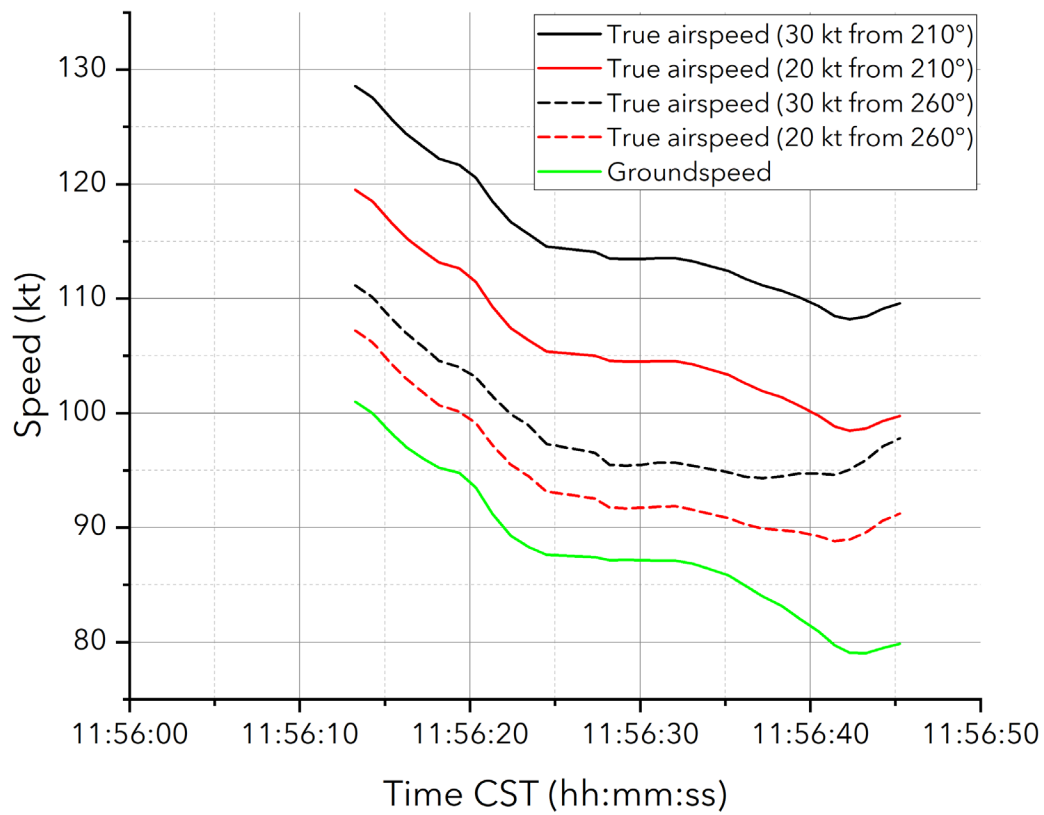
Figure 7 shows the groundspeed and true airspeeds for the flight, assuming different combinations of wind speeds and directions. Winds of 20 kt and 30 kt, and wind directions from 210° and 260° are considered. The true airspeed is the magnitude of the vector difference between the groundspeed velocity and the wind velocity. Winds from 210° would have been closer to a direct headwind, and therefore correspond to a higher true airspeed. The groundspeed was generally decreasing throughout the flight, but there was a slight increase at 11:56:43 near the end of the data. The airplane turns slightly to the right near the end of flight, which results in changes in the computed true airspeed that depend on the wind speed and direction assumed.

**Figure 7. Groundspeed and true airspeeds based on the winds aloft assumed.**
