**NTSB File No.:** CEN23FA285

**Aircraft:** Piper PA-60-601P Aerostar

## PROPELLER EXAMINATION REPORT

**Aircraft Accident/Incident report No.: 230706**

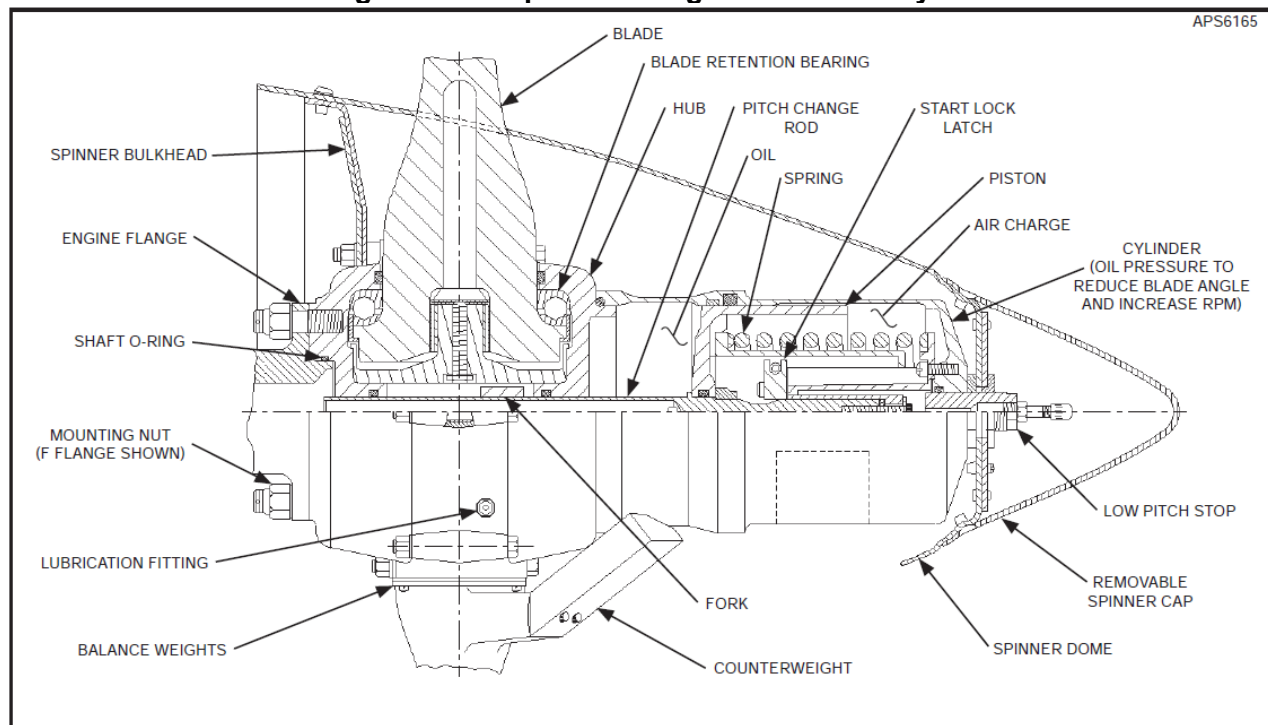
**Figure 1 – Propeller Configuration Cutaway**

**Propeller Description:** The propellers examined are 78" diameter, 3-blade single-acting, hydraulically operated, constant speed model with feathering capability. Oil pressure from the propeller governor is used to move the blades to the low pitch (blade angle) direction. A spring, counterweights, and an air charge move the blades to the high pitch/feather direction in the absence of governor oil pressure. The propeller incorporates start locks to keep propeller blade angle low to minimize the starting torque. The blades and hub are of aluminum construction. Propeller rotation is clockwise as viewed from the rear. See Figure 1 for a cutaway sketch of the propeller model series labeling the major components.
