# National Transportation Safety Board

CEN23FA340

## **AIRWORTHINESS**

Specialist's Factual Report

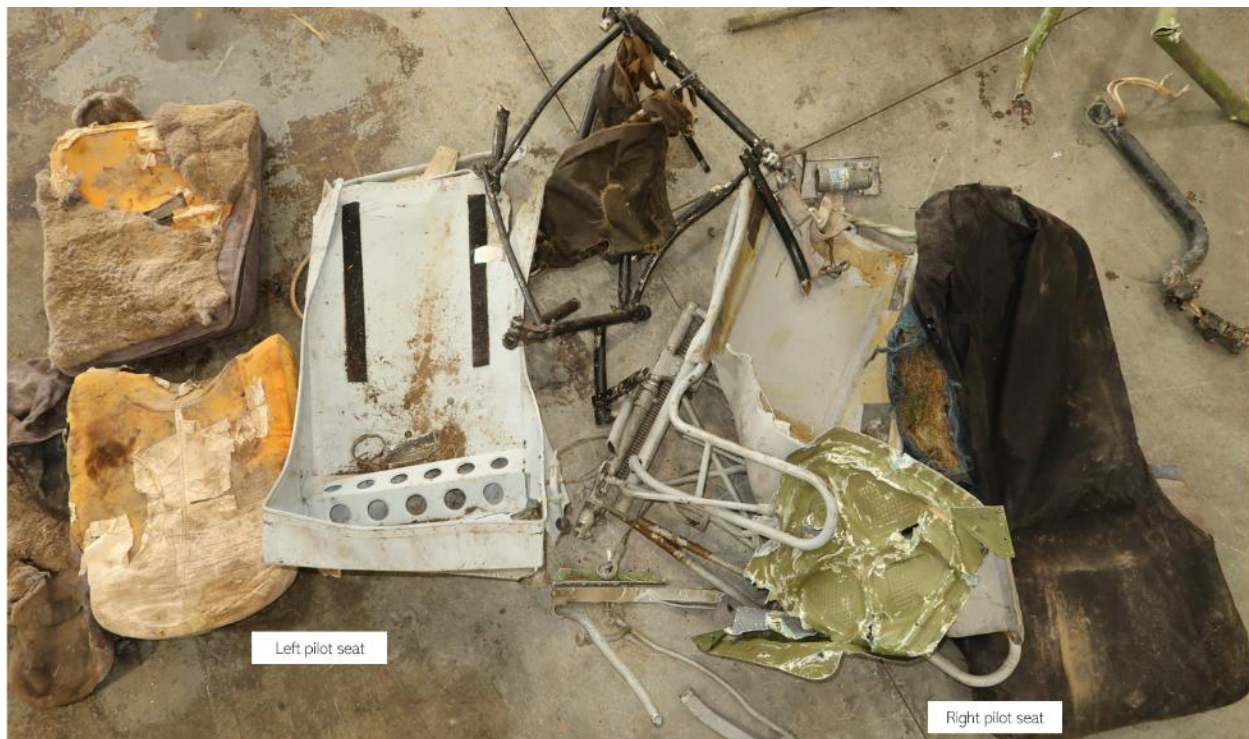
**Figure 4.** Pilot seat layout.

On scene photos of the cockpit show the right pilot seat, characterized by black seat covers, was intermingled with the right cyclic stick, which was still aligned with its associated gimbal assembly, positioned beneath the cockpit floor (Figure 3). The left cockpit seat did not appear to be in the immediate vicinity of the cockpit and the left cyclic stick was located some distance away from the main wreckage. During the wreckage layout, the left seat was located and both seats were set side by side for comparison. The left seat had a sheep skin cover over the cushions and some areas of red stains were observed on the sheep skin cover (Figure 4).

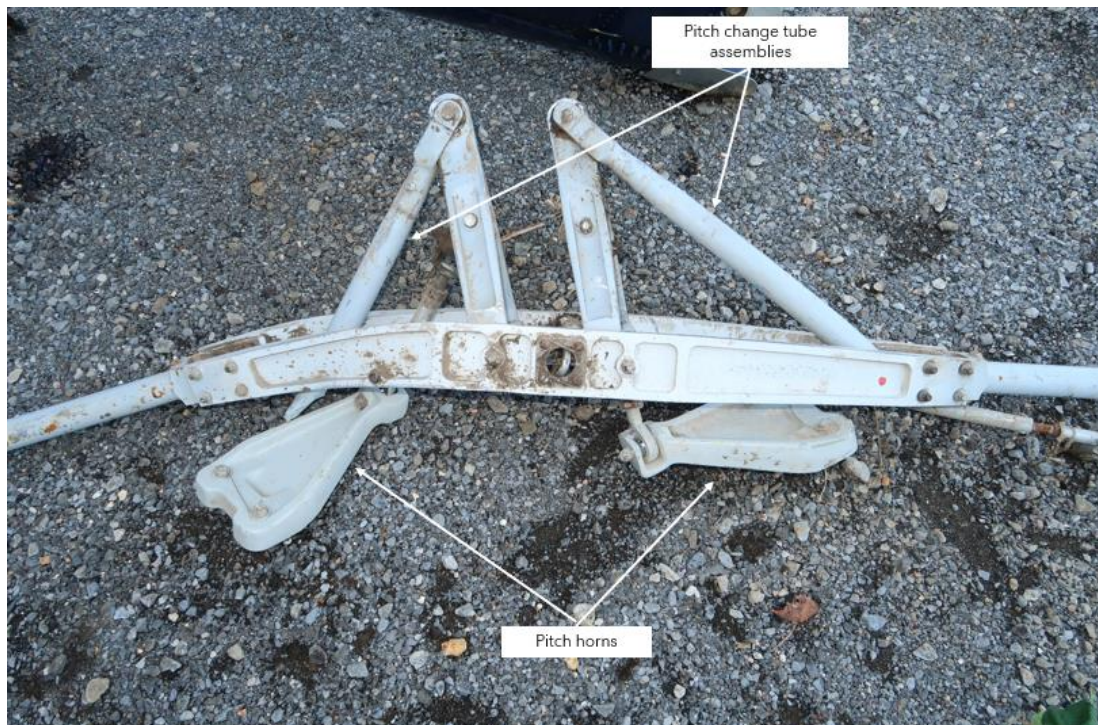
**Figure 12.** Stabilizer bar

The main rotor head remained intact but had separated from the mast and the fracture surface was consistent with torsion overload. The mast end fracture was oval in shape and exhibited features consistent with torsional shear (Figure 11). The pitch horns on each blade had pulled out of their base. The stabilizer bar had separated from the rotor head, but all control links were attached at their fittings (Figure 11). The pitch links and pitch horns were attached to the stabilizer bar assembly. Both viscous dampers had separated from the rotor mast.

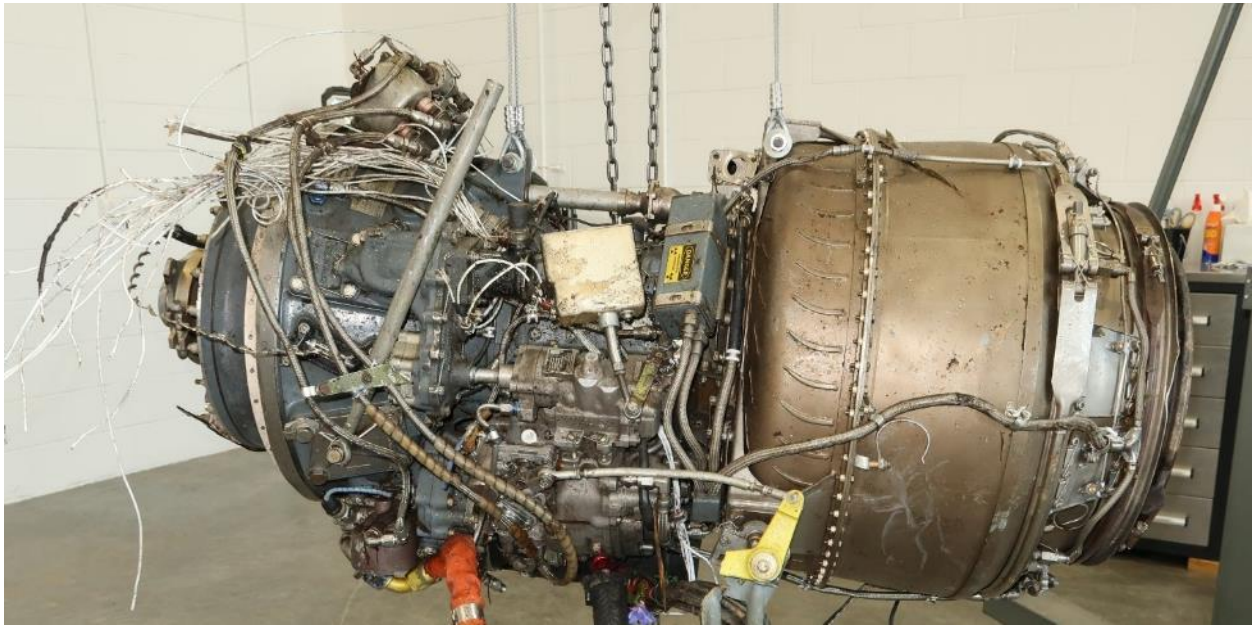
**Figure 16.** Accident engine hanging from the hoist.

The engine sling was placed on the engine and then hoisted up for examination purposes (Figure 17). N2/PT (power turbine section) was smooth with free rotation when turned by hand. Continuity was confirmed through to the output shaft. No visual damage or defects were noted on the 2<sup>nd</sup> stage power turbine blades when looking through the engine exhaust. Looking through the inlet, foreign debris was found, and the 1<sup>st</sup> and 2<sup>nd</sup> stage compressor blades exhibited foreign debris damage (FOD). The debris in the inlet was left in place. The compressor (N1) did not rotate using the N1 tach drive on the accessory gearbox. The accessory gearbox chip detector was clean of debris. Captured and retained oil from the accessory gearbox contained no debris or contamination. The oil pump housing exhibited impact damage (Figure 18). The fuel control unit (FCU) pointer was observed in the max (maximum) power position; however, the linkages were fractured, and the pointer was free and easily moved. The fuel control strainer/filter was clean, with no observed contamination, and the sample was retained. The inlet guide vanes (IGV) manifold lines were disconnected, and a fluid (fuel) sample was retained. The FCU was detached from the engine and the main drive shaft splines were inspected; no defects were noted. Fuel was present in all lines when disconnected including fuel nozzle lines. The FCU was reinstalled onto the engine for transportation purposes.

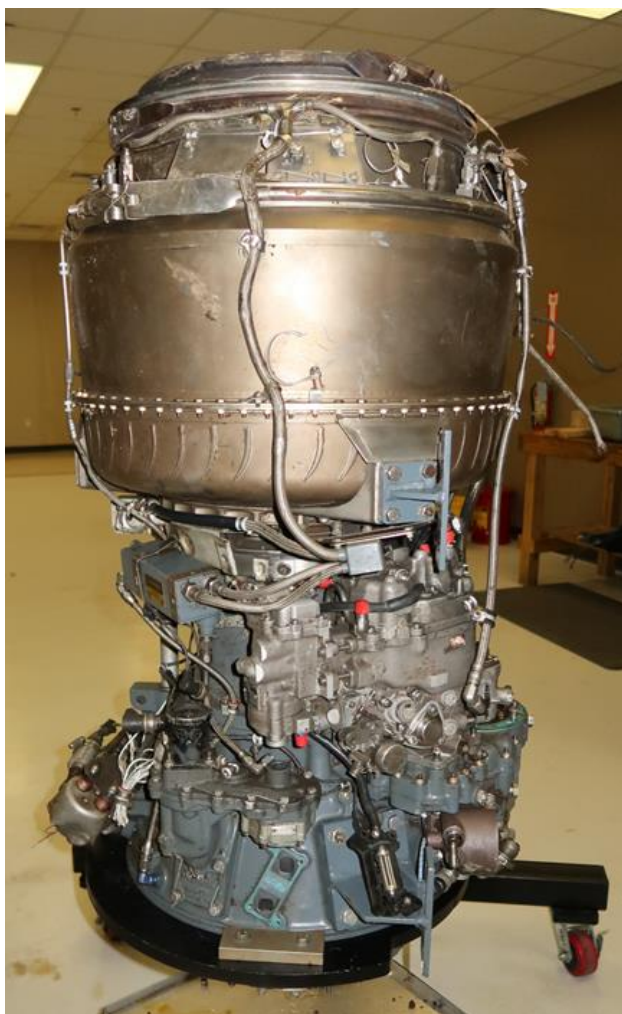
**Figure 18.** Accident engine installed on the engine stand for examination.

The engine was mounted on an adjustable engine stand (Figure 19). The combustor turbine section was removed. Metal spray was observed on the 2<sup>nd</sup> stage gas producer (GP) rotor assembly and turbine nozzle. Metal and organic debris was found in the 1<sup>st</sup> GP nozzle curl. The debris was probed with a magnet and ferrous material was collected. When the engine was rotated via the engine stand, the GP turbine freed up and could be rotated by hand. The accessory gearbox was removed from the engine case. Drive continuity was confirmed between the compressor drive gear to the accessory gearbox. The accessory gearbox input shaft was turned by hand with some stiffness. The engine oil pump was removed, and external impact damage was observed. The oil pump input drive shaft was very stiff to operate by hand. Once the oil pump was removed, the accessory gearbox gears rotated freely with no binding. All accessory gearbox drive pads (fuel control, start generator, tach generator) had drive continuity. The compressor/GP section rotated freely by hand.

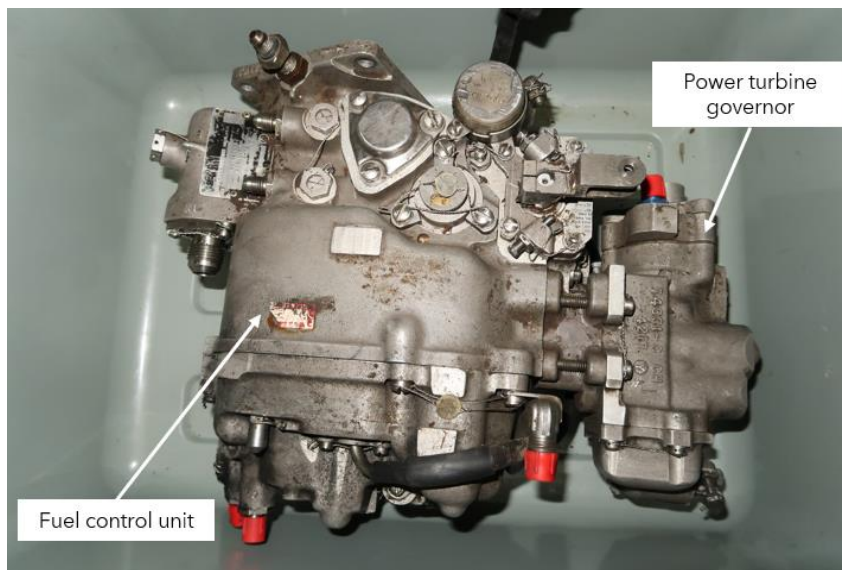
**Figure 21.** Fuel control unit with power governor attached.

FCU model TA-7, SN: 100770 A6, was removed from the engine and tested separately (Figure 22).

The main inlet fuel filter was checked for debris or blockages, and none were observed. The main fuel filter element was checked for debris or blockages with none observed. The FCU was mounted in the test fixture on the calibrated test bench. Upon the initial application of fuel to the FCU, a fuel leak from the power turbine (PT) governor body was observed. When setting the initial test bench conditions and FCU to standard test conditions, fuel flow was observed as 270 pph (pounds per hour) at 4200 rpm input, the normal value should be 930 pph, at 4200 rpm input. The test set up was double checked and the setup was retested, fuel flow remained 273 pph. The emergency mode (bypasses the metering function) was tested at 4200 rpm input and flow rate was 200 pph (normal is 200-210 pph). The governor was removed from the FCU body. The governor plunger was fully extended and not movable by hand. A factory provided governor simulator was installed on the FCU body and testing continued within normal operational parameters (Attachment 1).

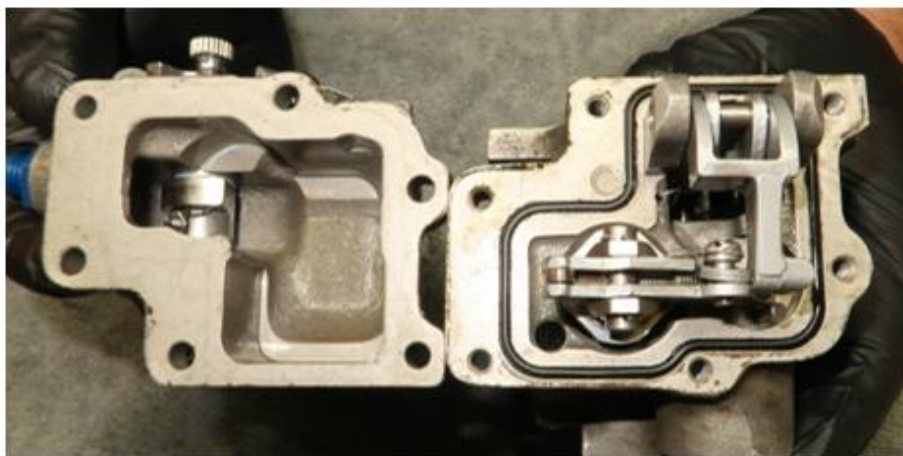
**Figure 22.** Power turbine governor.

The FCU power turbine (PT) governor examination was conducted next (Figure 23). All safety wire was present and intact. The end cover of the PT was removed to reveal the guide assembly. The guide assembly stack up was disassembled. Stack up elements were all present and no unusual wear was observed. The fly weight cover plate and bearing were removed. Examination of the fly weight (Figure 24) showed it was free to move, no binding, and the fly weight sapphire bearing was chipped at one corner. The serialized valve and sleeve moved freely, no binding. No scoring or other wear marks on the slide or metering edges were observed. The serial numbers matched: 72-565. The fly weight assembly yoke and pin moved freely. No unusual wear was identified. The fly weight base had been displaced away from the housing by 0.0635 inch from nominal. The piston rod was fully down (not the usual position for this item). The carbon seal in the plate and bearing assembly was observed pushed flush to the housing. It normally has a raised lip measuring around 0.032 inch (proud). A witness mark was identified on the interior lower cover opposite of an external impact witness mark. The misalignment of carbon seal was the likely source of the fuel leak identified while the unit was pressurized on the test fixture.
