# National Transportation Safety Board

CEN23FA359

## **ON-BOARD RECORDING DEVICE STUDY**

Aircraft Performance Study

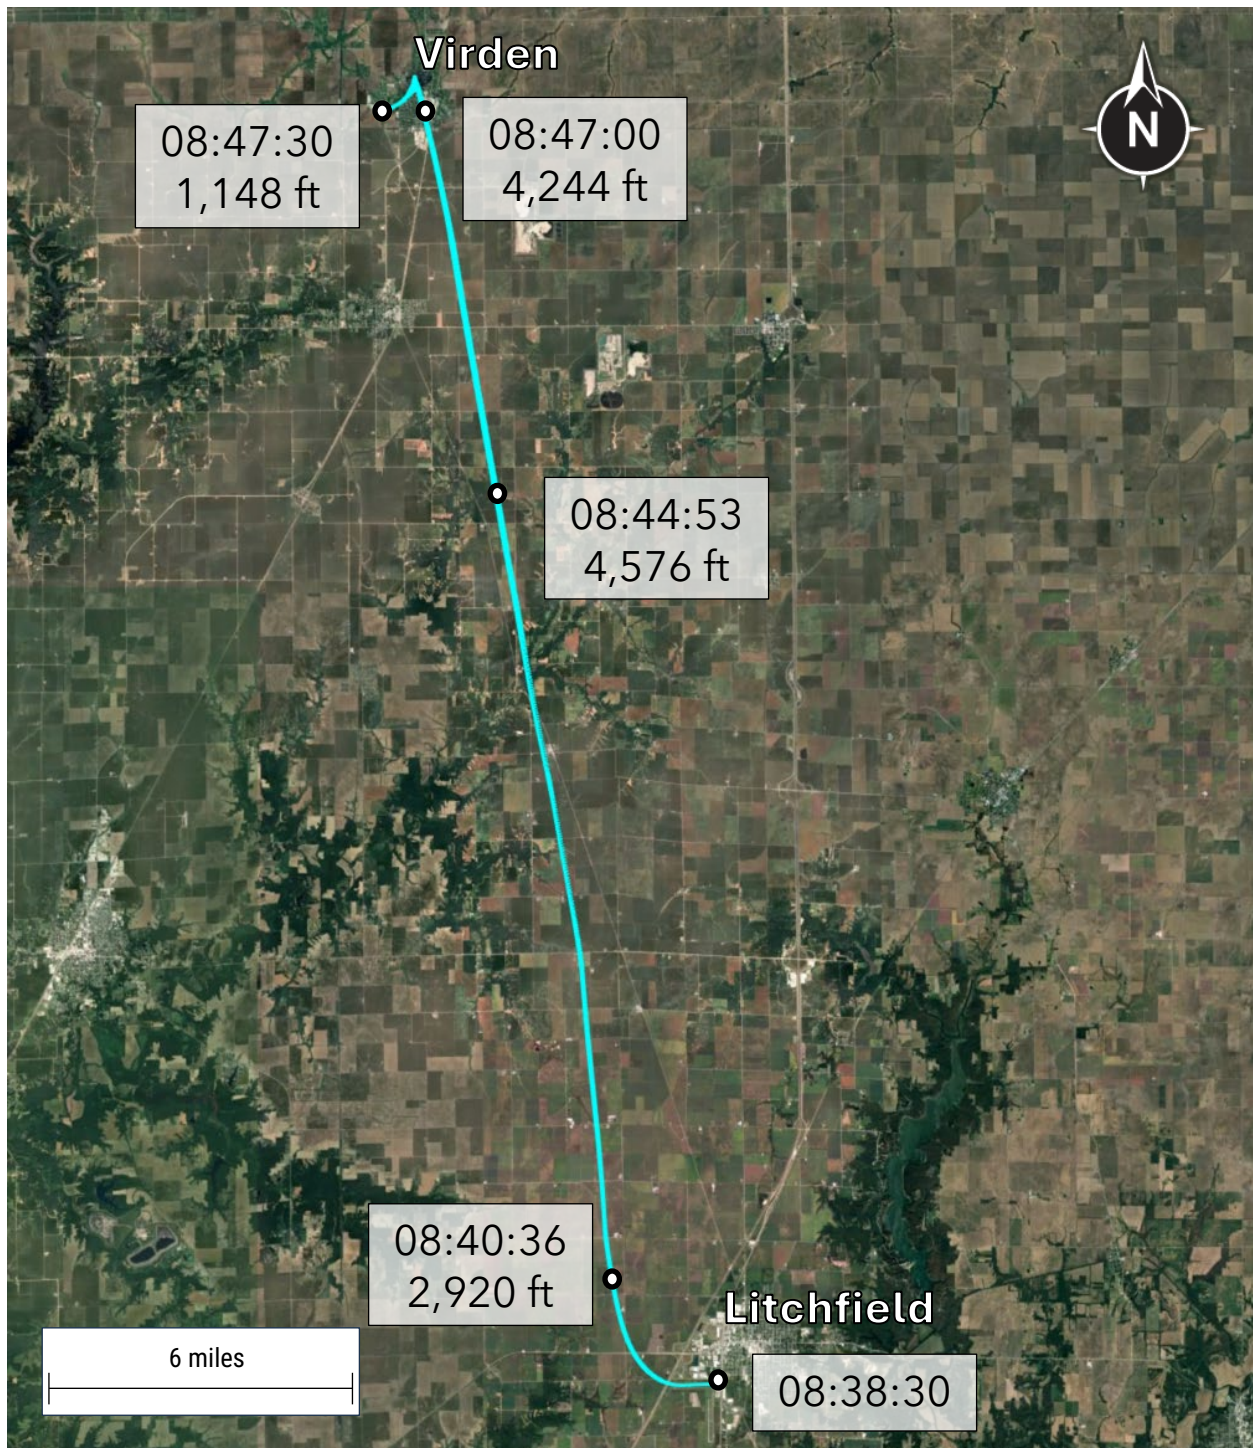
The airplane took off at 08:38 from Litchfield Municipal Airport (3LF) in Litchfield, Illinois. The airplane climbed and made a right turn onto a north-northwesterly heading. The initial right turn recorded a roll of 14° right wing down which was the largest roll deviation of the flight until the upset. By 08:42, the airplane was above 3,500 ft above mean seal level (MSL) and on a heading of approximately 345°. After the initial climb, pitch varied between 3.4° nose up and -2.2° nose down.

**Figure 2.** Garmin recorded flight path with times and altitudes noted.

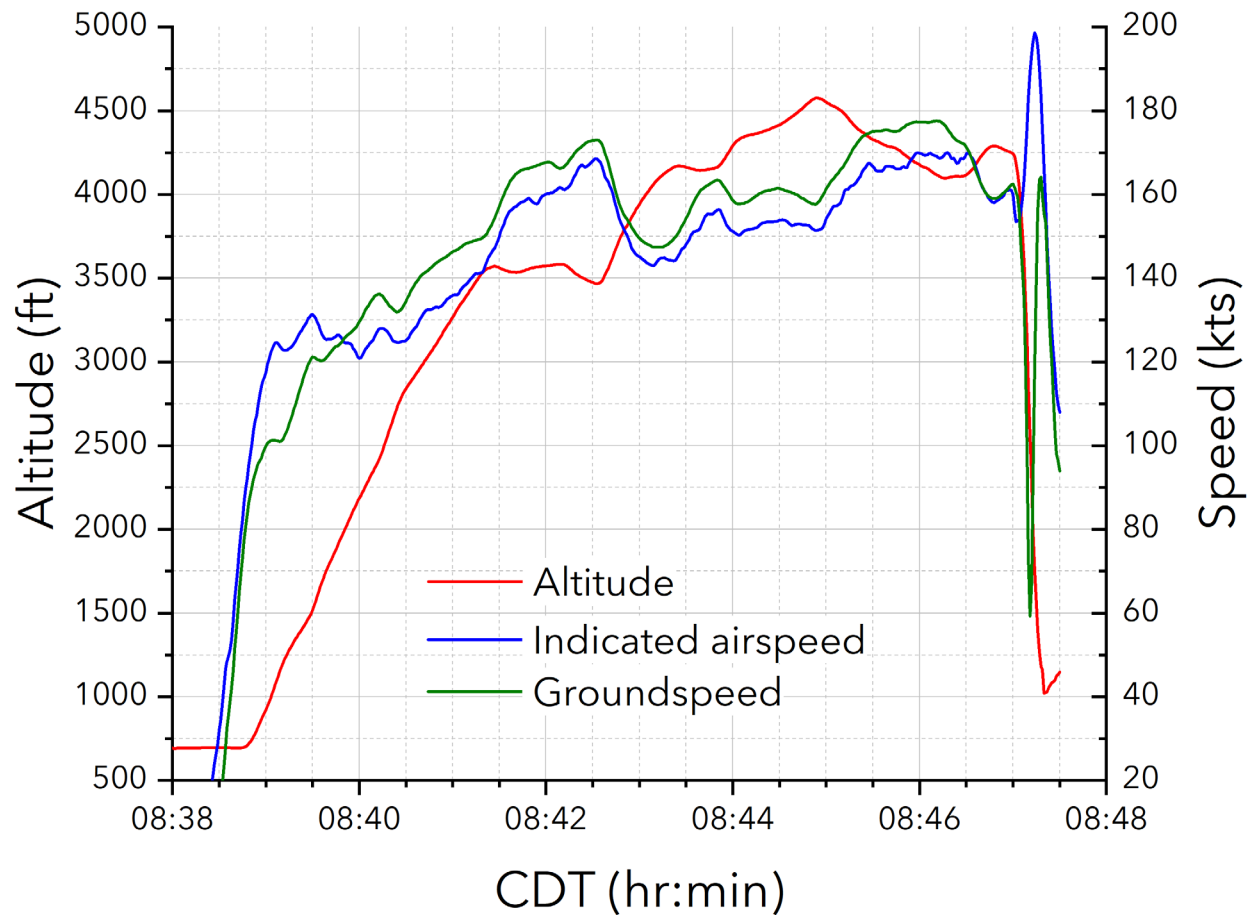
**Figure 3.** Garmin recorded altitude, indicated airspeed, and groundspeed.

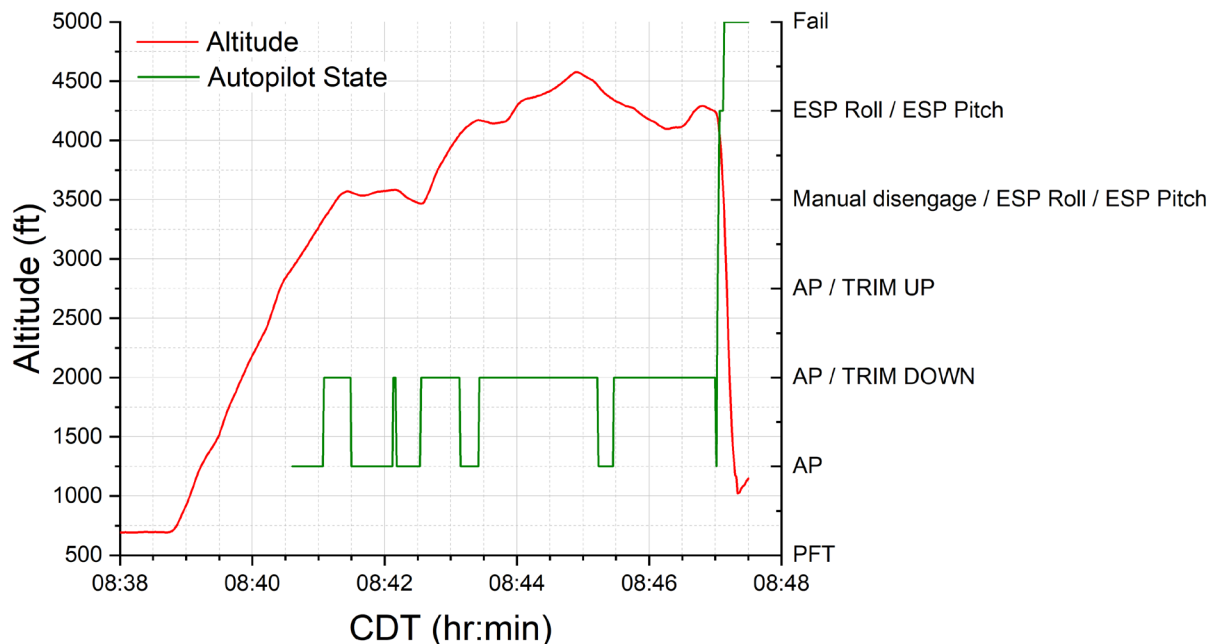
During the flight, the autopilot (AP) setting was recorded. Autopilot was initiated at 08:40:36, after the initial left turn was completed.

**Figure 4.** Garmin recorded altitude and autopilot setting.

At 08:46:30, as the airplane approached the town of Virden, Illinois, it climbed from 4,100 ft to 4,200 ft while slowing from 168 kts of indicated airspeed to 160 kts by 08:47. At 08:47:00, the autopilot, which had been in the "AP/TRIM DOWN" setting moved through "AP" then "AP/TRIM UP" to "Manual disengage/ESP Roll/ESP Pitch" then to "ESP Roll/ESP Pitch" where it remained for four seconds before recording "Fail" for the rest of the recording.
