# National Transportation Safety Board

CEN23FA359

## **ELECTRONIC DEVICES**

Location: Virden, Illinois  
Date: August 12, 2023  
Time: 08:48 central daylight time (CDT)  
Aircraft: Bierman/Van's RV-14A, N6161

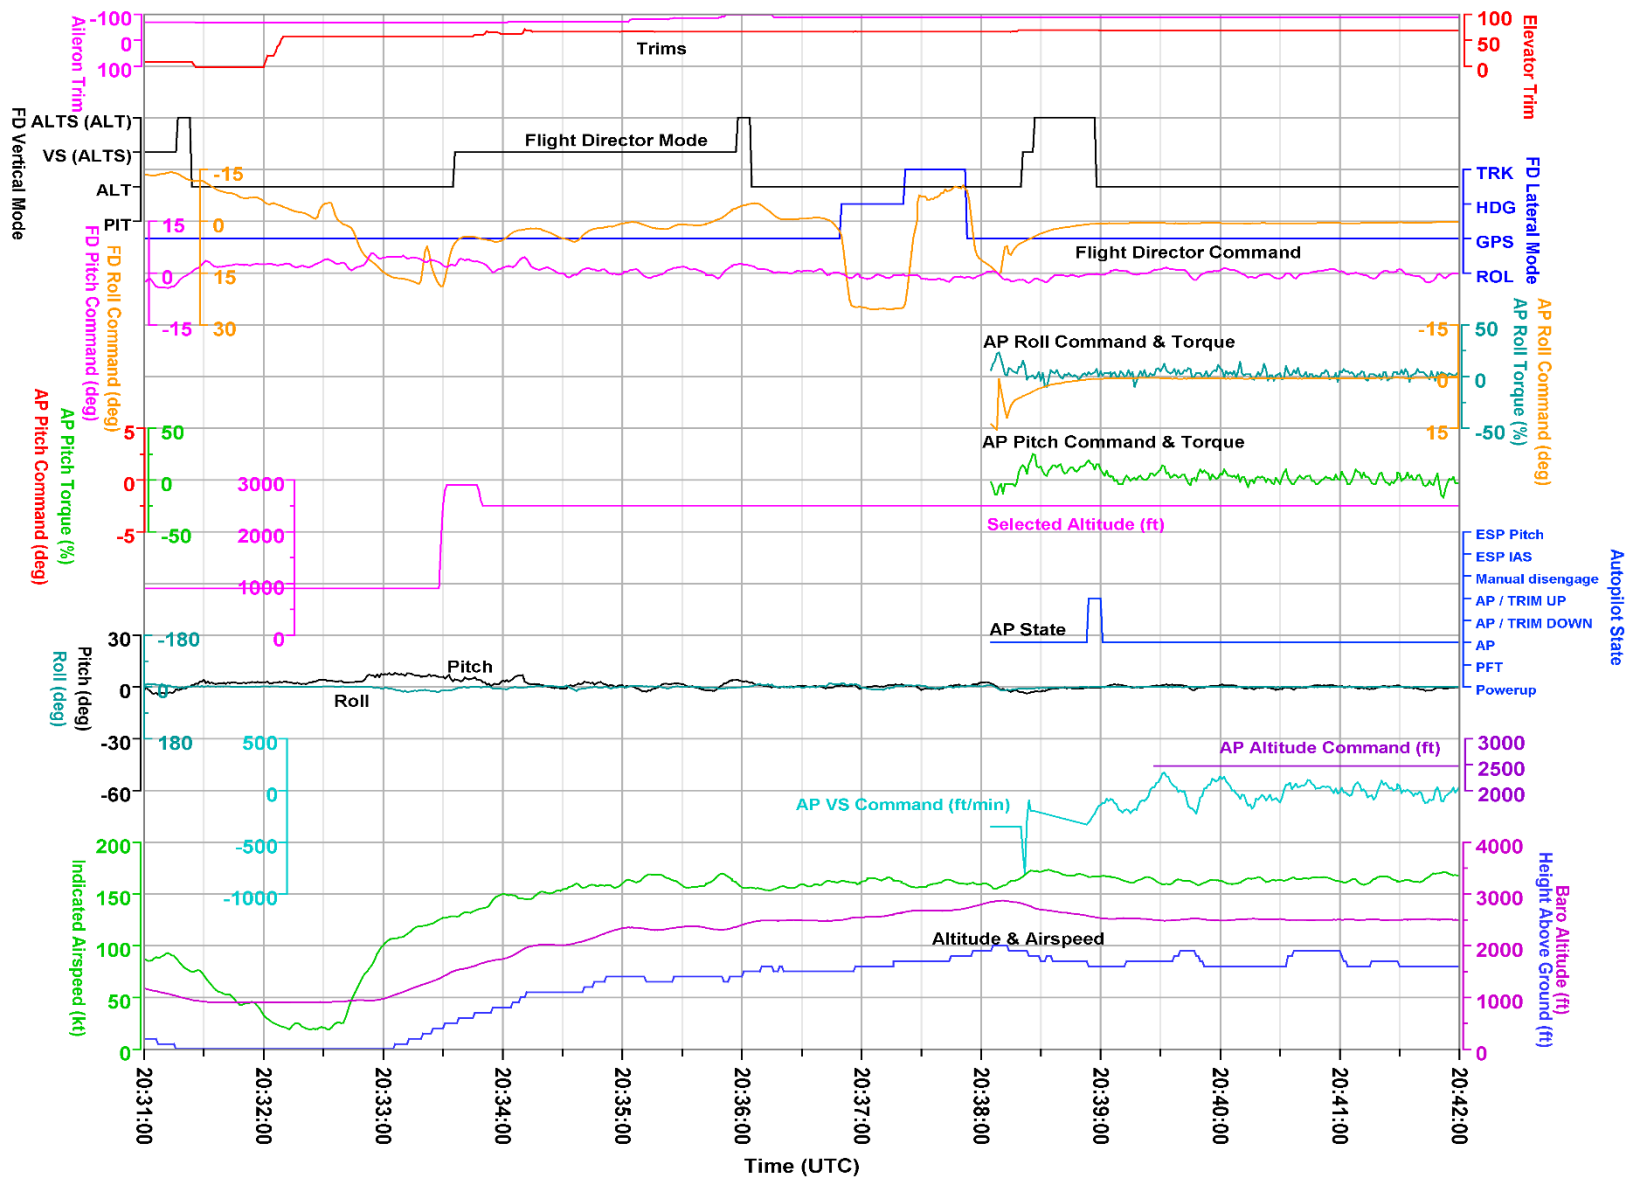
**Figure 19.** A plot of autopilot parameters for a portion of a session recorded on June 17, 2023, that details the aircraft performing a climb using the autopilot.

Figure 19 is an expanded time scale of the previous plot and focuses on the pilot's autopilot usage.

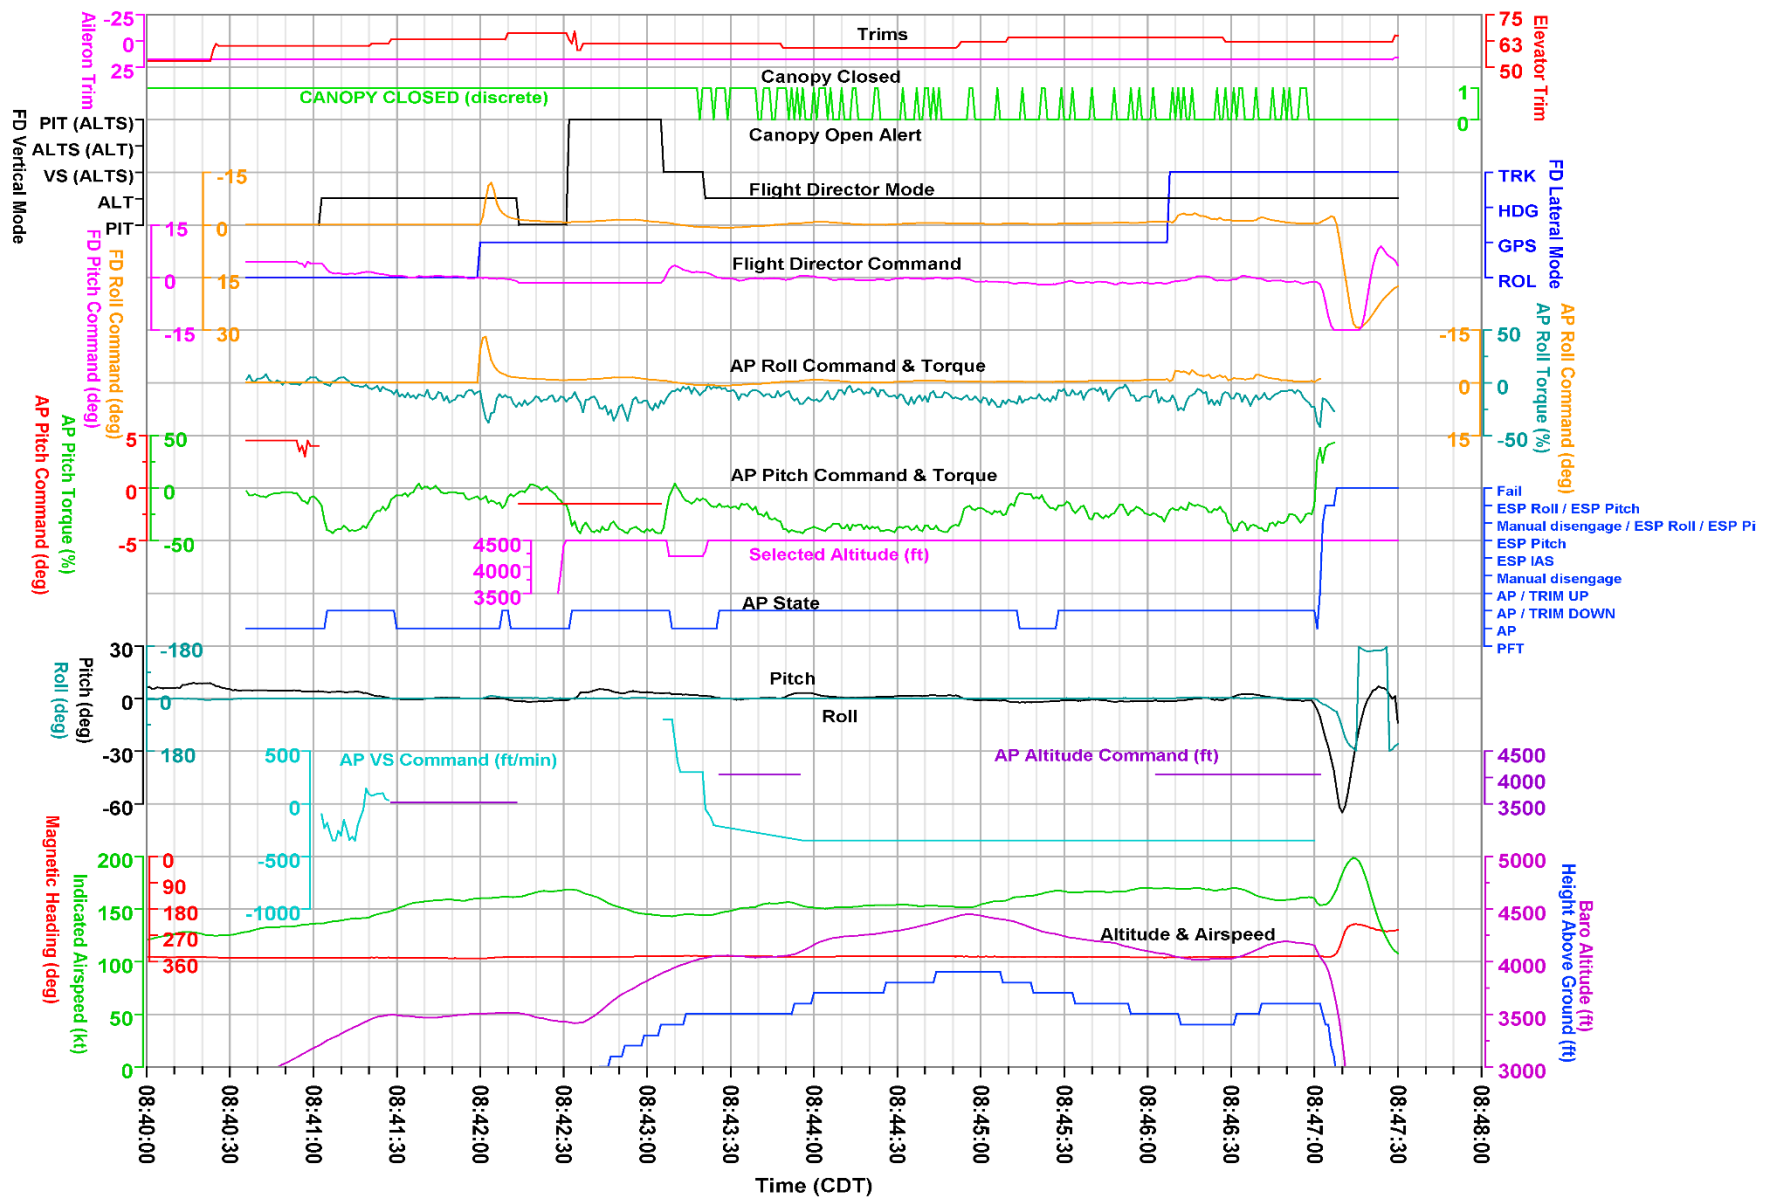
**Figure 29.** A plot of autopilot related parameters for the entire accident flight.

Figure 29 is a plot of basic parameters and numerous autopilot-related parameters during the accident flight on August 12, 2023. The plot contains the condition of the canopy warning status parameter. Note that the values for AP Pitch Torque % differ from previously plotted flights in which autopilot usage was engaged.

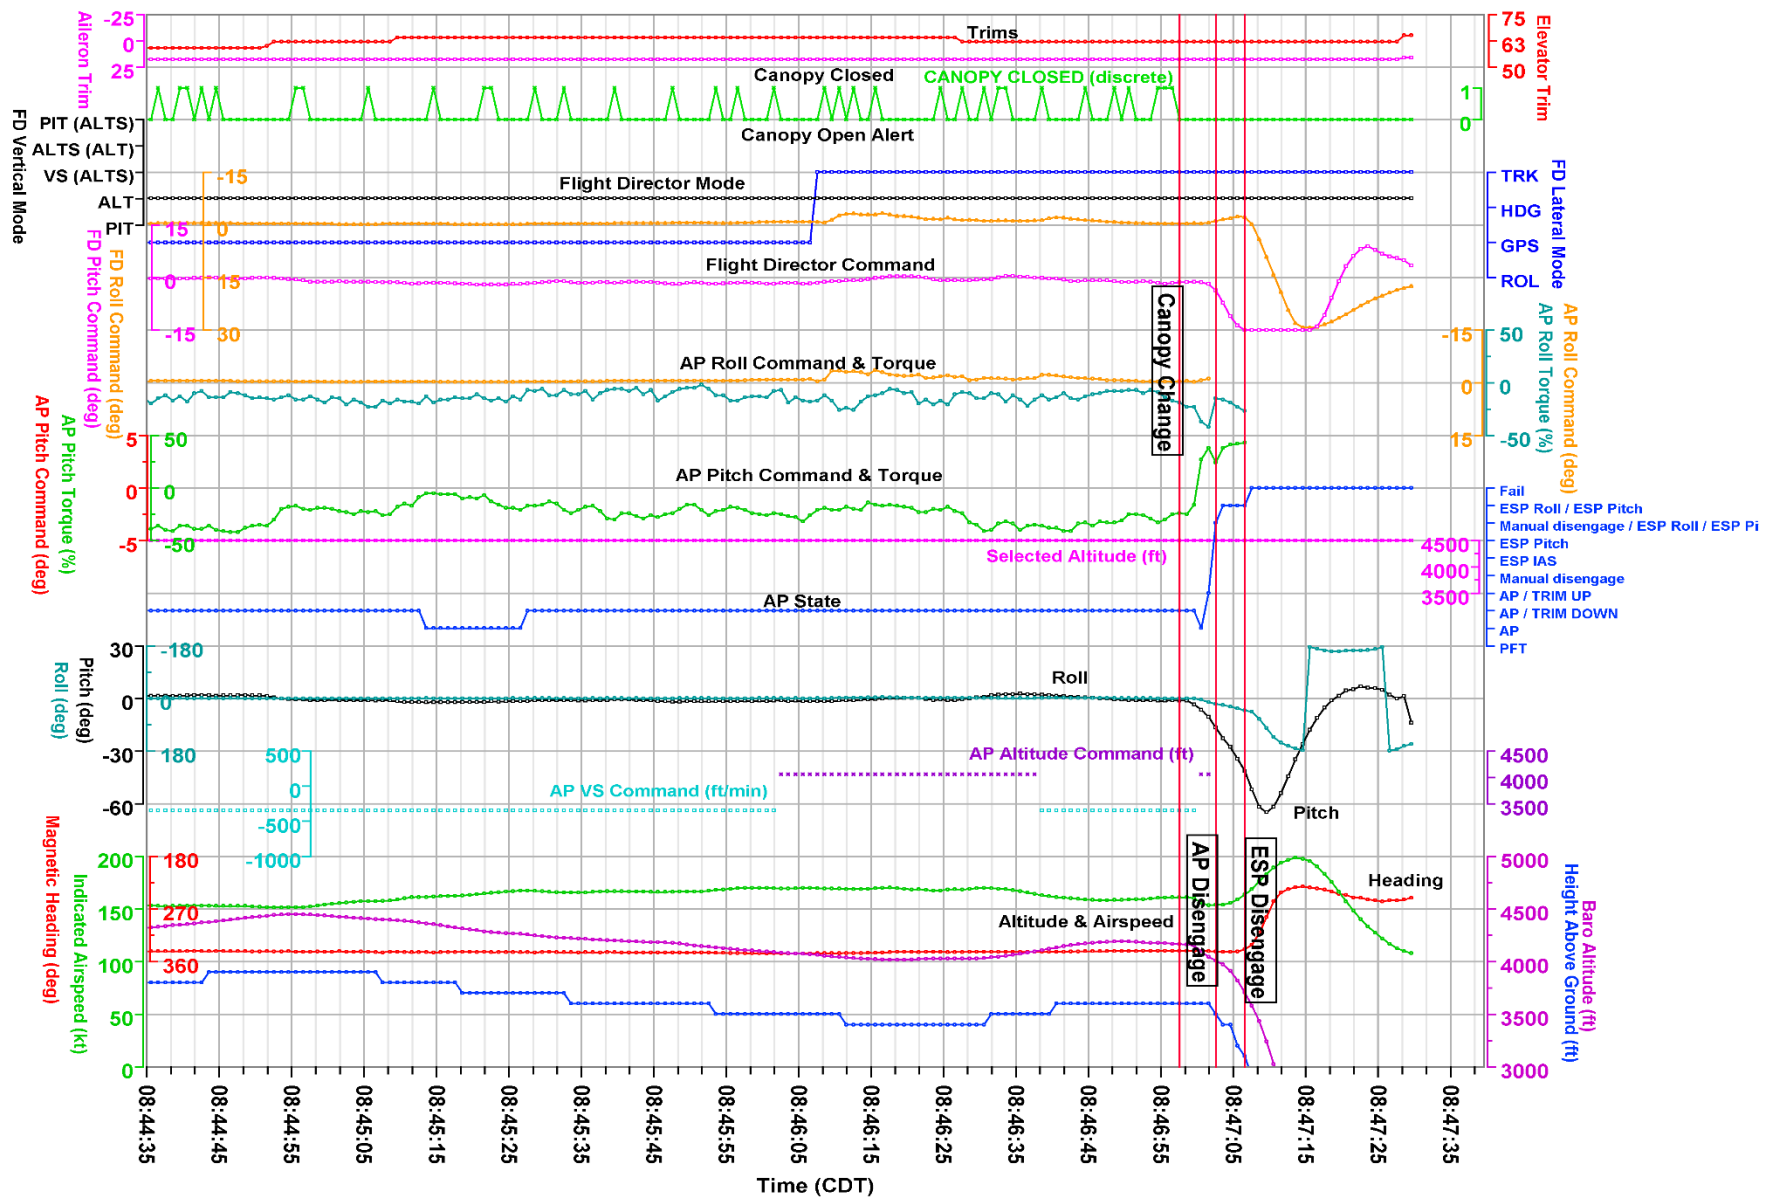
**Figure 30.** A plot of autopilot related parameters for the last approximately 8 minutes of flight.

Figure 30 is an expanded time scale plot of basic parameters and numerous autopilot-related parameters during the accident flight on August 12, 2023. The plot contains the condition of the canopy warning status parameter. The plot shows the last approximately 8 minutes of flight.

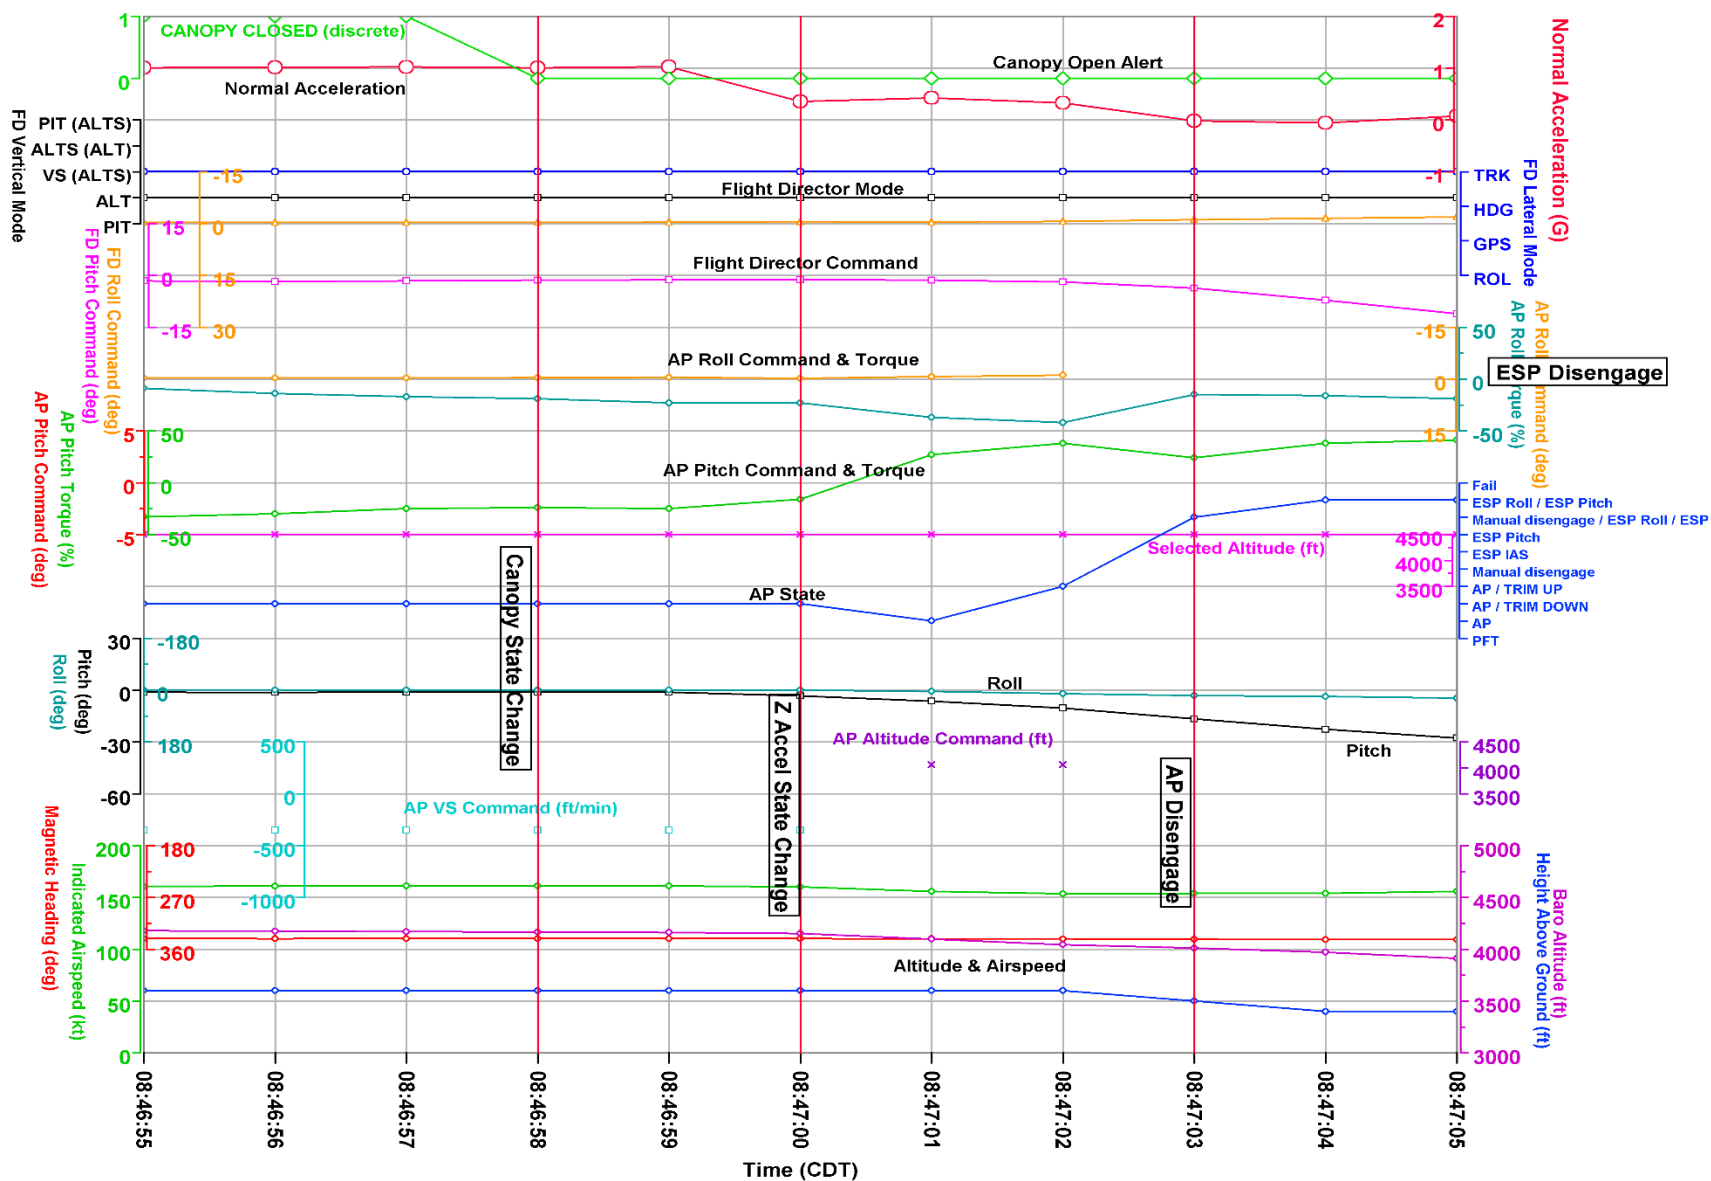
**Figure 32.** A plot of autopilot related parameters for the last 100 seconds of flight. The values for Normal Acceleration (Z Accel.) have been added to this plot.

Figure 32 is an expanded time scale plot of basic parameters and numerous autopilot-related parameters during the accident flight on August 12, 2023. The plot contains the condition of the canopy warning status parameter. The plot shows the last approximate 100 seconds of flight. Canopy warning state change, the time the
