# National Transportation Safety Board

CEN23FA359

## **AIRFRAME EXAMINATION**

Location: Virden, IL  
Date: August 12, 2023  
Time: 0848 central daylight time  
1347 UTC  
Airplane: Van's RV-14A

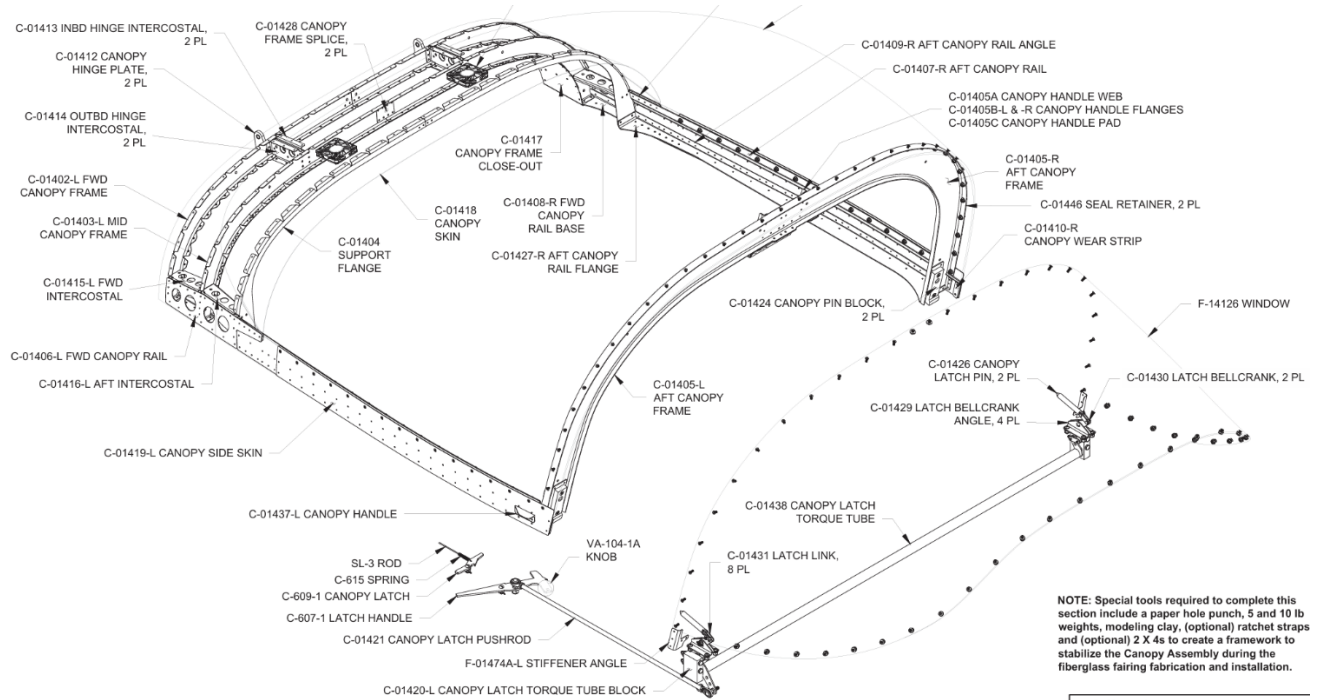
Figure 4. Canopy part names (Van's Aircraft manual excerpt)

The airplane was equipped with a tip-up style canopy. Examination of the airplane's canopy found that it was impact damaged and fractured in multiple locations. The roll bar was separated from the primary structure. The canopy hinge plates remained attached to the forward canopy frame. The canopy release pins were inserted into the canopy hinge plate.

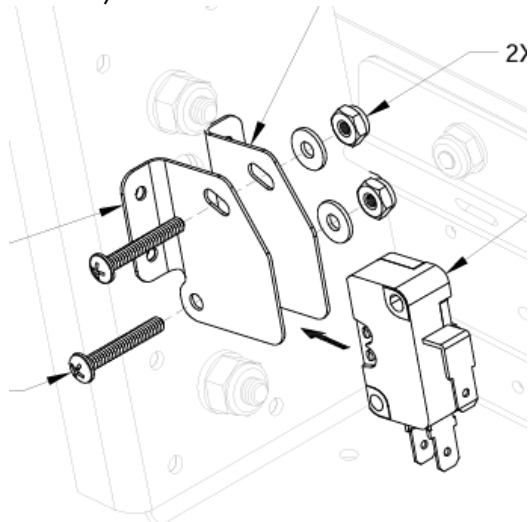
Figure 11. Canopy latch micro switch (Van's manual excerpt)

Per Van's build instructions, only one cockpit canopy micro switch (p/n ES-00306) is installed on the left side of the canopy frame (see figure 9).

After micro switch installation, the builder should set the micro switch's position in an assembled bracket so that left canopy pin only begins to depresses the micro switch's plunger when the pin is fully seated and the canopy is closed. A check of the micro switch's functionality showed that the switch operated within tolerances. The canopy latch micro switch was found in the aft-most position setting. This setting could allow for the micro switch to signal that the canopy is closed when additional canopy pin travel is needed for the canopy to be fully closed.
