# National Transportation Safety Board

CEN23FA401

## **WRECKAGE EXAMINATION SUMMARY**

Location: Huntsville, Texas  
Date: September 6, 2023  
Time: 1148 central daylight time (1648 UTC)  
Airplane: Cessna 150K, Registration No. N6059G

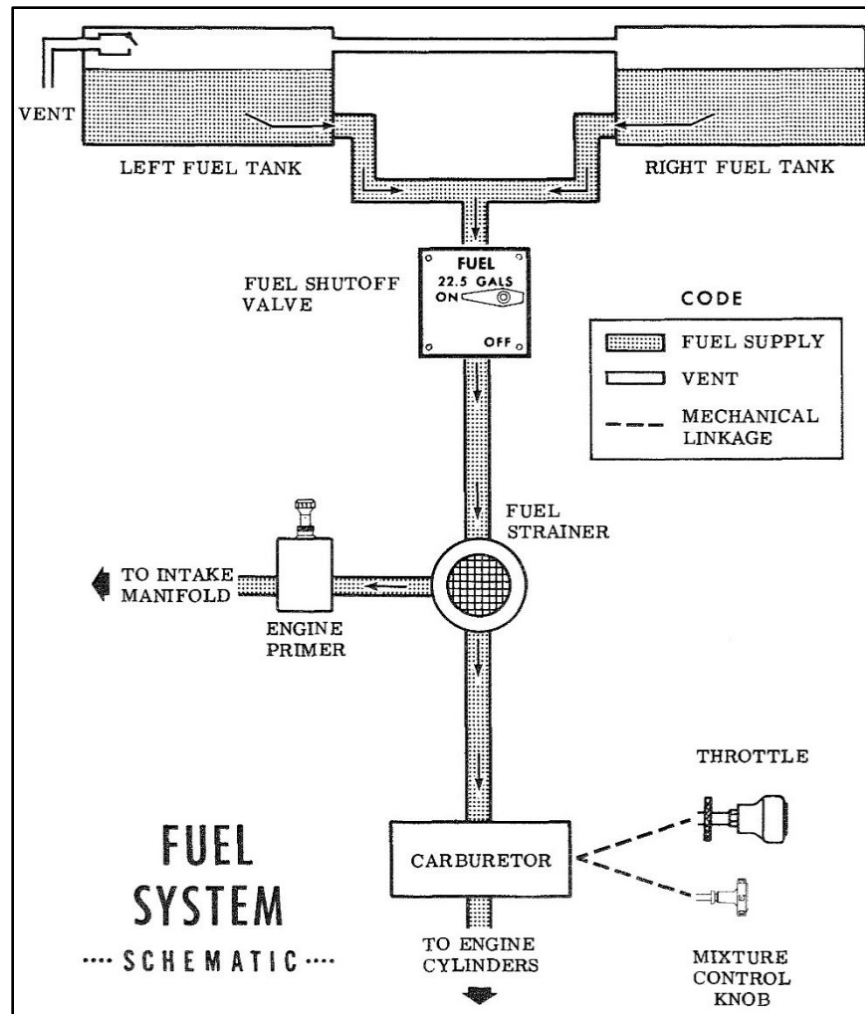
**Figure 1.** Fuel system schematic

The airplane was equipped with a 26 gallon capacity (22.5 gallons usable) fuel system, consisting of two 13 gallon main fuel tanks (11.25 gallons usable each). The two fuel tanks are combined before the fuel shutoff valve, as depicted in figure 1.

shutoff valve assembly remained intact. The fuel lines from each wing fuel tank combined through a Y-shaped fuel fitting upstream of the fuel shutoff valve, as previously shown in figure 1. The fuel line from the fuel shutoff valve assembly to the fuel strainer assembly was impact separated about 2 inches forward of the fuel shutoff valve assembly. The fuel strainer assembly was displaced aft through the firewall into the cockpit floor area. The filter bowl was separated from the fuel strainer assembly and was impact damaged. The fuel strainer screen filter remained attached to the fuel strainer and exhibited debris, as shown in figure 6. The fuel line from the fuel strainer assembly to the carburetor was separated and not observed.
