# National Transportation Safety Board

CEN23LA014

Group Chair's Factual Report

Location: Dallas, TX  
Date: October 15, 2022  
Time: 1448 central daylight time (CDT)  
1948 universal coordinated time (UTC)  
Airplane: Diamond DA-62, N84LT, 62.C003

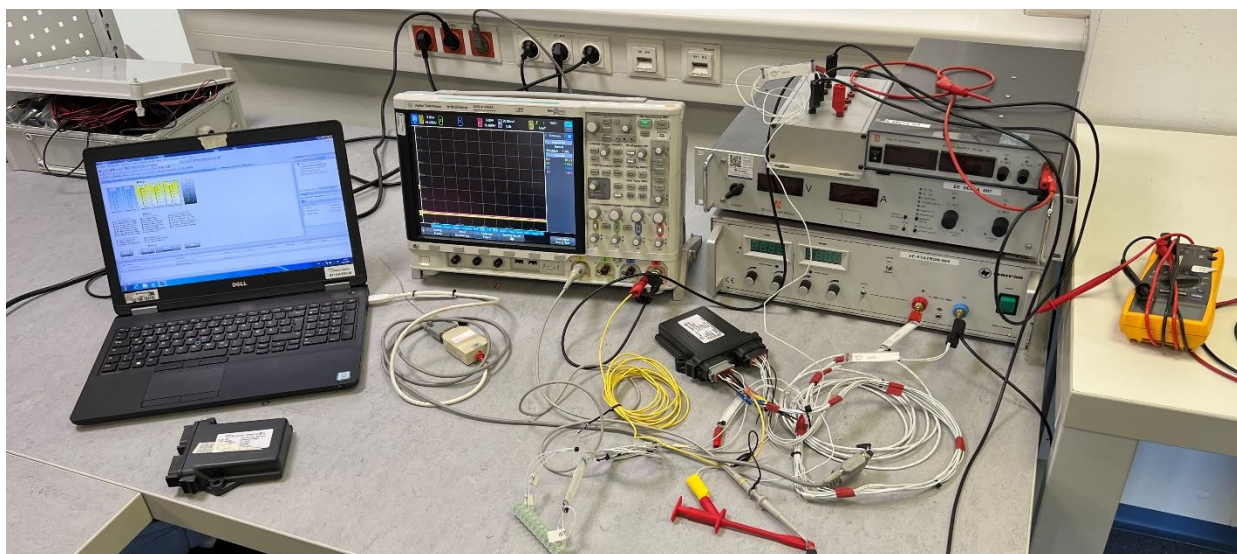
LH voltage regulator part number E4A-91-200-000-011 serial number 1448 and RH voltage regulator part number 4A-91-200-000-011 serial number 1411 were tested per Test Plan P004.06.06. Both regulators passed all testing without any under/overshoots observed. Figure 10 shows the test set-up for the voltage regulators.

**Figure 10.** Photo of the voltage regulator test set-up. (Courtesy of Austro Engines)

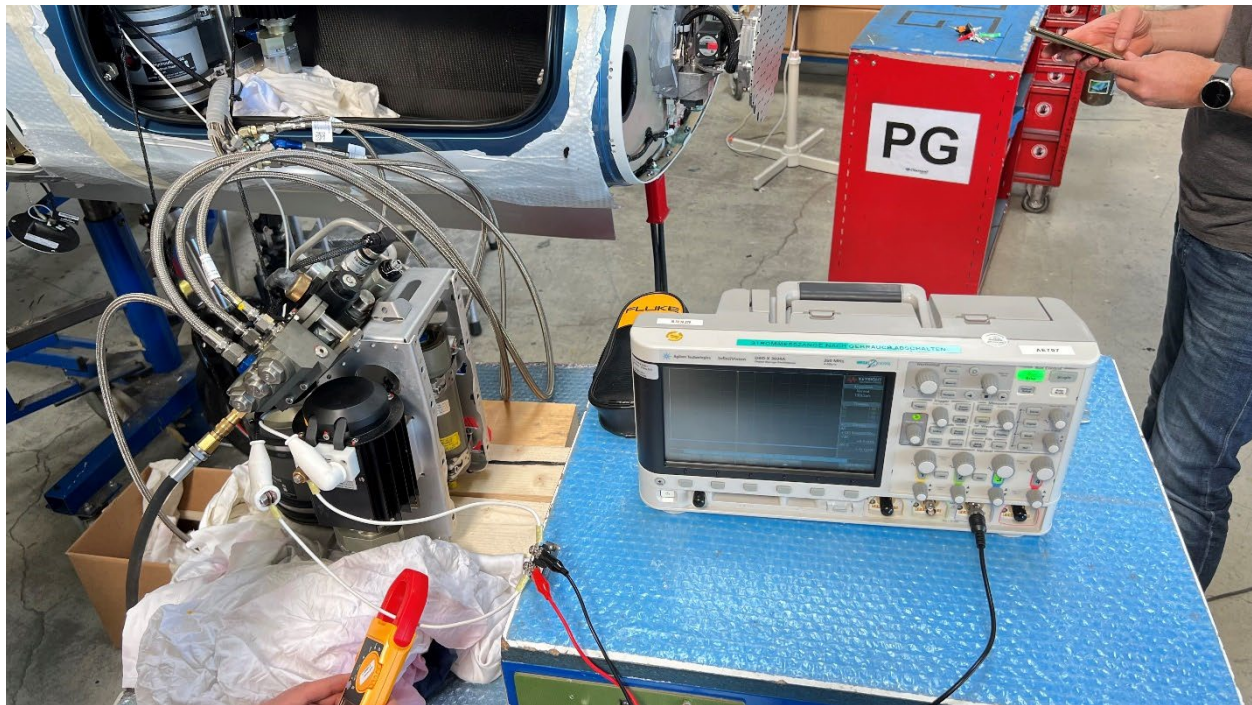
The hydraulic power pack was connected to aircraft serial number 62.243 (Figure 12). The hydraulic system was bled. A one Ohm shunt resistor was installed inline with the electrical supply to measure current.

**Figure 12.** Photo of the hydraulic power pack test set-up. (Courtesy of Austro Engines)
