**From:** Sean Payne  
**Sent:** Wednesday, November 15, 2023 1:56 PM  
**To:** Joshua Lindberg  
**Subject:** CEN23LA064 (Patterson, Louisiana) Appareo Vision 1000 - Email Report  
**Attachments:** Appareo2.jpg; Appareo1.jpg

### Email Report

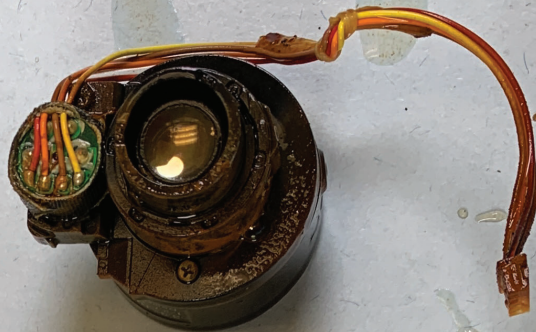
The Vehicle Recorder Division received an Appareo Vision 1000 device. The device is pictured in Appareo1.jpg. The device was subject to damp environmental conditions and was subject to corrosion before recovery from the accident site. The device exhibited moisture and corrosion throughout.

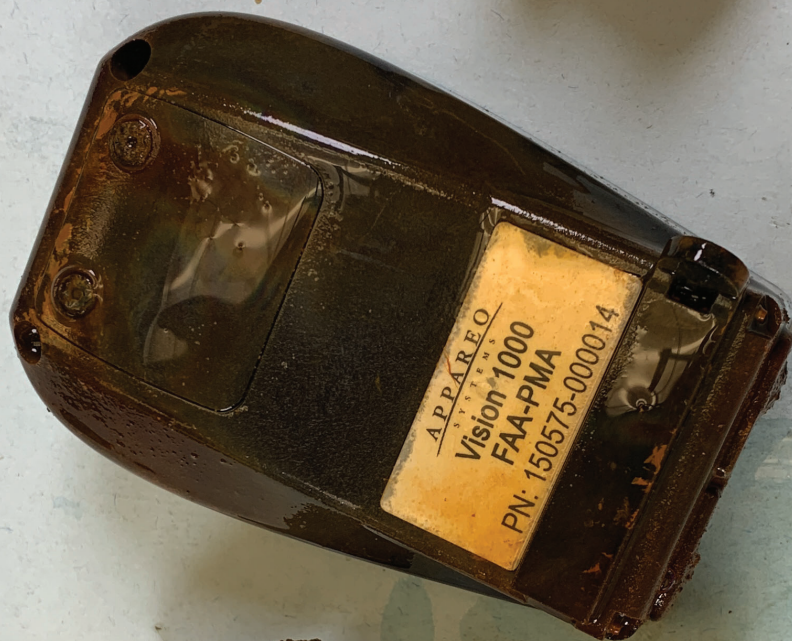
The device was absent of a removable memory device. Appareo2.jpg shows the memory device slot empty, as received.
