# National Transportation Safety Board

CEN23LA101

## **SURVIVAL FACTORS**

Specialist's Factual Report

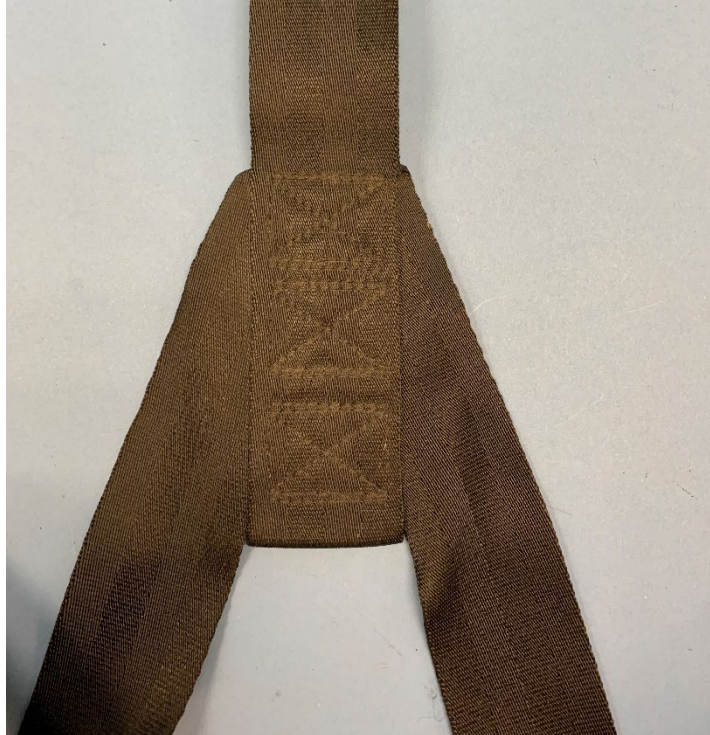
**Figure 9.** Rear seat belt showing the yoke of the shoulder belt.

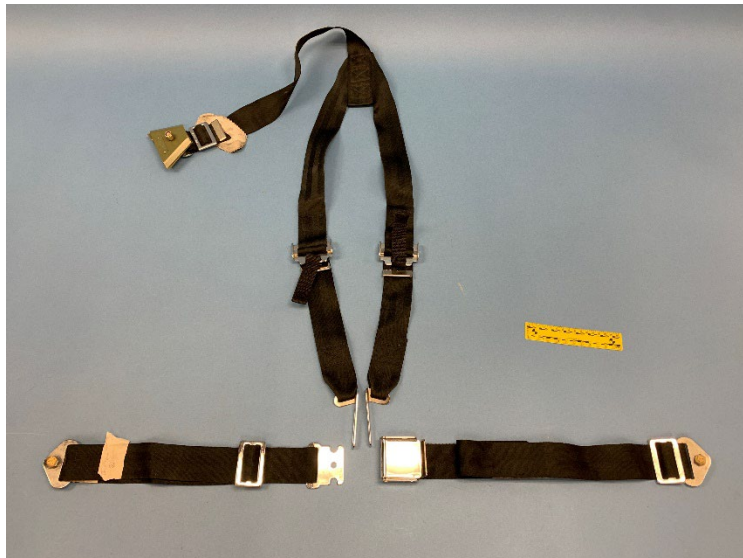
**Figure 10.** Rear seat restraint.

Three anomalies were noted regarding the accident airplane's restraint system. First, there was a separation of the pilot restraint threading at the 'Y' junction. (see figure 11). Second, the lap belt portions were wrapped around the seat back instead of secured directly to the seat as designed<sup>1</sup>. Finally, examination of the metal shoulder
