# National Transportation Safety Board

CEN23LA223

## **EXAMINATION SUMMARY**

Location: Lake Village, Arkansas  
Date: June 3, 2023  
Time: 1158 CDT  
Airplane: Air Tractor AT-502B, N509HB

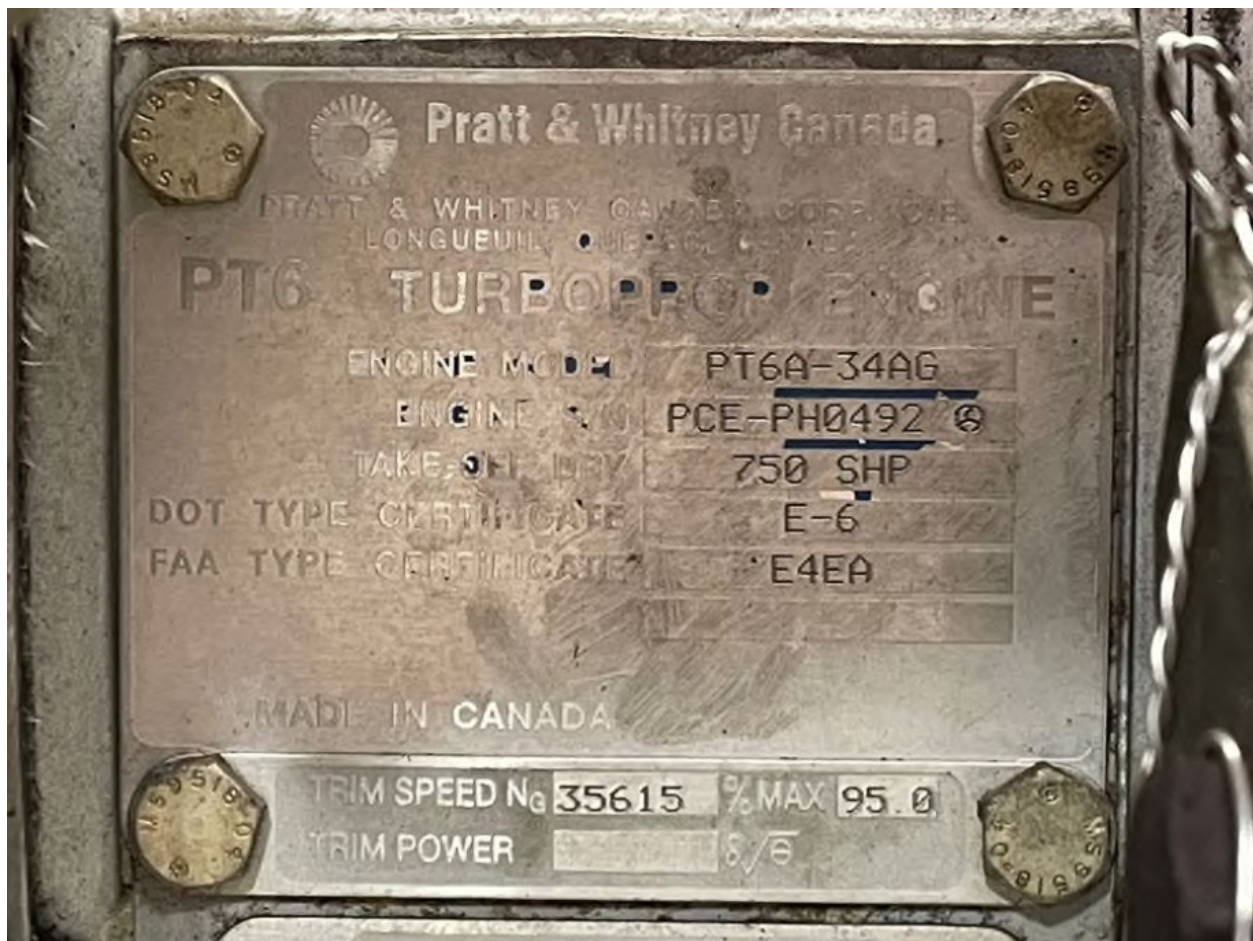
Figure 3 - Data Plate

The engine was still within the air frame (Figure 1). The propeller was still attached to the engine and showed some damage to the propeller tips (Figure 2). The data plate confirmed the engine S/N was PCE-PH0492 (Figure 3).

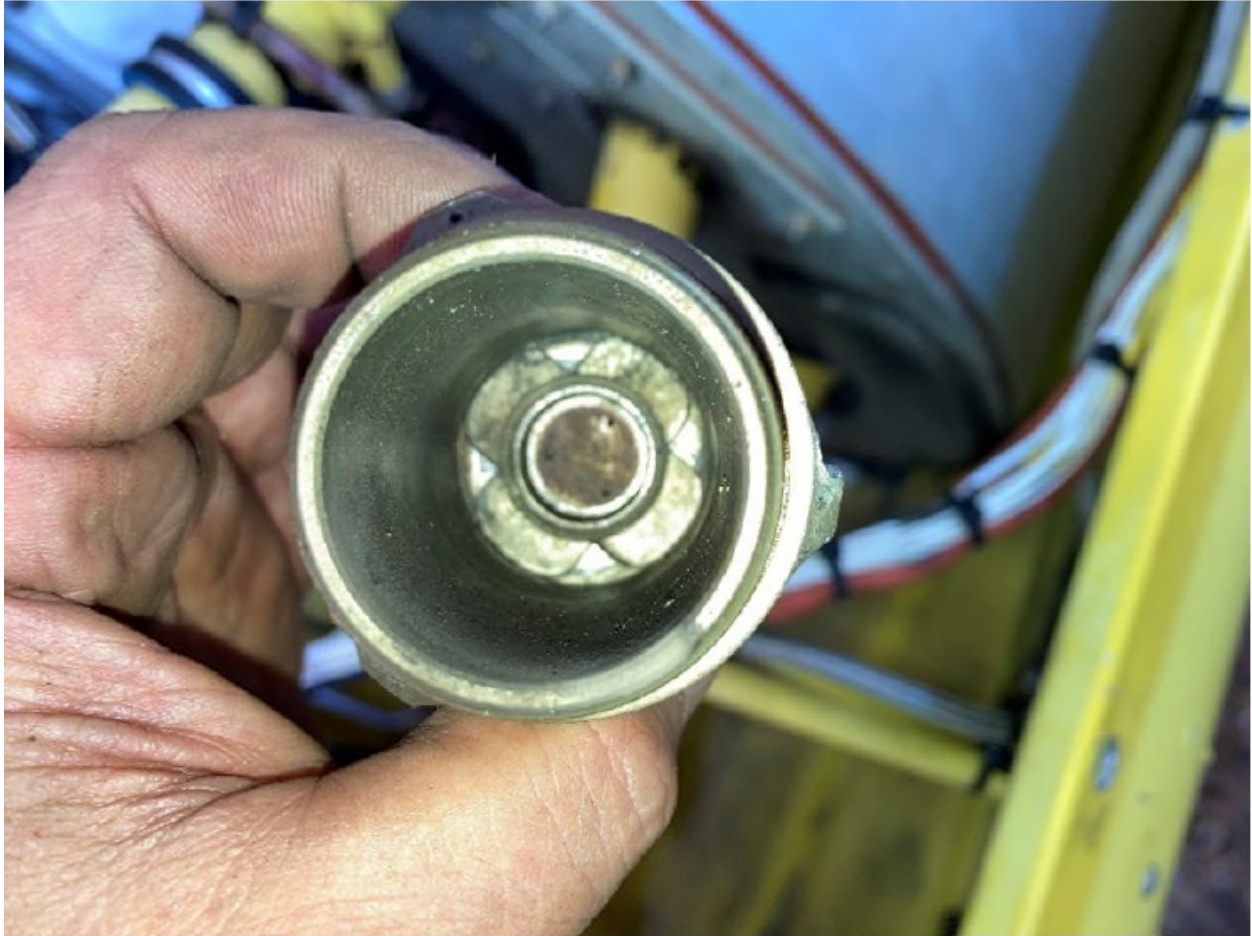
Figure 16 - P3 Filter bowl

found tight and secured (Figures 13 and 14). The P3 filter and bowl, which was tight and secured, were clean and dry (Figure 15).
