# National Transportation Safety Board

CEN23LA232

## **MATERIALS LABORATORY**

Factual Report 24-022

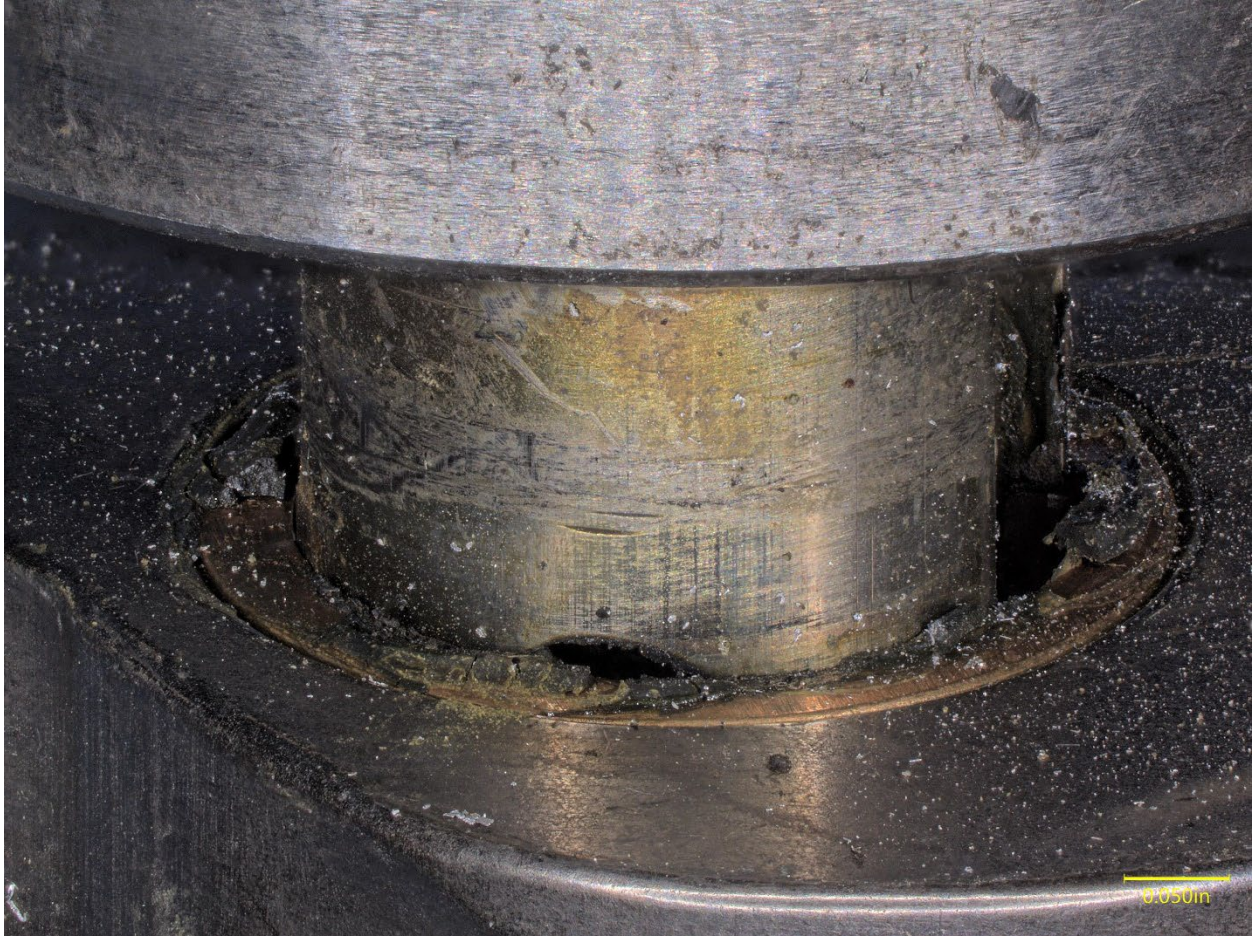
**Figure 8.** Angled view of the shaft and camgear face from the pinion side of the shaft, showing the pinhole.

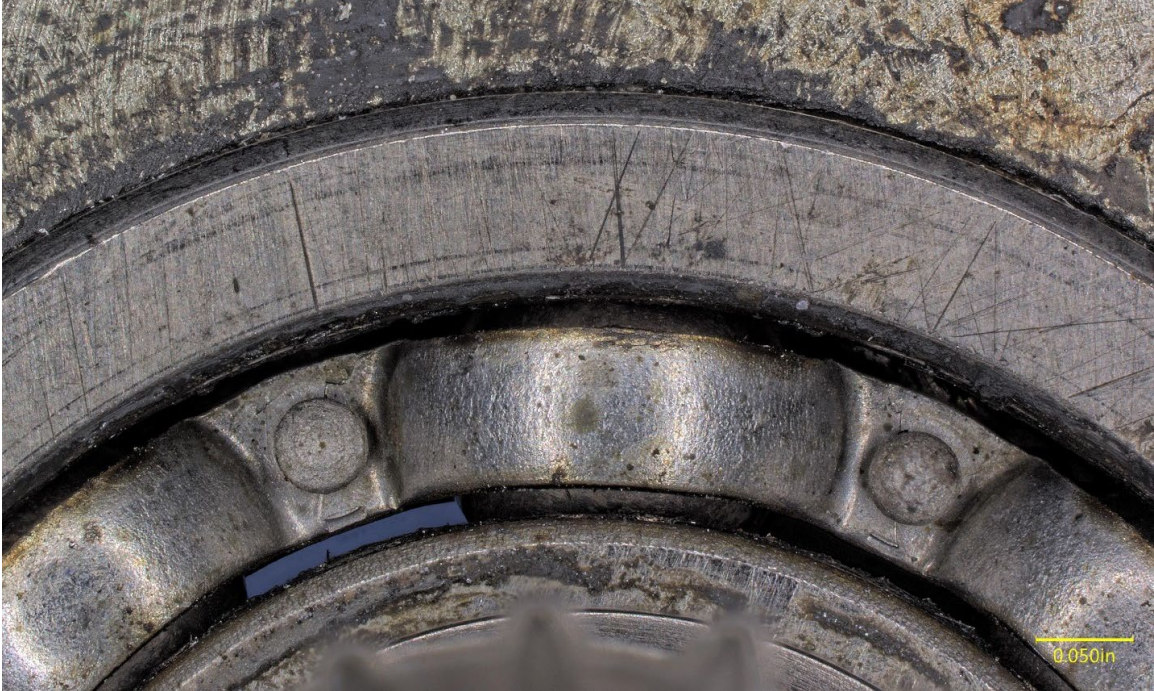
The bearing balls were still in place with no loose debris, as shown in Figure 64. The race surfaces facing the balls did exhibit dark material buildup, as illustrated in Figure 65.

**Figure 64.** Closer view of the cage and roller balls inside the bearing in Figure 56.
