# National Transportation Safety Board

CEN23LA232

## POWERPLANTS

Group Chair's Factual Report

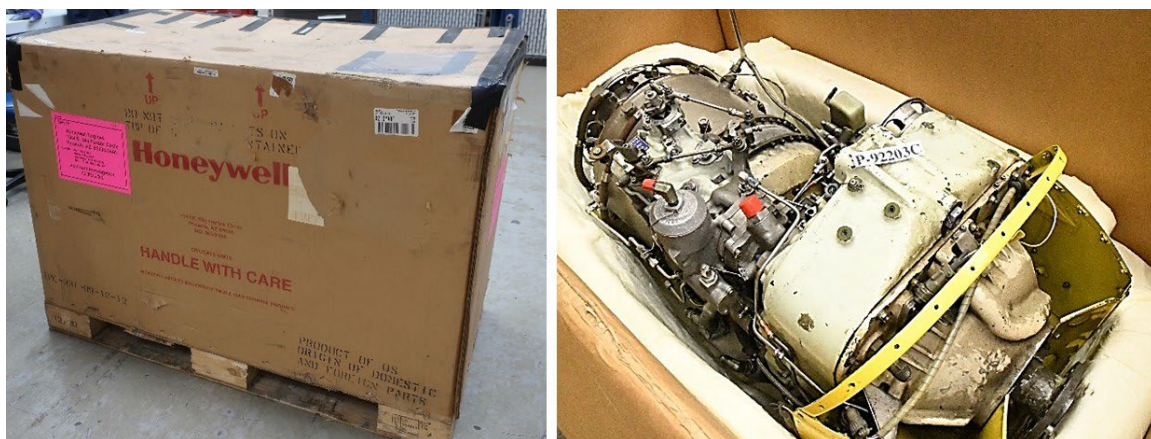
**Photo 1. Shipping Container (L), Engine As Received (R)**

The engine was secured in a cardboard shipping box in the Honeywell Product Integrity Laboratory when the investigation team arrived (**Photo 1**). Honeywell reported that with the prior approval of the NTSB investigator-in-charge the shipping container had been opened and the engine removed for a visual scan.

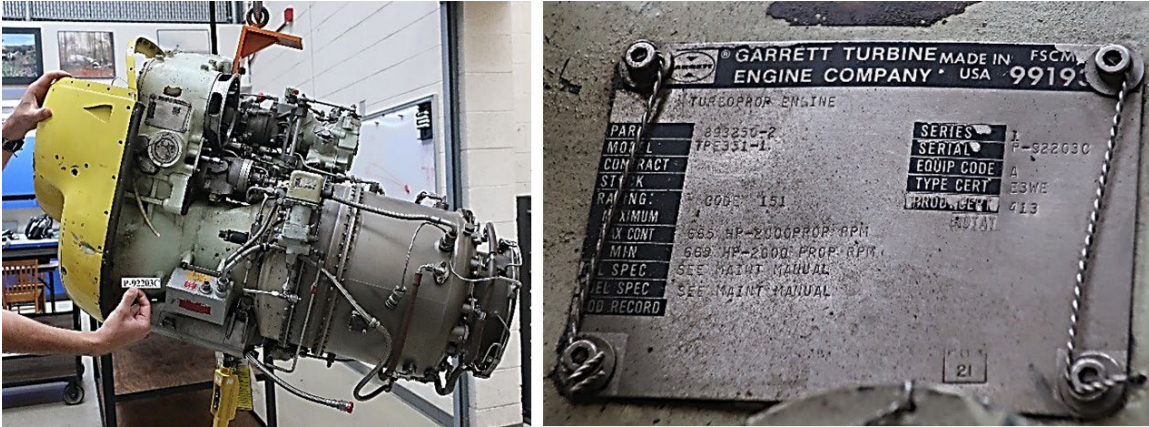
**Photo 2. Engine Removed From Shipping Container (L), Engine Data Plate (R)**

The engine was removed from the shipping container and according to the engine data plate the ESN was P92203C (**Photo 2**). The engine did not show any signs of uncontainment or external fire damage.

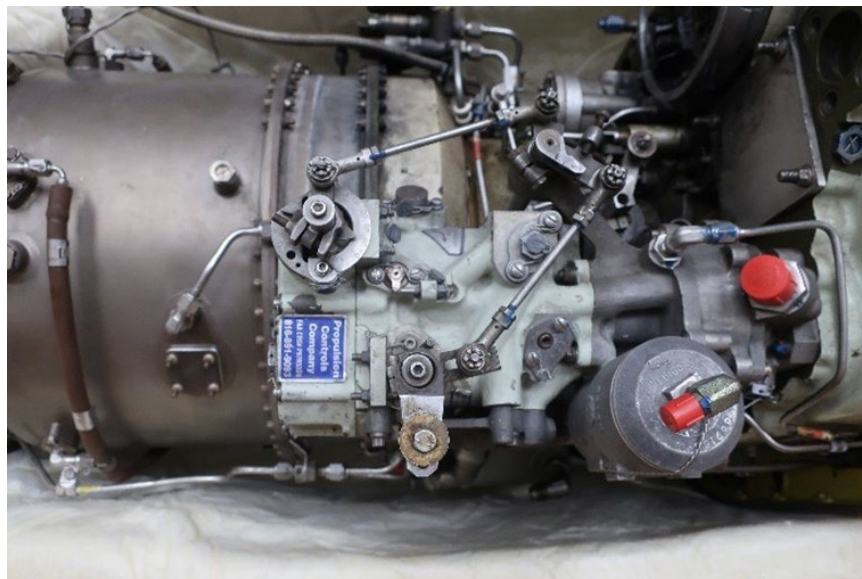
**Photo 3. Fuel Control Unit - As Received**

According to the on scene (wreckage exam) photos, the fuel control power lever indicator position showed a power setting at approximately the 40% position. With the engine still in the shipping container prior to teardown work at the Honeywell facility, the power lever indicator was observed to be at approximately the 20% position (**Photo 3**). Movement of the power lever linkage resulted in smooth and corresponding movement of the propeller pitch control (PPC) linkage.

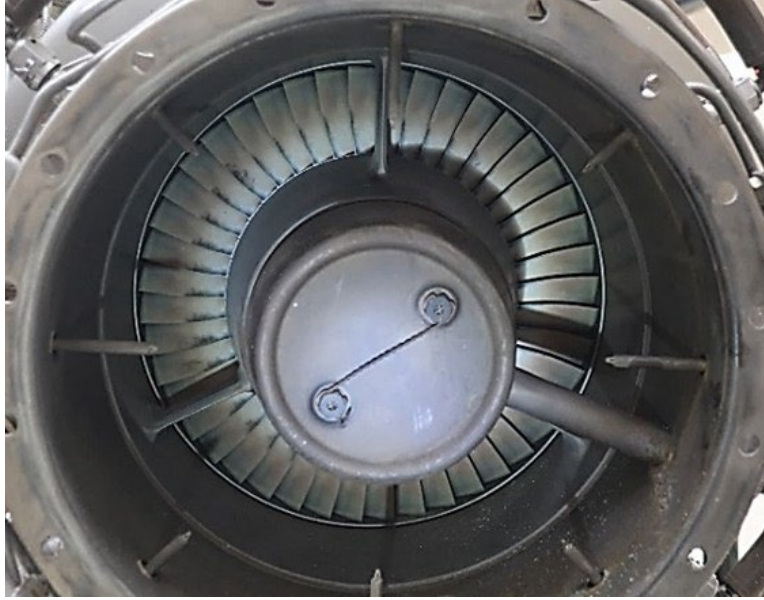
**Photo 4. Power Turbine Rotor/Blades - Looking Through Exhaust Duct**

When looking through the exhaust, all the power turbine rotor blades appeared present, intact, and undamaged (**Photo 4**). Hand rotation of the power turbine rotor, as well as the starter generator shaft coupling, resulted in with smooth and continuous rotation of the propeller flange.

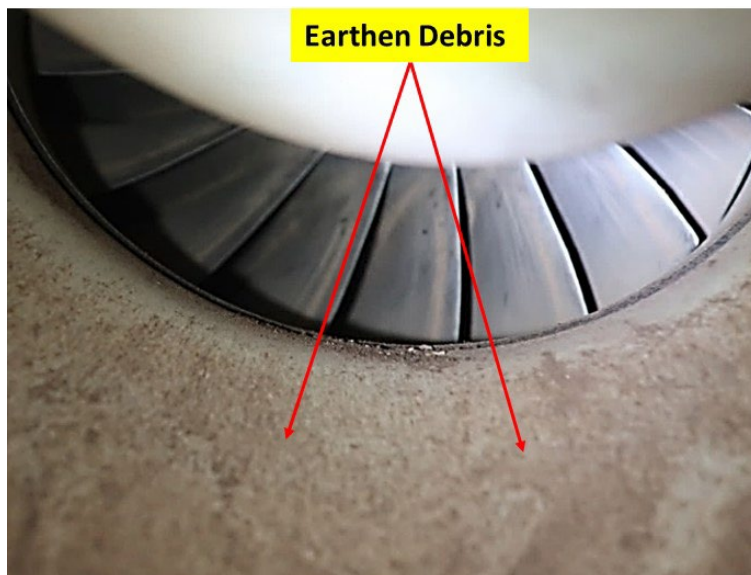
**Photo 5. 1<sup>st</sup> Stage Centrifugal Impeller - Looking Through the Inlet**

The compressor inlet was covered with a film of earthen debris but otherwise the impeller appeared intact and undamaged (**Photo 5**).

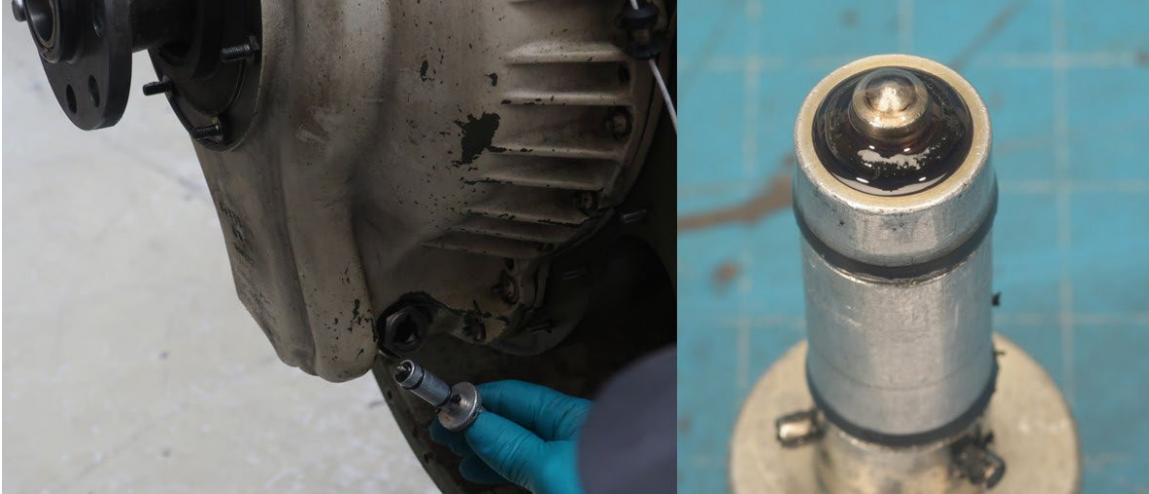
**Photo 10. Magnetic Chip Detector**

The magnetic chip detector (MCD) was removed from the lower forward sump area of the accessory gearcase and inspected. The MCD appeared clean with no observed metallic particles adhered to the magnet (**Photo 10**).

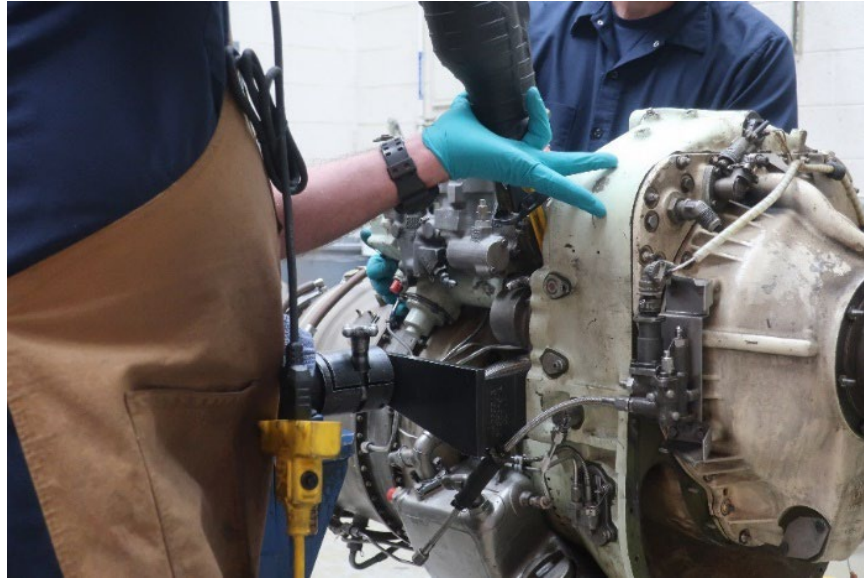
**Photo 13. Removal of the Fuel Control Unit**

The FP and FCU was removed as one assembly from the accessory gearbox, which required removal of four stud nuts (between the gearbox and the FP). Three of the stud nuts were removed normally, however, the fourth nut (lower right side nut) was seized in place and could not be unthreaded off the stud. This fourth stud was cut with a reciprocating saw (**Photo 13**) in order to facilitate removal of the FP/FCU assembly. Once the FP drive shaft was exposed, the drive shaft splines were found intact with no evidence of damage (**Photo 14**).

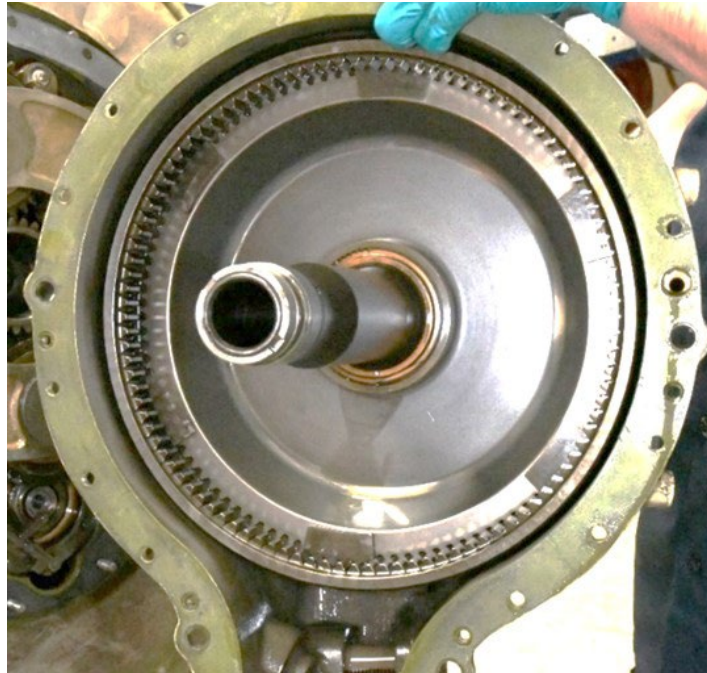
**Photo 15. Ring Gear**

With the nose cone removed, there was no evidence of damage found on the exposed ring gear (**Photo 15**) nor the planetary carrier (**Photo 16**).

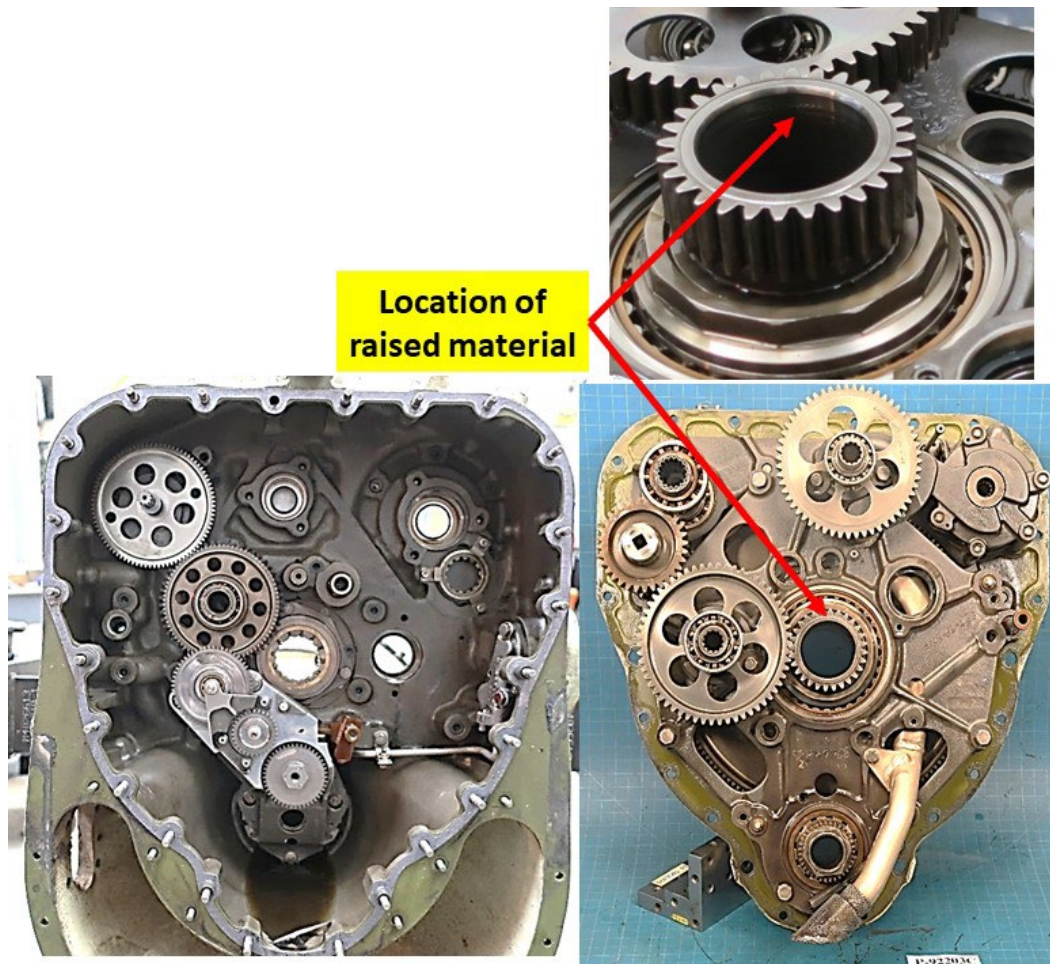
**Photo 17. Gearbox Accessory Case (L) and Accessory Gearbox Diaphragm (R)**

Removal of the diaphragm exposed the accessory gearbox interior which appeared in good condition with no evidence of damage. The exposed gears and bearing elements appeared shiny and oil wetted. Continuity between all gears was reconfirmed. The sun gear exhibited localized raised metal on the inner diameter (ID) bore of the gear (**Photo 17**)

A circumferential score mark was found on the propeller shaft, approximately 1.5 inches in length near the mid shoulder (?) which corresponds to an area of rough (raised material) on the aft ID of the gear bore (**Photo 17**). Additional rubbing contact was observed on the aft end of the propeller shaft (**Photo 18**).

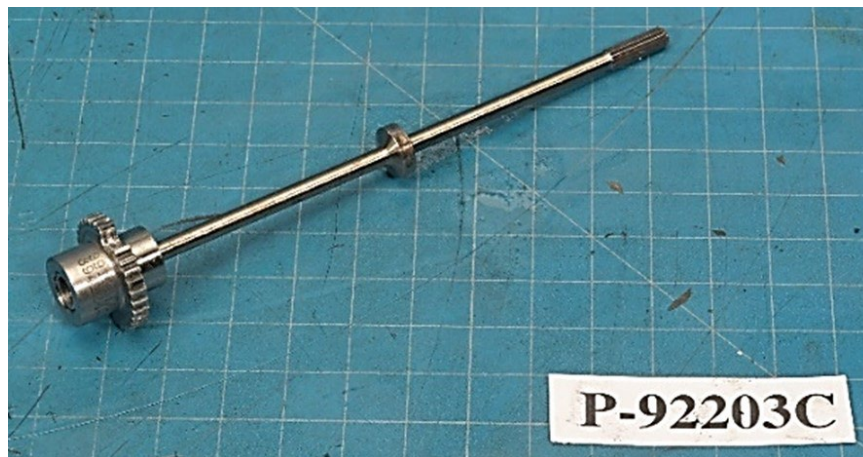
**Photo 19. Quill Shaft**

The quill shaft, which is located inside the coupler shaft and preloads the coupler and torque sensor in a positive direction, appeared to be straight with no evidence of damage (**Photo 19**).

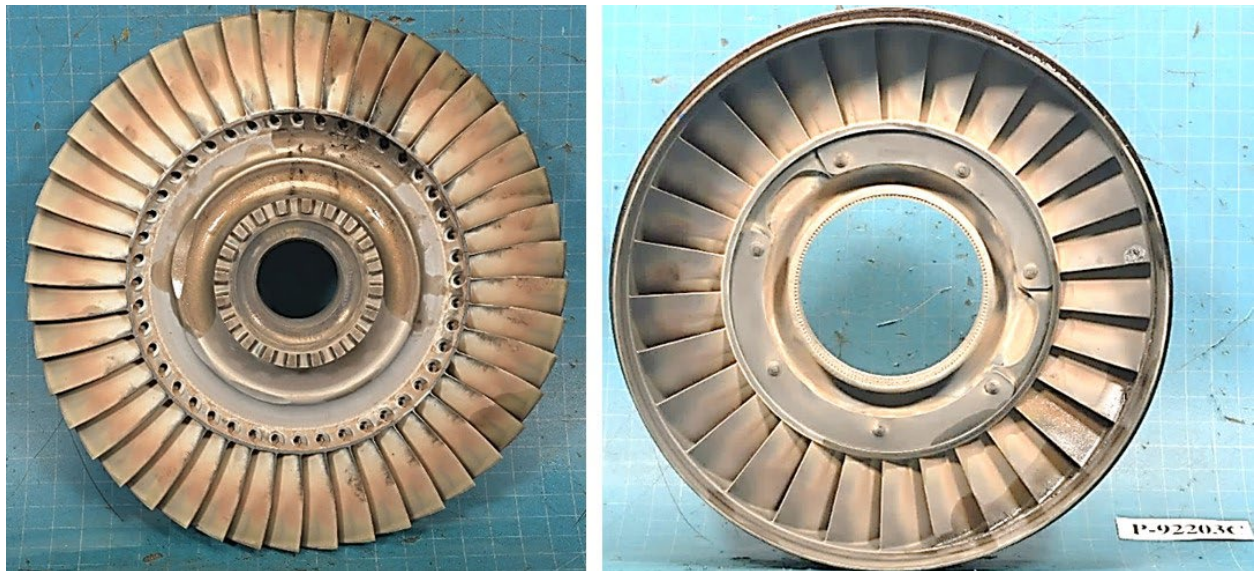
**Photo 20. Stage 3 Turbine Rotor (L) and Stage 3 Nozzle (R)**

All stage 3 turbine rotor blades were present, intact, and found to be undamaged with no signs of blade tip rub/contact. The stage 3 turbine rotor curvic coupling teeth, located on the forward side of the disk, were in good condition. The stage 3 nozzle exhibited no evidence of damage but earthen material was found on both the turbine 3 rotor and nozzle. (**Photo 20**).

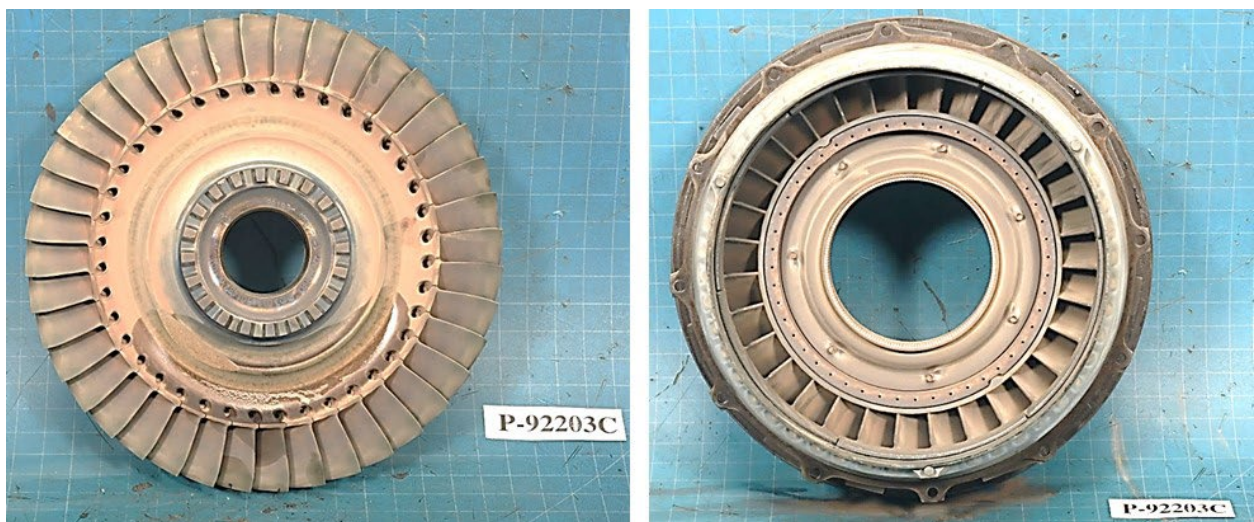
**Photo 21. 2<sup>nd</sup> Stage Turbine Rotor (L) and Stage 2 Nozzle (R)**

All stage 2 turbine rotor blades were present, intact, and found to be undamaged with no signs of rub/contact on the blade tips. The stage 2 turbine rotor curvic coupling teeth on both the forward and aft sides were in good condition. Similarly, the stage 2 nozzle exhibited no evidence of damage. Earthen material was present on both the stage 2 turbine rotor and nozzle (**Photo 21**).

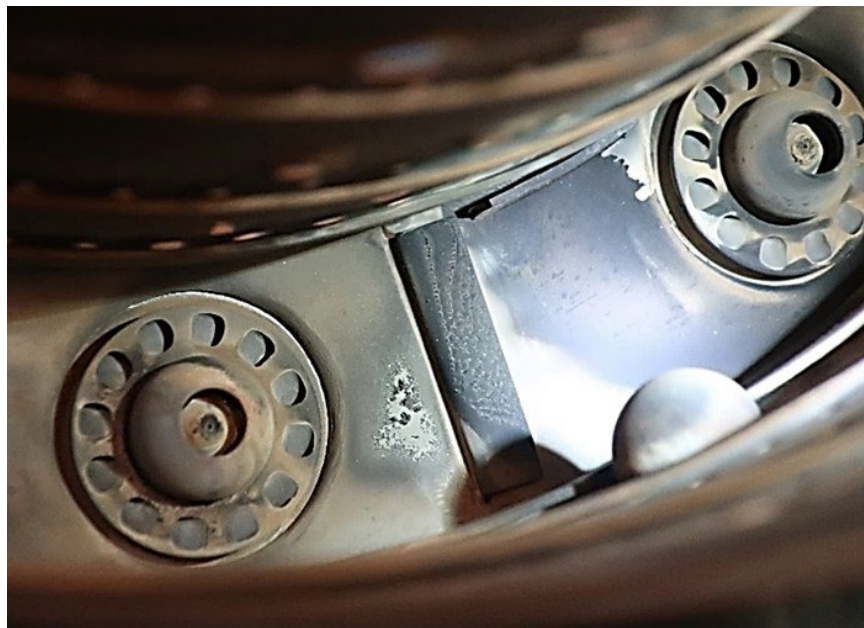
**Photo 25. Fuel Nozzles**

The fuel nozzles and the swirlers did not exhibit evidence of streaking or coke accumulation (**Photo 25**).

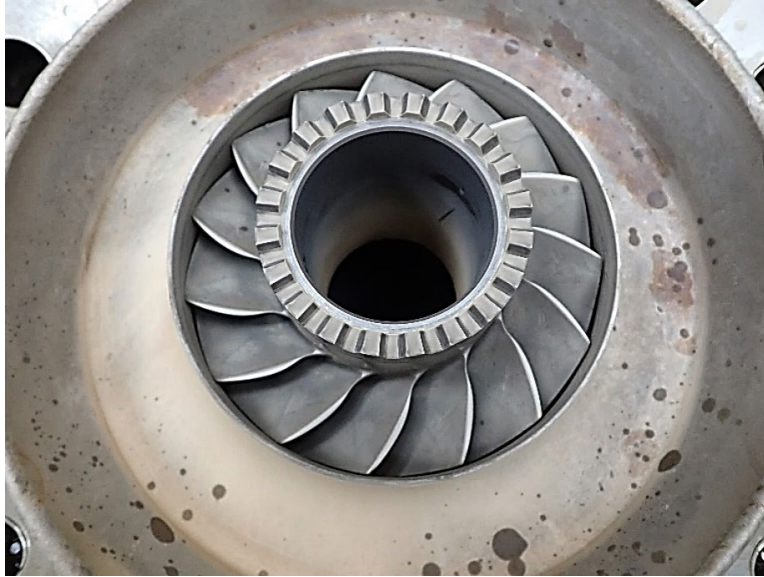
**Photo 28. Forward End (Inducer) of the Stage 2 Impeller (Installed)**

The forward end of the stage 2 impeller curvic coupling teeth showed even wear consistent with operation and no evidence of damage (**Photo 28**).

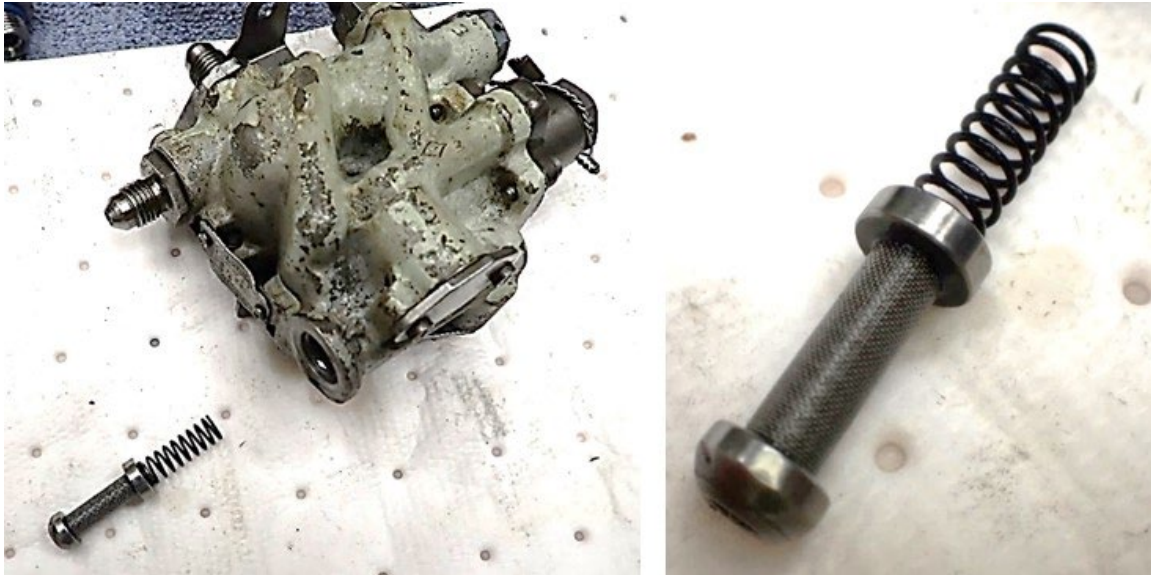
**Photo 32. Fuel Flow Divider Assembly (L) and Filter Screen (R)**

The last chance screen in the fuel flow divider was removed and inspected. No debris/particles were present and no evidence of damage was found (**Photo 32**).

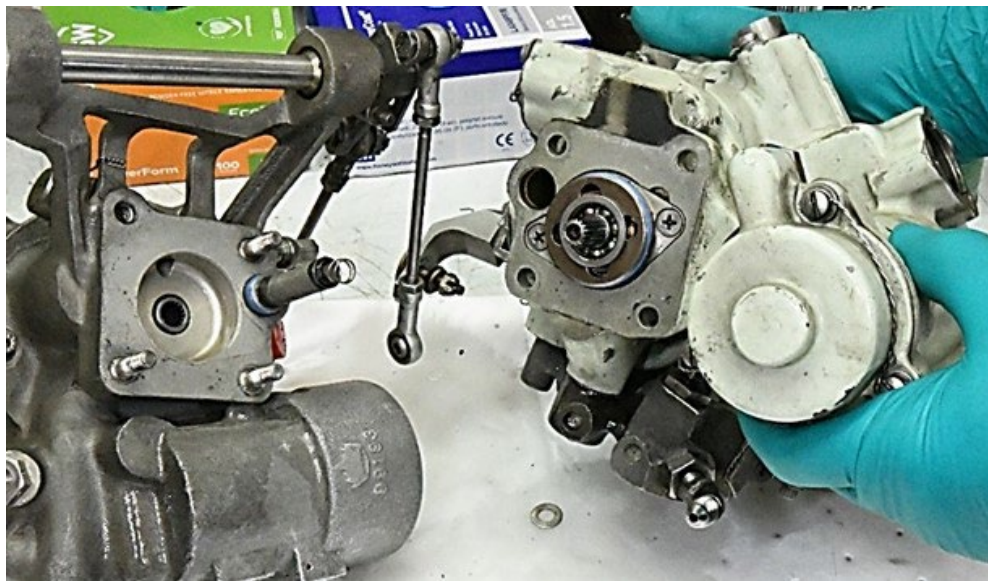
**Photo 33. Fuel Pump AND Fuel Control Unit - Separated**

The FP was removed from the FCU. The FP filter screen was removed and it exhibited no debris/particles and no evidence of damage. The FP drive shaft exhibited no evidence of damage and hand rotation was found to be smooth and continuous (**Photo 33**).

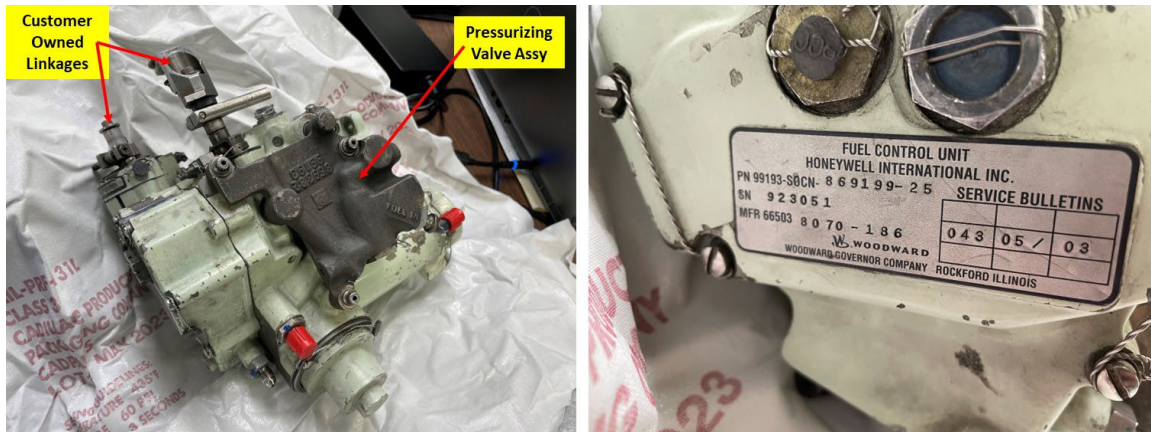
**Photo 36. Fuel Control Unit - As Received (L), FCU Data Plate (R)**

The accident FCU, Honeywell PN 869199-25, Woodward PN 8070-186, SN 923051, appeared intact and with one piece of customer (non-Woodward) hardware was attached as received (**Photo 36**).

Bench testing of the FCU was performed according to acceptance test specification TSP-1629. Several test points were out-of-range based on the test standard as noted on the test report (Attachment 1). Test results appeared consistent with the cam gear travel being limited, but not seized, on the cam shaft during testing. A position indicator installed during testing verified that the cam shaft was able to translate, but with limited travel. The position indicator revealed movement of the cam shaft stop with a Pt2 of about 11 pounds per square inch absolute (psia).

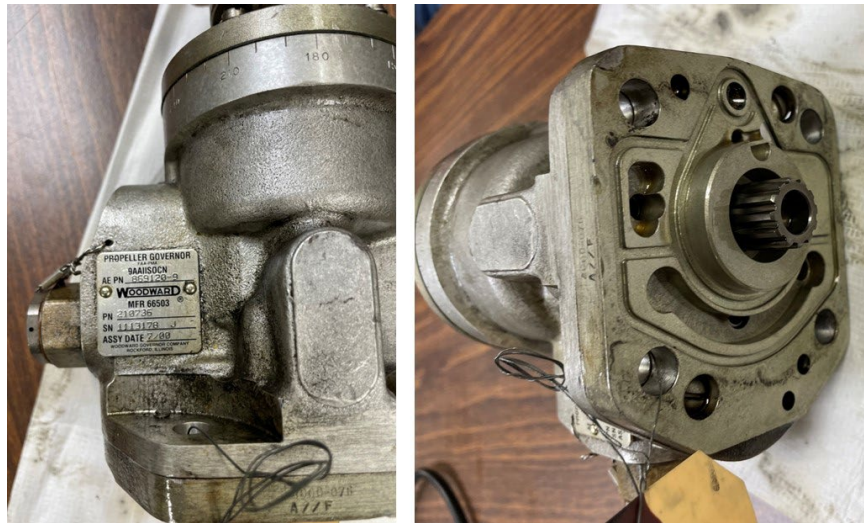
**Photo 38. Propeller Governor**

Propeller governor Woodward PN 210736, SN 1113178, appeared intact and undamaged (**Photo 38**) The as received visual inspection was performed revealing the maximum speed lever and connecting hardware were customer owned hardware. The input drive shaft rotated freely under hand pressure and the control arm appeared intact and rotated normally. There were no findings to prevent performance of the As Received bench test.

The as received bench test found all test points within limits except for the three parameters listed below. Refer to Attachment 2 for the full test results.

According to Woodward Inc., these three parameters (Maximum RPM, Minimum RPM, and Arm Travel) are common field adjusted parameters and the presence of non-Woodward lockwire indicates a field adjustment was performed on this propeller governor. These three parameters being outside of standard Woodward Inc. defined limits would not preclude normal operation. Given the bench test results in parallel with no other findings or anomalies found, it was determined that further disassembly of the propeller governor was not warranted.

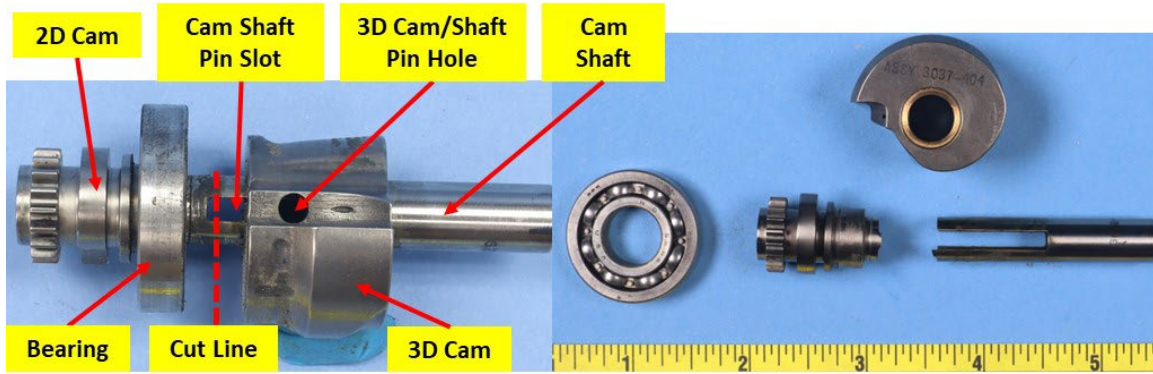
**Photo 40. Cam Shaft Pre-Cut (L), Post-Cut (R)**

To facilitate separation of the 3D cam and the cam shaft, the cam shaft was cut between the 3D cam and the bearing, once the cam shaft was cut the 3D cam slid off the cam shaft (**Photo 40**).

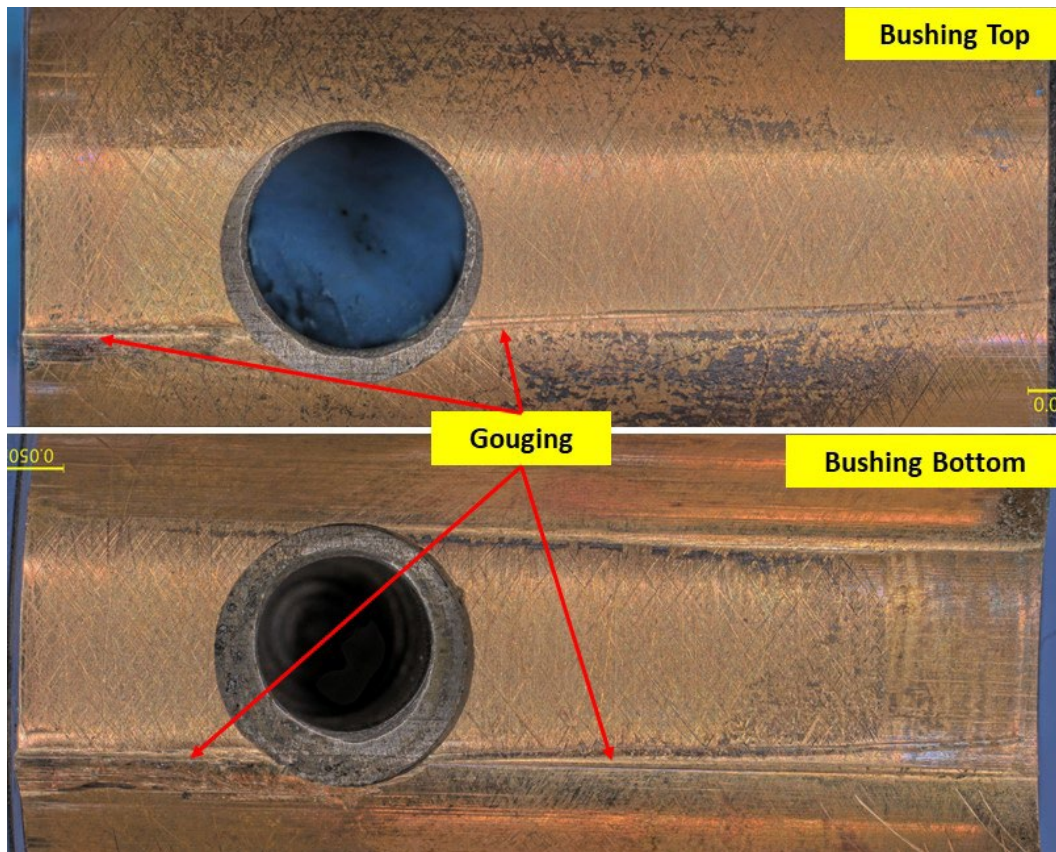
**Photo 43. 3D Cam/Bushing Cut in Half**

The 3D cam bushing, made of a copper alloy, located at the inner diameter of the 3D cam, appeared to have areas of wear and distinct gouges located axially within the cam bushing on either side of the assembly pin hole (**Photo 42**) and correspond to the cam shaft slot edges. The 3D cam was sectioned in half to expose the surface of the bushing (**Photo 43**).
