# National Transportation Safety Board

CEN23LA232

## **POWERPLANTS**

Honeywell Lab Analysis Report

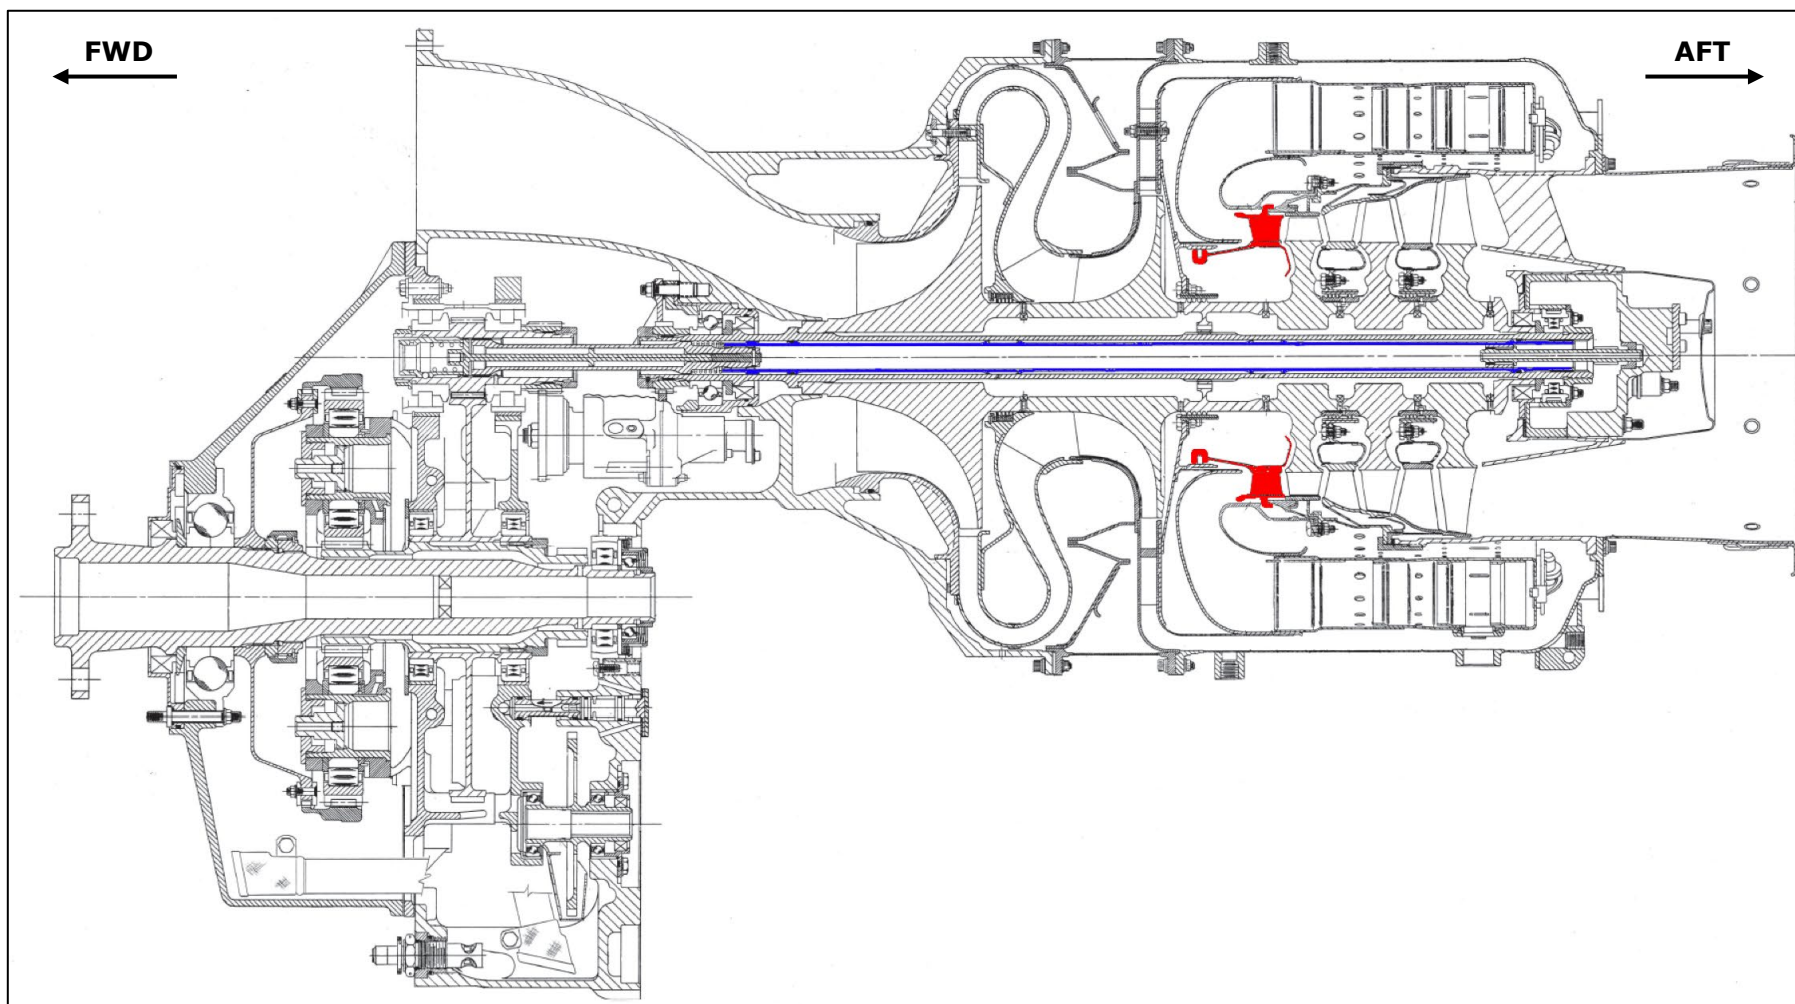
**Diagram 1.**

Schematic of the TPE331-1 engine showing the submitted 1<sup>st</sup> stage nozzle (P/N 896450-5, colored in red), and torsion shaft (P/N 3102028-2, colored in blue).
