# National Transportation Safety Board

CEN24FA170

## INVESTIGATION SUMMARY

Location: Bristol, Indiana  
Date: April 30, 2024  
Time: 1418 EDT  
Airplane: N6271F, Zodiac CH-601 HDS

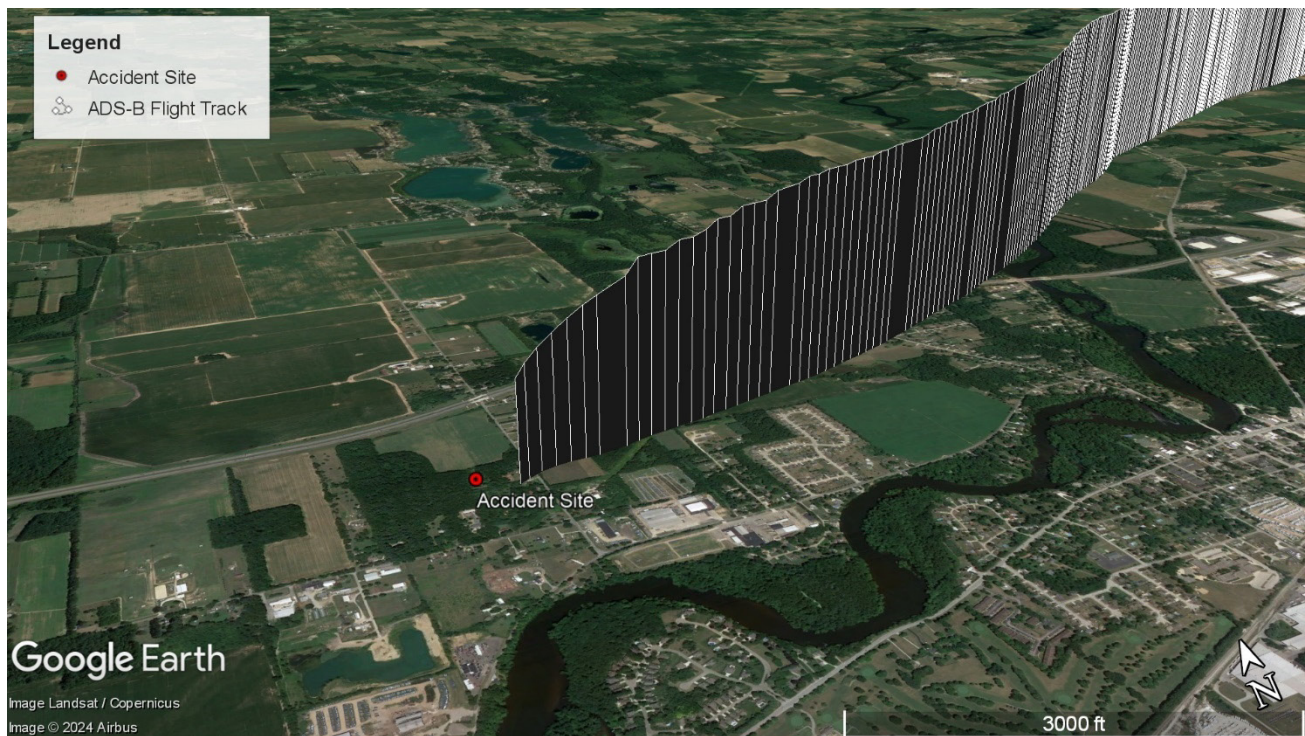
ADS-B data showed that the airplane originally departed EKM at 1152 and landed at OEB at 1225. The return flight departed OEB at 1339 and proceeded southwest bound with a cruise altitude between 4,200 ft mean sea level (MSL) and 4,500 ft MSL. About 1415, the airplane started descent and continued toward EKM. At 14:17:57 the airplane started a steep descent, and which turned into a steep descent with a slight left turn. The final data point was recorded at 14:18:05 at an altitude of 1,635 ft MSL (870 ft AGL).

Figure 1. ADS-B flight track on Google Earth.

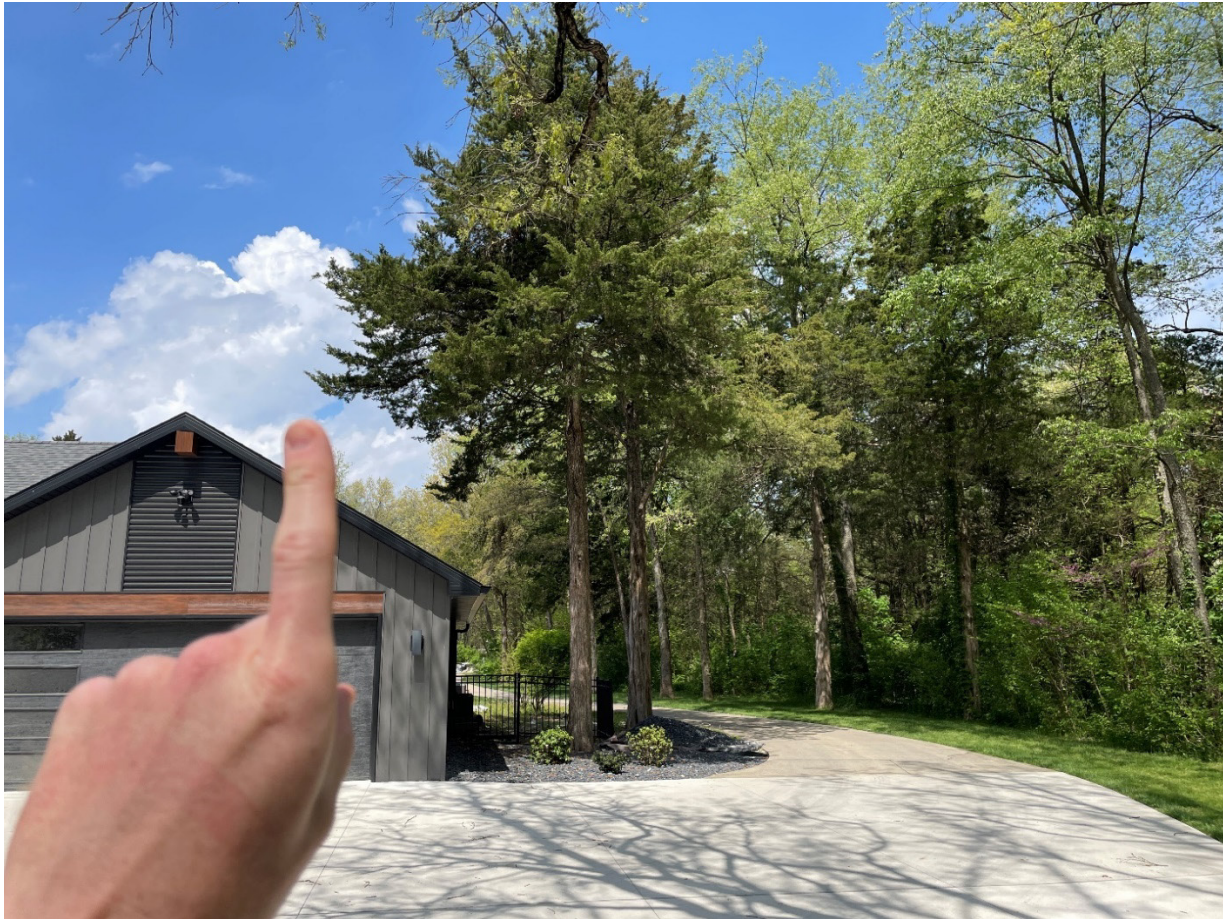
She was standing in her driveway and facing SE when she heard the airplane up and behind her. She turned around and saw the airplane descending straight down toward the ground. She believes she saw the top of the airplane because she didn't notice any wheels. She did not see any smoke or fire. The engine was very loud and continued to operate very loud until the impact. The impact was a loud explosion, but she didn't see it hit the ground because of the trees. The photo below shows where she saw the airplane in a vertical descent.

Figure 12. Witness 3 location where she observed the airplane descending vertically toward the ground and then went behind trees on the right.

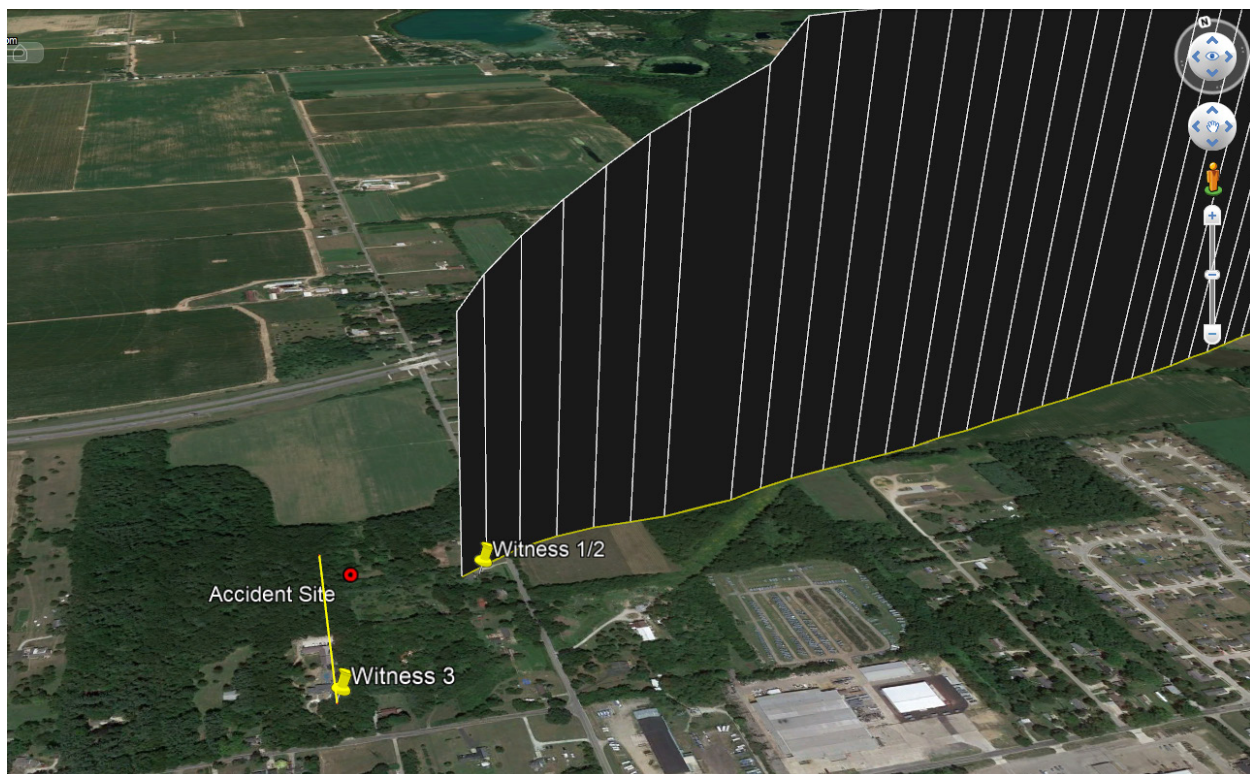
Figure 13. ADS-B flight track on Google Earth, witness locations, and accident site. The yellow line represents the direction that witness 3 was looking when she saw the airplane.
