# National Transportation Safety Board

CEN24FA228

## **ENGINE TEARDOWN**

Location: Steamboat Springs, CO  
Date: June 17, 2024  
Time: 1623 Local  
2223 UTC  
Airplane: Cessna 421, N245T

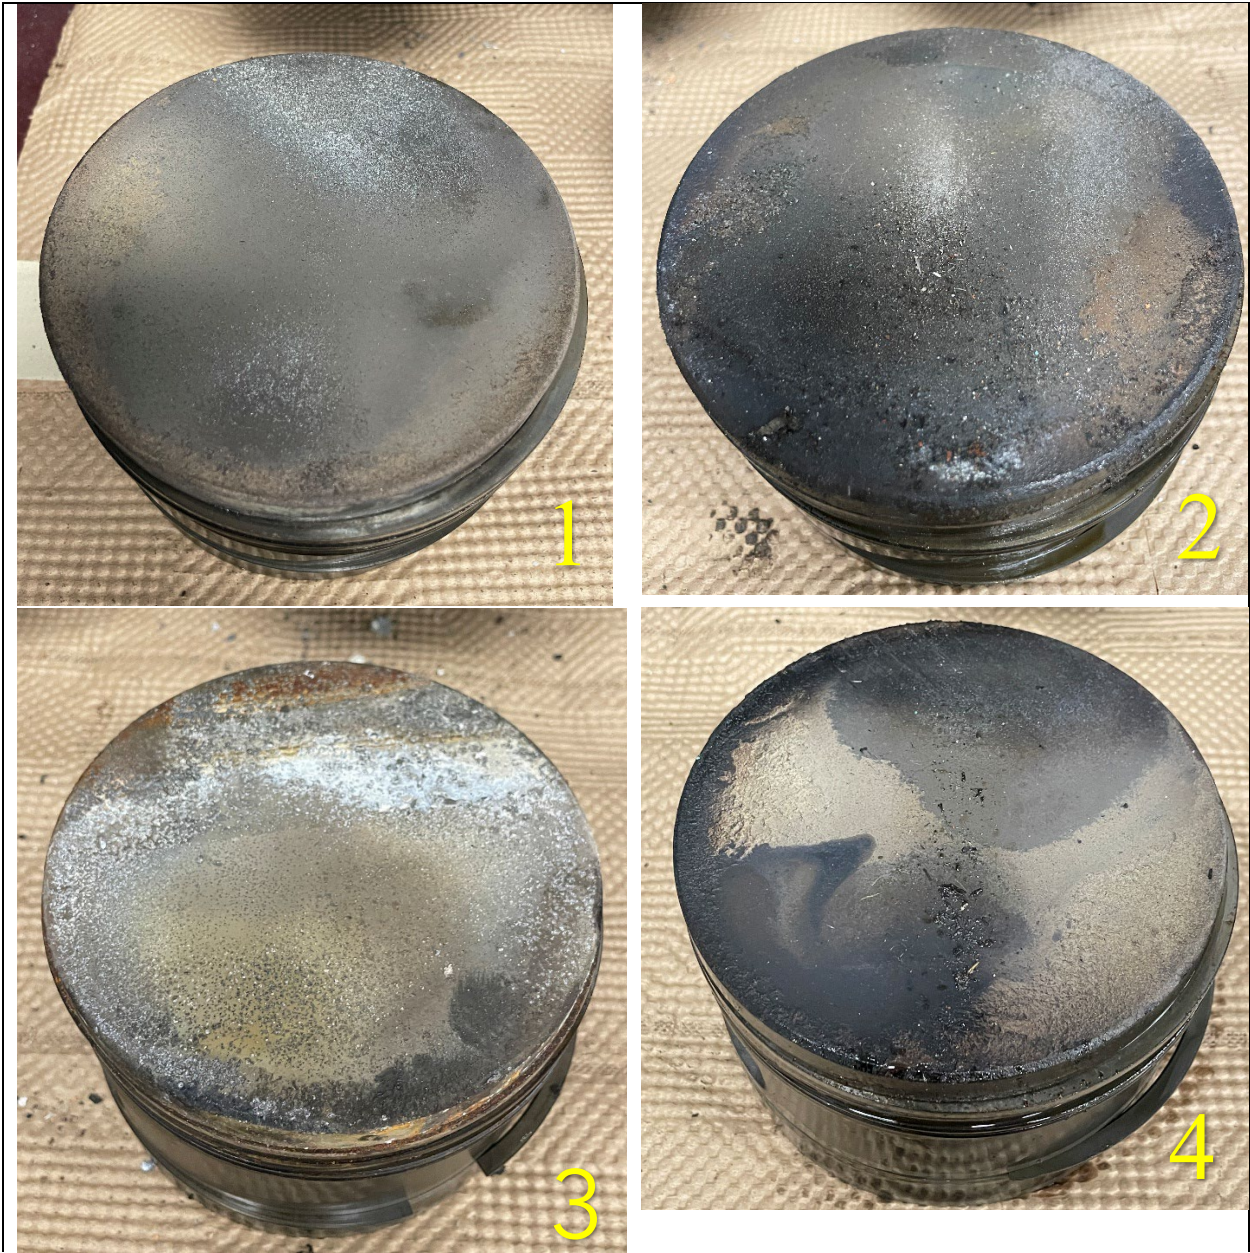
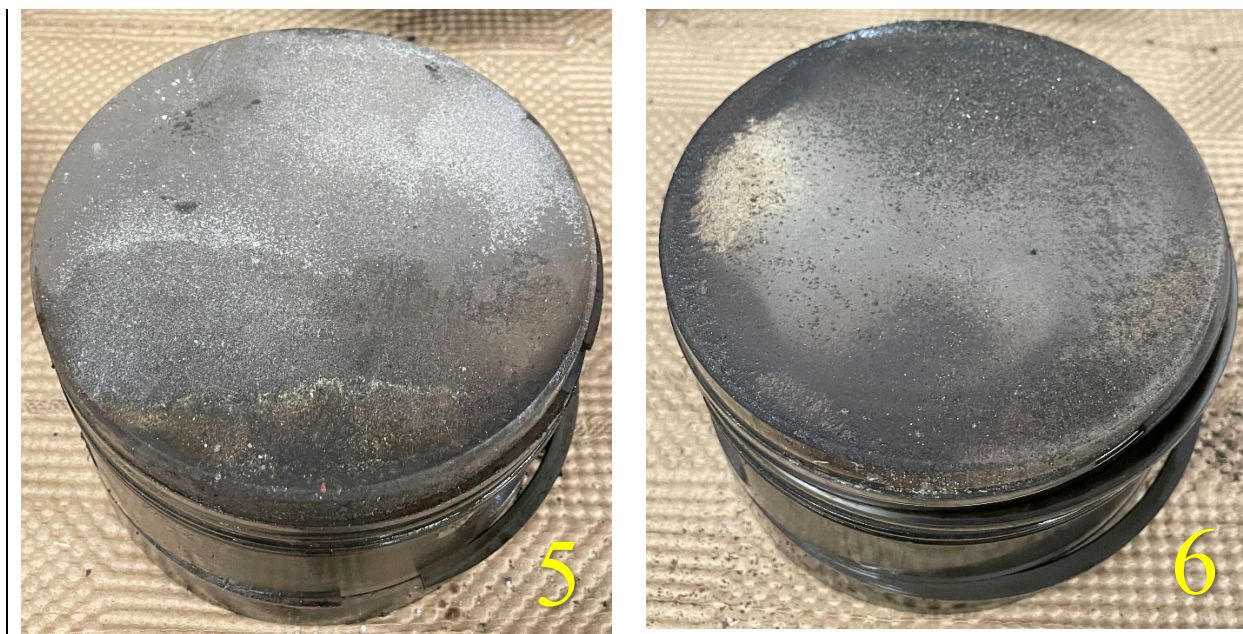
**Figure 11 Right Engine Piston Heads**

The rocker boxes were removed, and no anomalies were detected. The rocker arms were removed and photo documented with defects noted.
