# National Transportation Safety Board

CEN24FA248

## EXAMINATION SUMMARY

Location: Andale, Kansas  
Date: July 5, 2024  
Time: 0801 CDT  
1301 UTC  
Helicopter: Faber Vincent L, Scorpion 133, S/N: F883417

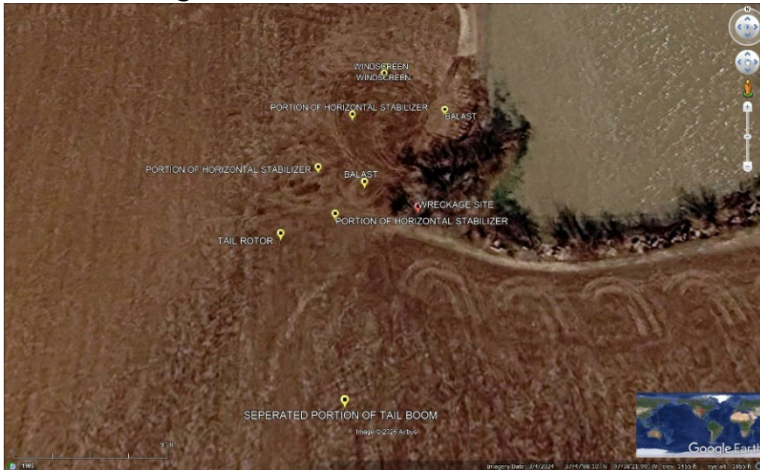
The helicopter impacted a ravine adjacent to a cultivated field on a northeasterly heading and came to rest inverted on northerly heading. The postimpact fire damaged several trees near the main wreckage. The accident site was

about 1.6 miles northeast of the owner's address and point of departure. The tail rotor and tubular structure of the tailboom were located about 150 yards southwest of the main wreckage. The debris path was on a northeasterly heading and about 300 ft in length.

Google Earth image of accident site.
