# National Transportation Safety Board

CEN24LA085

## **AIRPLANE PERFORMANCE STUDY**

Location: San Marcos, Texas  
Date: January 2, 2024  
Time: 1710 CST  
2310 GMT  
Airplane: LearJet 35A, N46MF

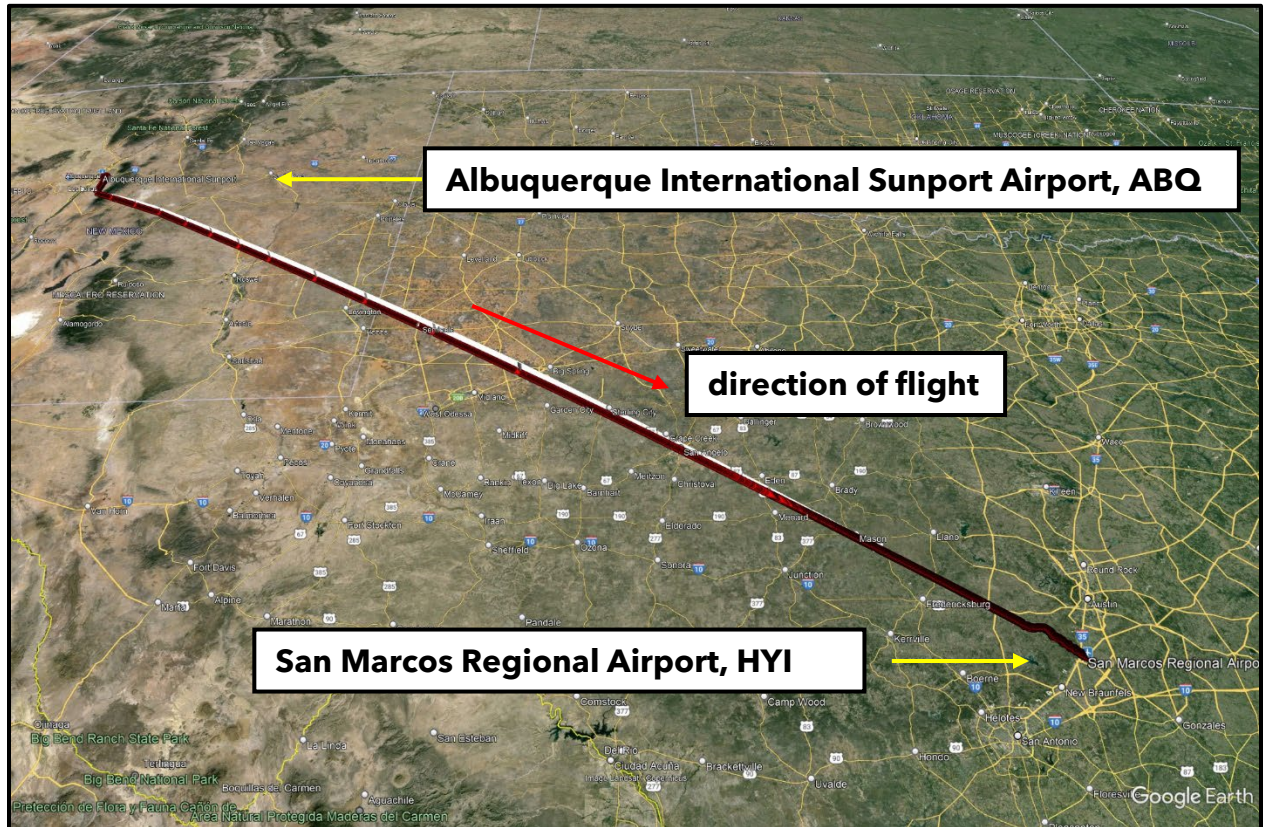
The airplane departed Albuquerque International Sunport Airport (ABQ), Albuquerque, New Mexico, about 1448 mountain standard time and flew to San Marcos Regional Airport (HYI), Austin, Texas. See Figure 1. The crew flew the instrument landing system ILS 13 approach to the ungrooved asphalt runway 13 which is 5,601 ft long.

**Figure 1: The One Hour, Twenty-Two Minute Flight departed Albuquerque International Sunport Airport at 1548 CST**

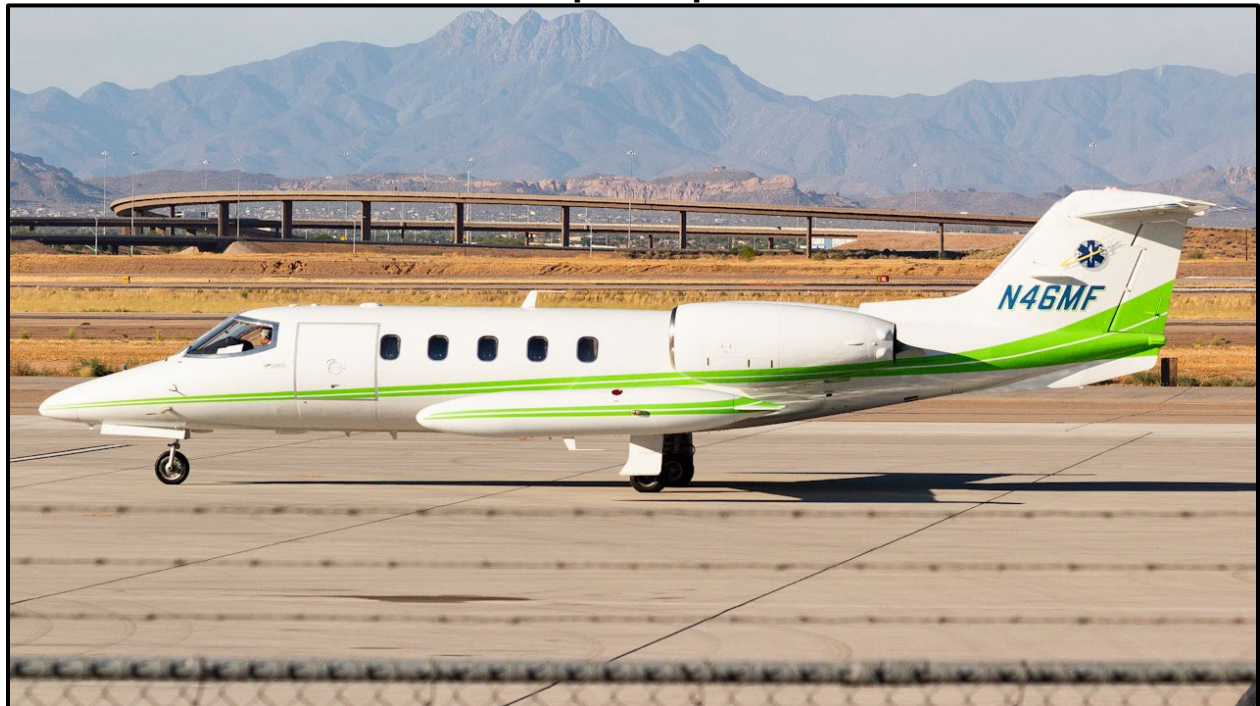
A picture of the accident airplane, a LearJet 35A, is shown in Figure 2. It was manufactured in 1981 and is registered to Med Flight Air Ambulance, Inc. The airplane is equipped with two Honeywell (previously Garrett) TFE731 turbofan engines.

**Figure 2: Accident Airplane, N46MF, a 1981 LearJet 35A**

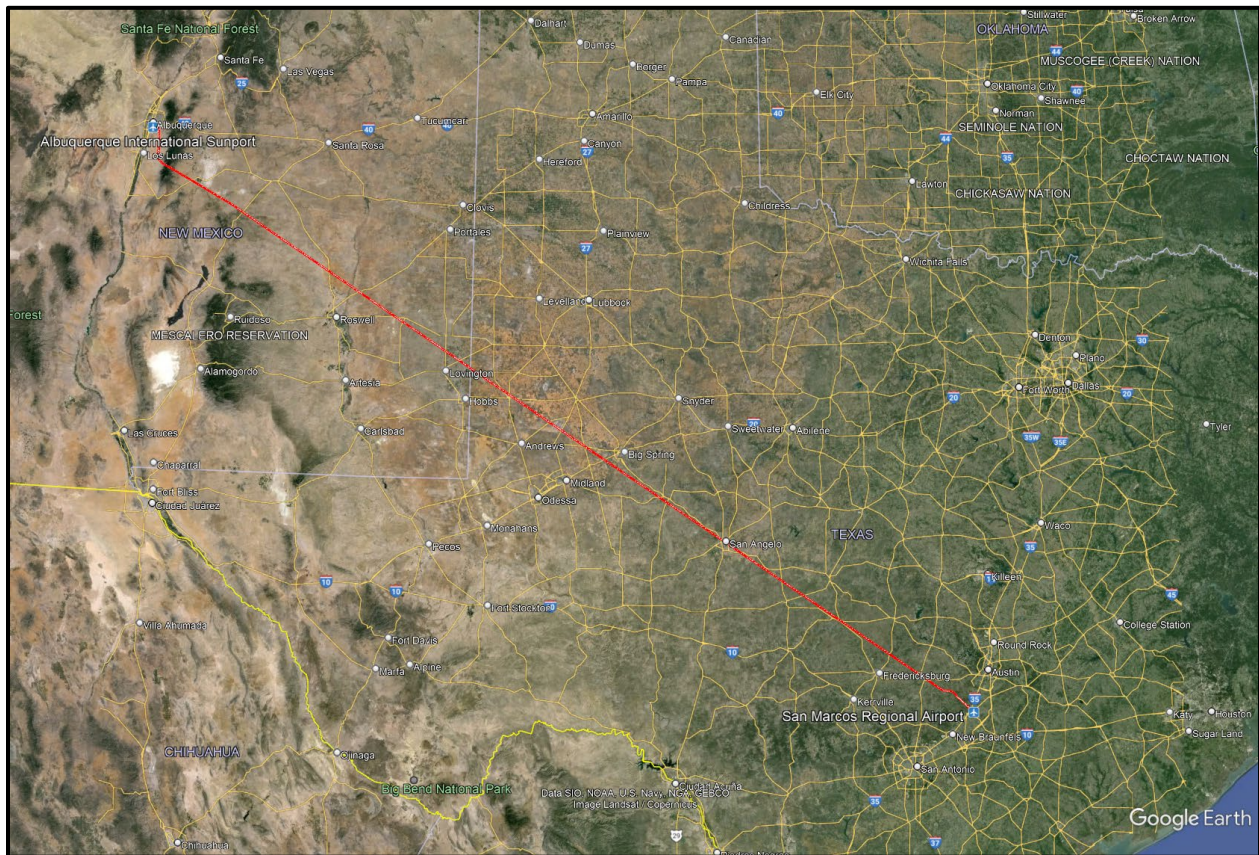
Figure 4 shows an over-head view of the recorded ADS-B ground track from Albuquerque to the wreckage location off the end of runway 13. Figure 5 is the same ground track but focuses on the last 3 NM of the approach and landing and includes altitude and estimated calibrated airspeed (KCAS). N46MF crossed the runway 13 threshold at approximately 144 KCAS and 300 ft agl. The optimal threshold crossing height (TCH) is between 40 and 60 feet<sup>3</sup>.

**Figure 4: Recorded ADS-B Ground Track for 550 NM Accident Flight**
