# National Transportation Safety Board

CEN24LA140

## **ENGINE DATA MONITOR**

Location: San Saba, Texas  
Date: March 25, 2024  
Time: About 1142 CDT  
Airplane: Cessna T210M, N498TB

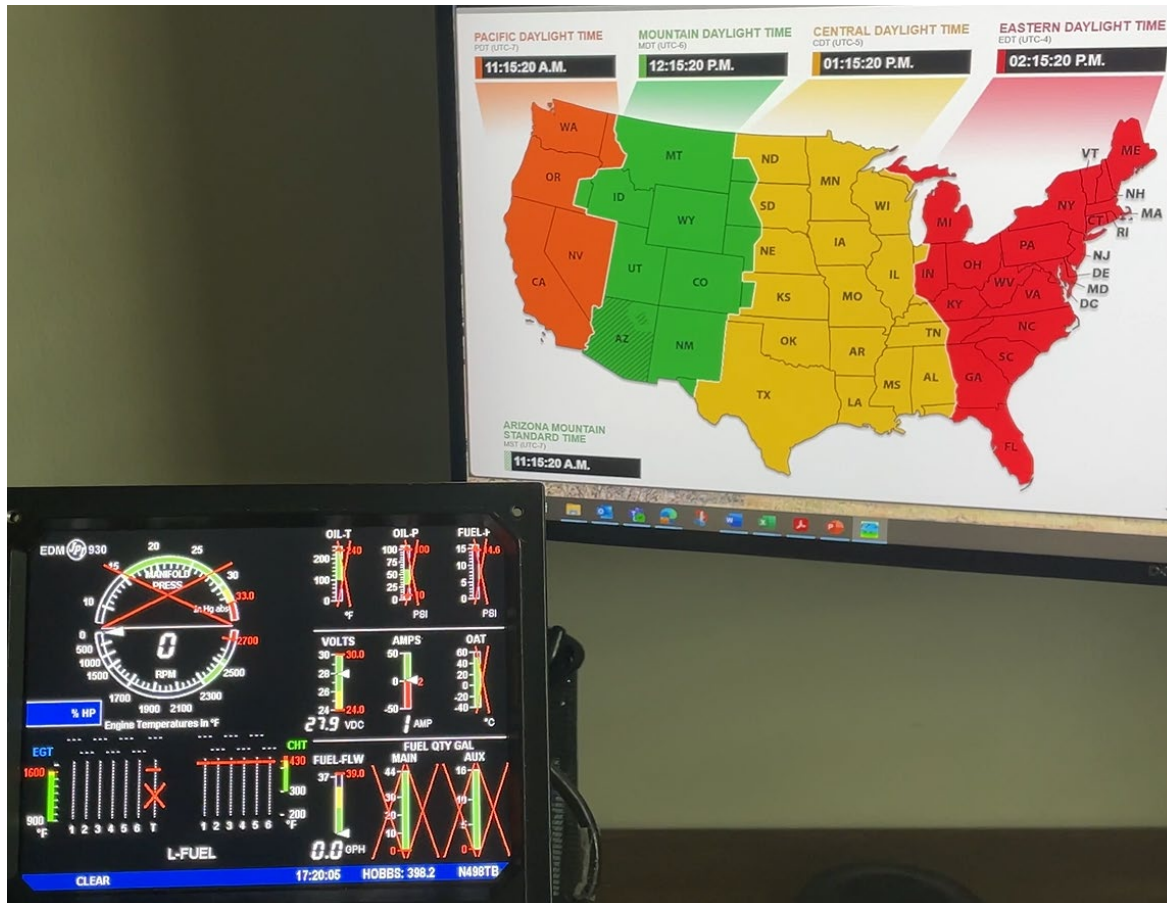
The EDM 930 data was recorded in universal coordinated time (UTC) and was slightly offset from the actual time when compared to the official U.S. time according to [www.time.gov](http://www.time.gov). The difference between Central Daylight Time and UTC is 5 hours. The accident flight time in this report has been offset from the recorded time by subtracting 4 hours, 14 minutes and 45 seconds.

**Figure 3.** Recorder screen powered on for actual time correlation.
