# National Transportation Safety Board

CEN24LA145

## **EXHAUST & CABIN HEAT SYSTEM EXAMINATION SUMMARY**

Location: Alpine, Arkansas  
Date: April 2, 2024  
Time: 1056 CDT  
1556 UTC  
Airplane: N86UM, Mooney M20E, S/N 1137

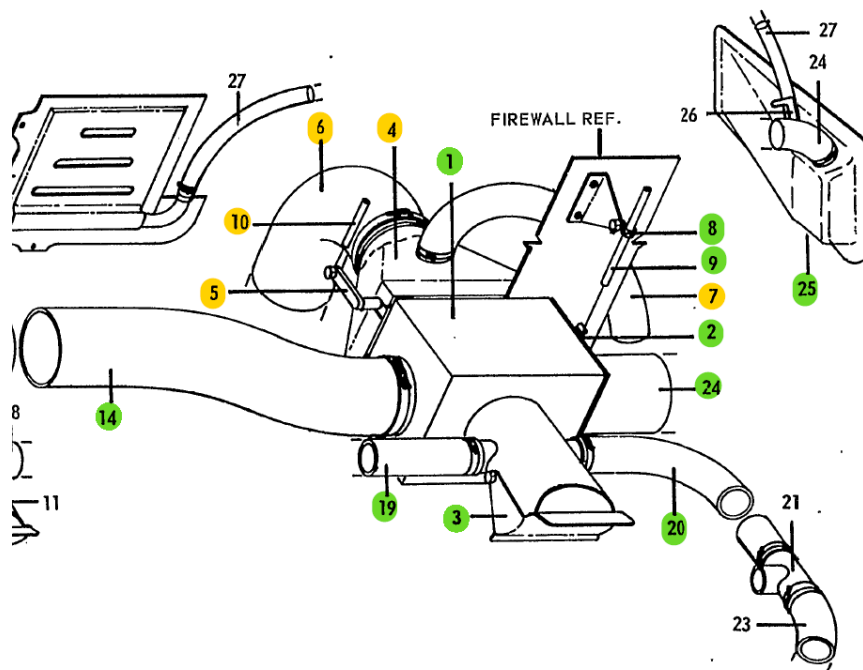
Figure 6. Part Catalog Figure 56 Exploded Diagram.

Visual inspection showed minor crush damage to the junction box (Index #7) and a fracture of the cabin heat valve control arm (Index #10). The inlet scat tube was properly attached to the cover assembly and the cover assembly was attached to the firewall base plate. One screw was observed to be missing from the cover to base plate connection. The junction box outlet ducts (Index #19 & 20) were found disconnected with unapproved parts covering both outlets. Additional unapproved parts were found covering various scat tubing inlets within the glareshield assembly.
