CEN24LA146

Group Chair's Factual Report - Attachment #2  
Pratt & Whitney Canada Materials Investigation Report  
October 20, 2025

**Extract from Report No.: 24-060**

**Vincent Flying Service Inc.  
Schweizer Grumman Ag-Cat Model 164B, N75099  
Kaplan, Louisiana  
April 2, 2024  
PT6A-15AG, 14007**

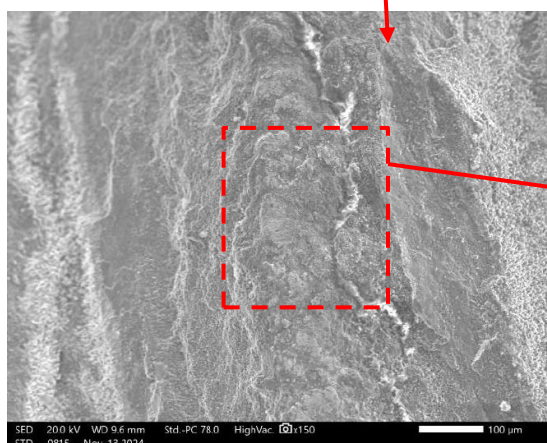
Photo No. 11

- 4.7 Magnified view of the damaged area indicated by the red bracket in Photo No. 90 showed area of wear damage (green arrows, Photo No. 9 & Photo No. 10), stripped thread (double ended arrow, Photo No. 10) and presence of corrosion product (blue arrows, Photo No. 9 & Photo No. 10. The remaining thread of the bolt #2 did not show any evidence of damage indicative that the thread has been stripped. SEM images showed the surface of the bolt #2 and a suspected striped thread (Photo No. 94 & Photo No. 12). SEM-EDS analyses using semi-quantitative and standardless method were performed (Table No. 1). The contents of the primary elements detected (Fe, Mo, Cr, Mn) on the surface do not match the base material composition. High oxygen content was noted on the surface and near the thread indicating presence of corrosion.

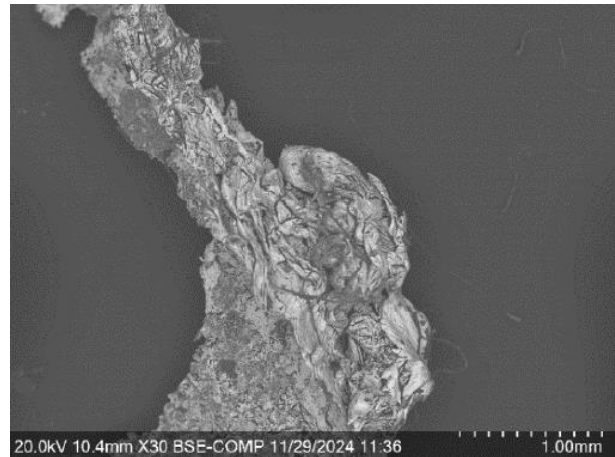
Photo No. 42

- 5.1 The two particles mechanically detached from the CT vane (Photo No. 39) were sent to the chemical laboratory (Photo No. 40). SEM-EDX analyses were performed on both particles and were identified as nickel alloy in presence of aluminum, titanium, chromium, cobalt, niobium and molybdenum (Photo No. 41 & Photo No. 40 and Tables No. 8 & 9). The alloy is undefined to a specific material. The high level of aluminum concentration could suggest the presence of a coating.
