# National Transportation Safety Board

CEN24LA146

## **POWERPLANTS**

Group Chairman's Factual Report

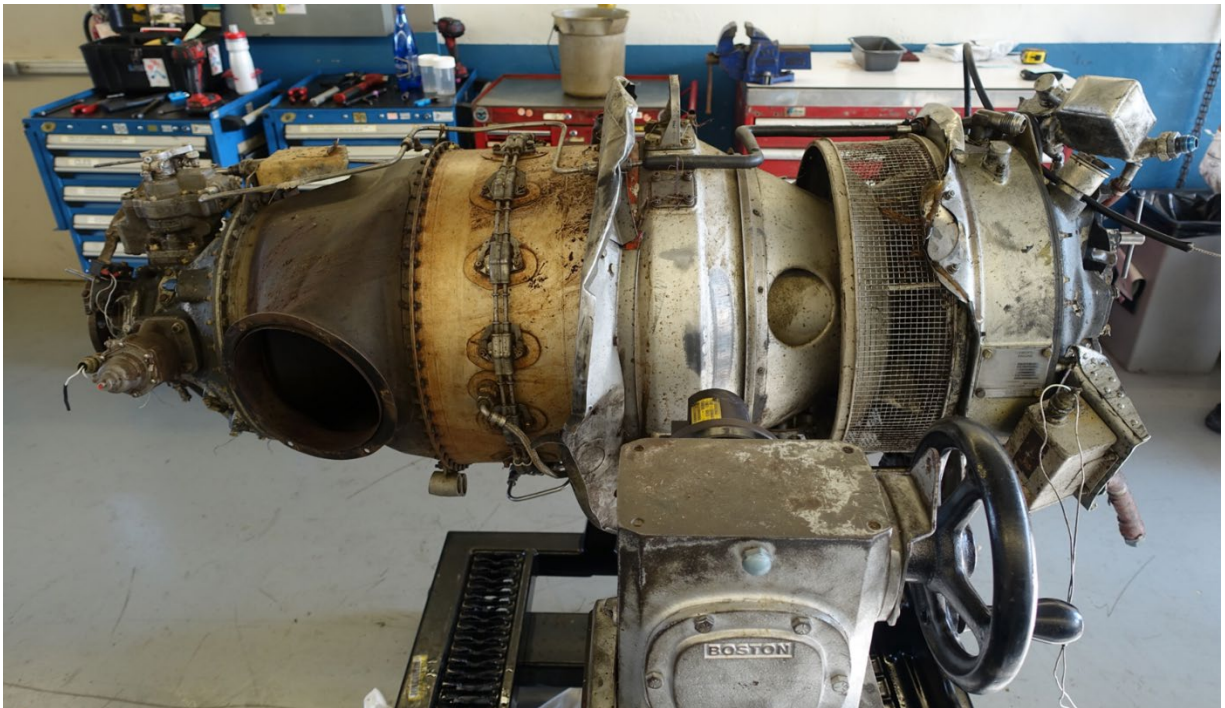
**Photo 4- Left Side of Engine, as Received**

The engine was secured in a wood shipping crate in the P&WC Plant 5, Service Investigation Quarantine Area when the NTSB arrived (**Photo 3**). The engine was shipped with the 3 o'clock position facing down and was held in place with banding to prevent movement. Multiple airframe components were shipped with the engine including a section of the engine mounting structure, fuel hoses, and sections of engine harness. When the engine was lifted by overhead hoist, clear fluid drained from the engine that looked and smelled consistent with water. The airframe components were removed to facilitate installation in the engine work stand (**Photos 4, 5, and 6**).

All engine surfaces were covered with dirt and pond debris. There was no evidence of undercowl fire or radial uncontainment through the engine cases. The fuel pump and FCU exhibited impact damage and were separated from the accessory gearbox (AGB) mount pad and the flange connecting the two components was fractured. The start controller had impact deformation and was partially separated from the engine. The oil cooler and ignition exciter box had crushing damage and were displaced. The starter generator, No. 3 and 4 bearing scavenge pump, and RGB oil scavenge pump were not shipped with the engine, but their respective AGB mount pads were damaged consistent with separation during the impact sequence (**Photo 7**). The exhaust case had impact damage 360 degrees around the engine and clear liquid was pooled at the 6 o'clock position. The power turbine blades visible through the exhaust were all full length and in good condition. The propeller governor remained attached to the engine, but the speed lever assembly was impact damaged and the lever was rotated past the maximum stop (**Photo 8**). The beta valve plunger was manually opened and closed, and it moved smoothly across the stroke travel length. Beta components including the beta arm, retaining pin, and carbon block were deformed and/or out of normal position. The Ng and Nf spools were both seized and could not be rotated. The P3 and Py<sup>2</sup> line b-nuts connections were lockwired and torqued.

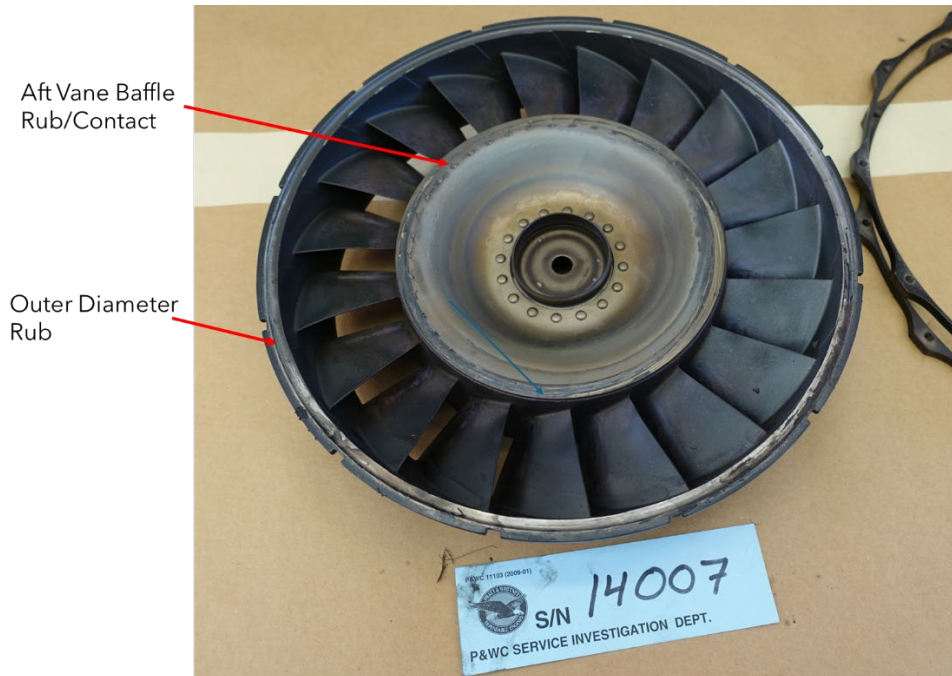
**Photo 13- PT Vanes, Aft/Suction Side**

The PT blades were all complete with no leading or trailing edge impact damage (**Photo 12**). A 180 degree section of the blades were discolored with a debris that could be easily wiped off by hand, consistent with water submersion. The PT blade fir trees on the leading edge side of the disk had 360 degree rub damage with coincident circumferential rub on the aft/trailing edge side of the PT vane baffle. The PT vane baffle circumferential rub was deepest from the 10 to 6 o'clock positions and static impact marks were also present from the 4 to 10 o'clock positions (**Photo 13**). The PT blade outer platform had 360 degree rub damage with coincident rub on the PT blade shroud and aft surface of the PT outer diameter vane ring (**Photo 14**). The PT shaft was in good condition and unremarkable. The No. 3 roller bearing and No. 4 thrust (ball) bearing elements were intact and rotated smoothly (**Photo 15**).

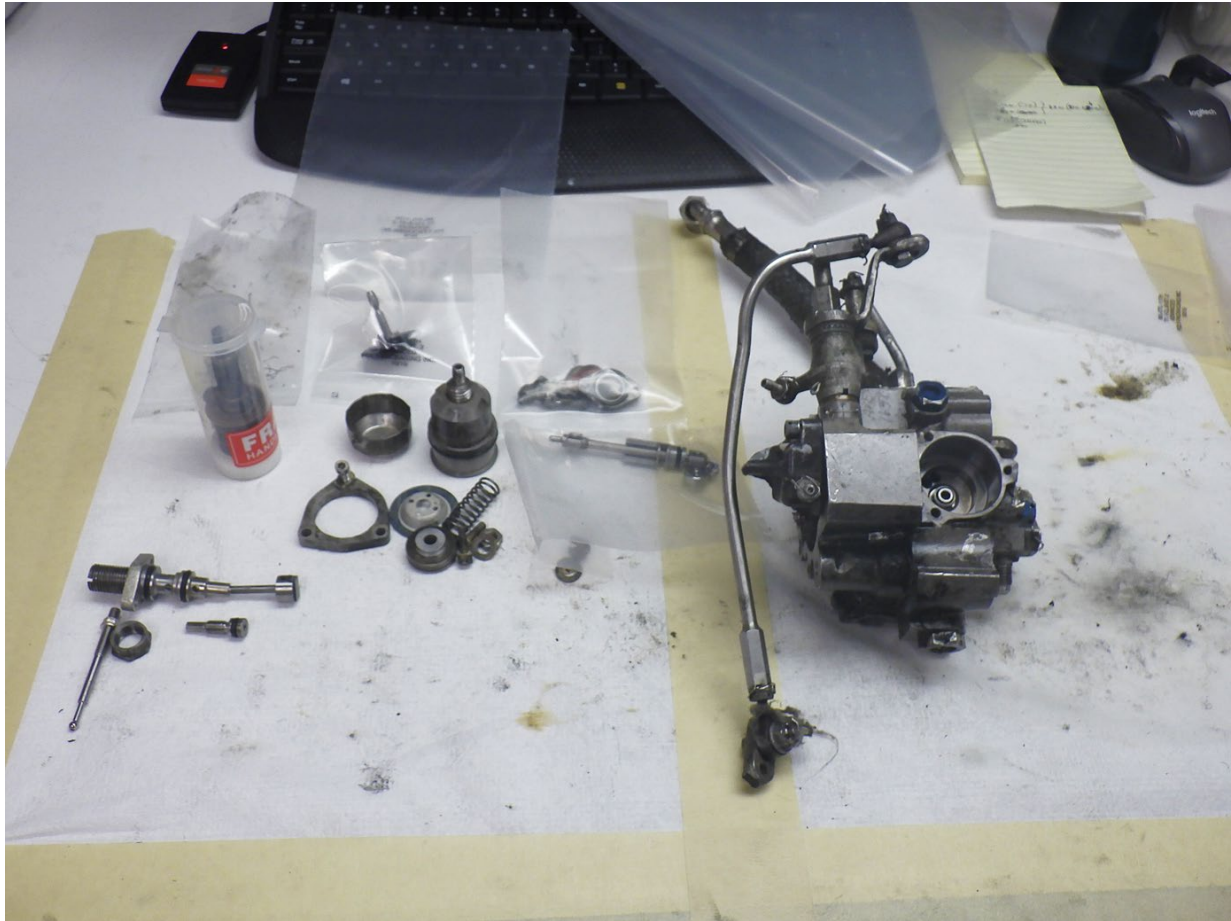
**Photo 33- FCU, Partially Disassembled**

missing. The FCU air inlet adapter Px and Py fittings both had dark debris accumulation, with more significant buildup on the Px fitting. The air inlet adapter Px and Py orifices both had dark discoloration but neither the Px and Py orifices were obstructed (**Photos 30**). The Px and Py inlet adapter fittings and FCU air inlet adapter were retained for additional lab analysis. The FCU bellows had impact damage at the FCU case nut that deformed the threaded portion of the acceleration bellows. The acceleration bellows were intact, and the bellows measurement was within allowable component manual limits (**Photo 32**). A pressure leak check was performed on the FCU governor bellows that confirmed that there was no air leakage. The FCU metering valve was intact and undamaged. The metering valve slid smoothly in the valve sleeve. The FCU torque arm was intact and passed a pressure leak check. The FCU bypass valve diaphragm was intact and in good condition. The FCU data plate back face was marked "OH 7/08/2021", indicating that the unit was overhauled on July 8, 2021. The partially disassembled FCU is shown below in **Photo 33**.

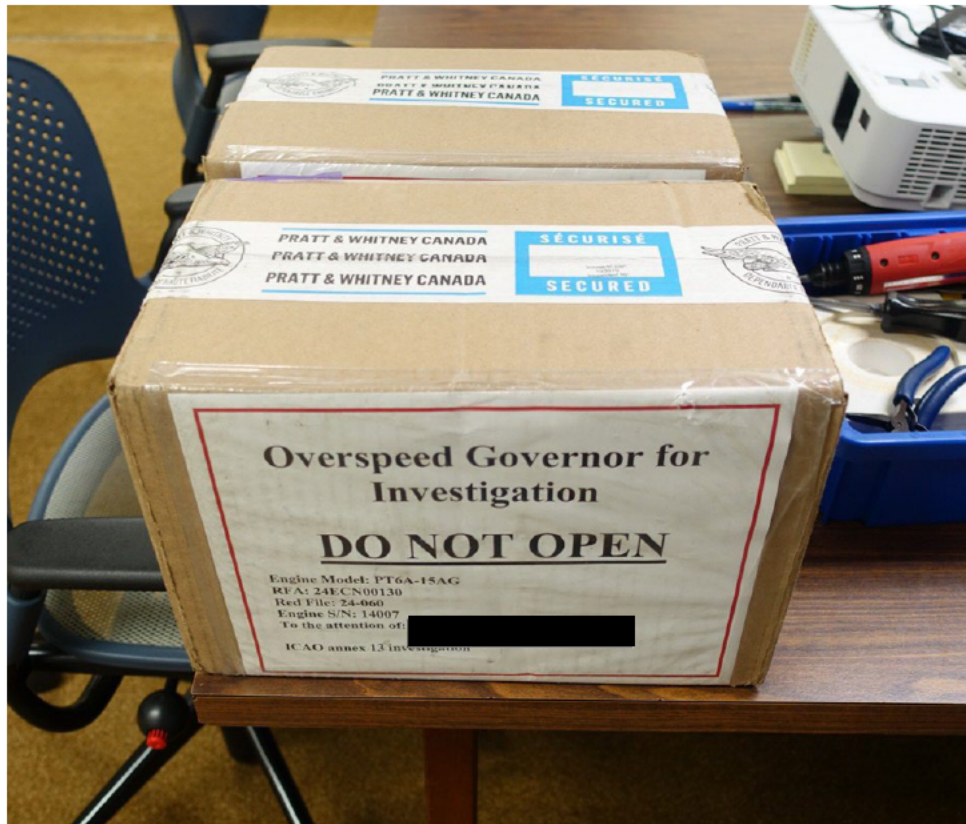
**Photo 34- Shipping Boxes, as Received**

The accident engine propeller governor and overspeed governor were secured in cardboard shipping boxes in a Woodward conference room when the investigation team arrived (**Photo 34**). Both boxes were in good condition and sealed.

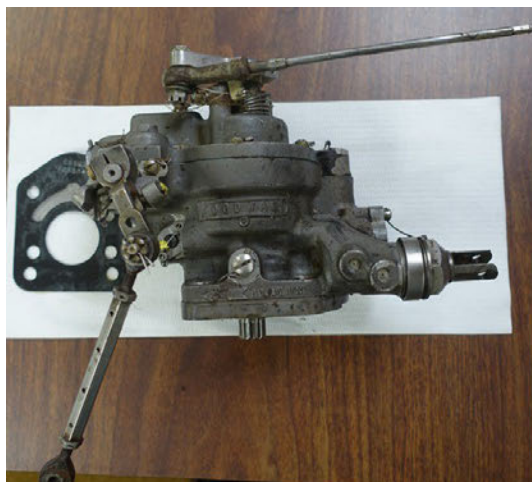
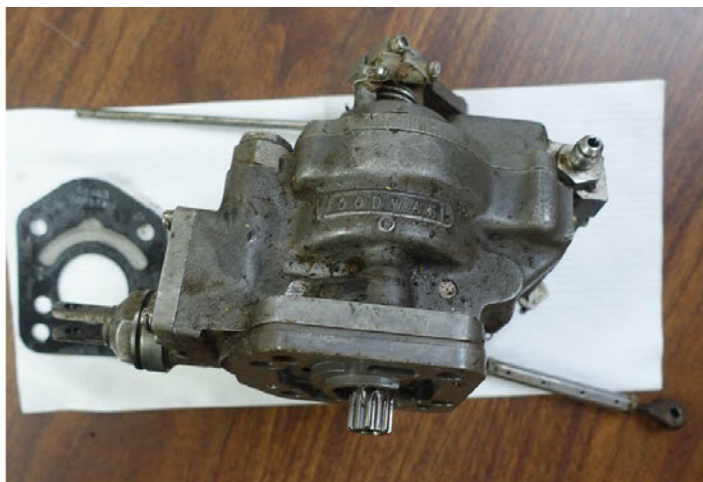
**Photo 35- Propeller Governor, as Received**

The propeller governor, part number (PN) 8210-002-01, serial number (SN) 11902330, was shipped new from Woodward on 11/5/1996 and had not been returned to Woodward for repair or overhaul since delivery (**Photo 35**). The data plate marking indicated the governor was overhauled on February 7, 2023 (**Photo 36**). According to the engine logbook, it was installed on the accident engine on May 9, 2023.

The propeller governor was intact with grass and dirt debris on external surfaces. The customer installed hardware and speed setting lever had impact deformation, and the lever stop was displaced beyond the high speed stop. The reset lever rotated along the full length of travel, but the mechanic stated that the rotation felt "a little sticky." The driveshaft rotated normally. The lockwire, seals, and torque sealant were non-Woodward parts. The propeller governor was installed on the test bench in the as-received condition (**Photo 37**). The governor was tested in accordance with test specification procedure (TSP)-810, revision AH. Multiple test points were outside of specification due to the speed setting lever deformation (**Photo 38**). The customer installed hardware attached to the speed lever was removed, which restored normal rotation of the speed setting lever. The bench test procedure was run again, and all test points were consistent with similar service run

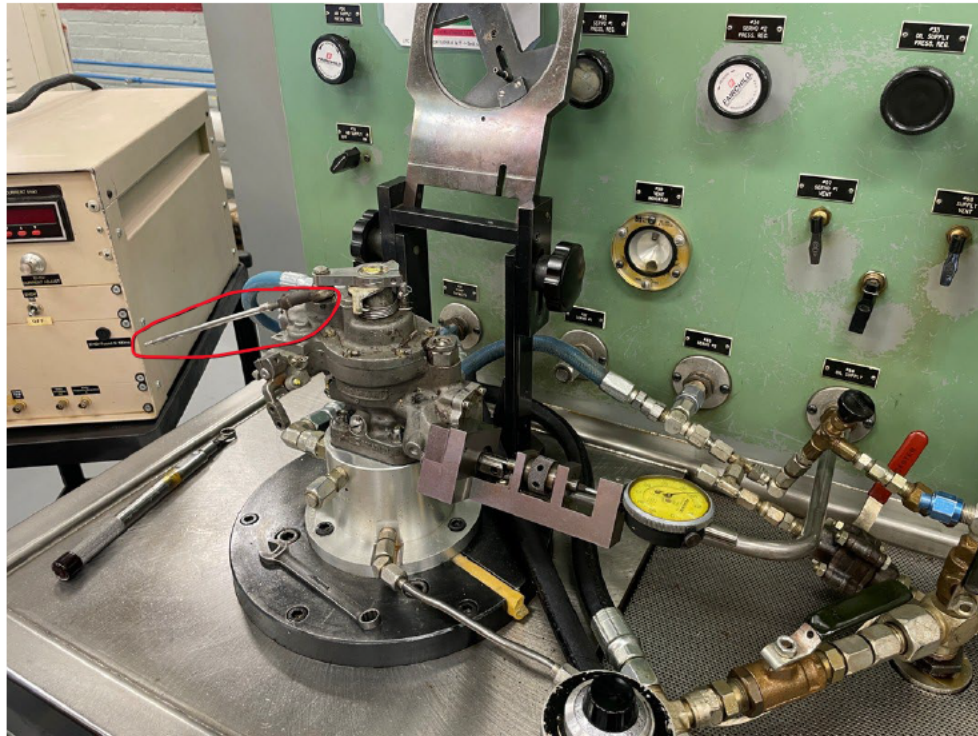
**Photo 37- Propeller Governor on Test Bench**

units according to Woodward. Minor deviations from the specification were typical of customer adjustment. The TSP run sheets are included as Attachment 1.

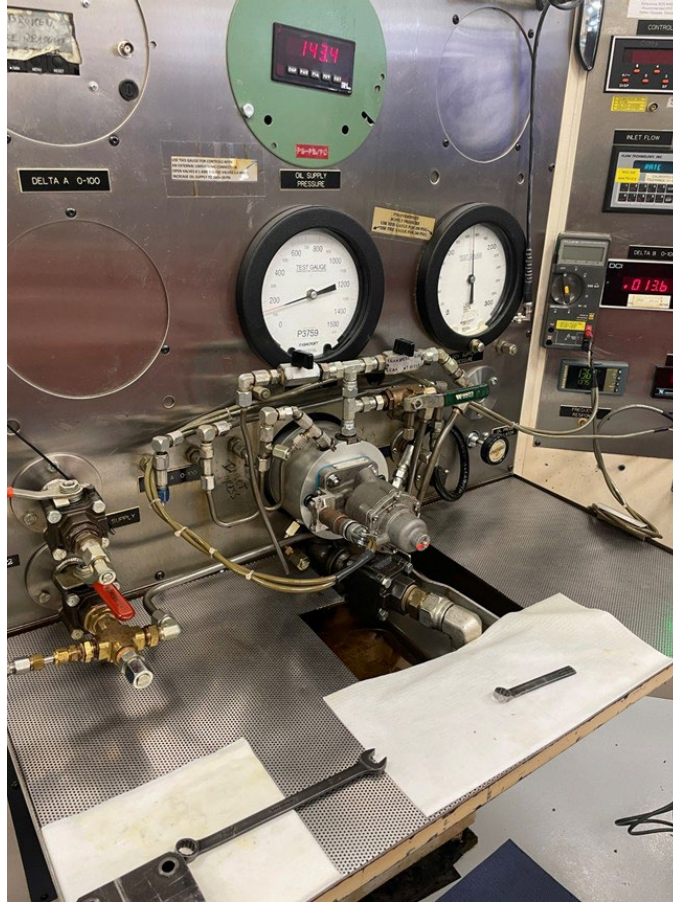
**Photo 40- Overspeed Governor on Test Bench**

The overspeed governor was intact with grass and dirt debris on external surfaces (**Photo 39**). The receptacle was bent but the wiring appeared to remain connected. The mechanic noted non-Woodward lockwire, seals, and torque sealant. The input driveshaft rotated normally. The overspeed governor was installed on the test bench and tested in accordance with TSP-847, revision AC (**Photo 40**). The maximum speed was recorded above specification. According to Woodward, the recorded value was typical of customer field adjustment. All other test points were within TSP specification.
