# National Transportation Safety Board

CEN24LA193

## **POWERPLANTS**

Group Chair's Factual Report

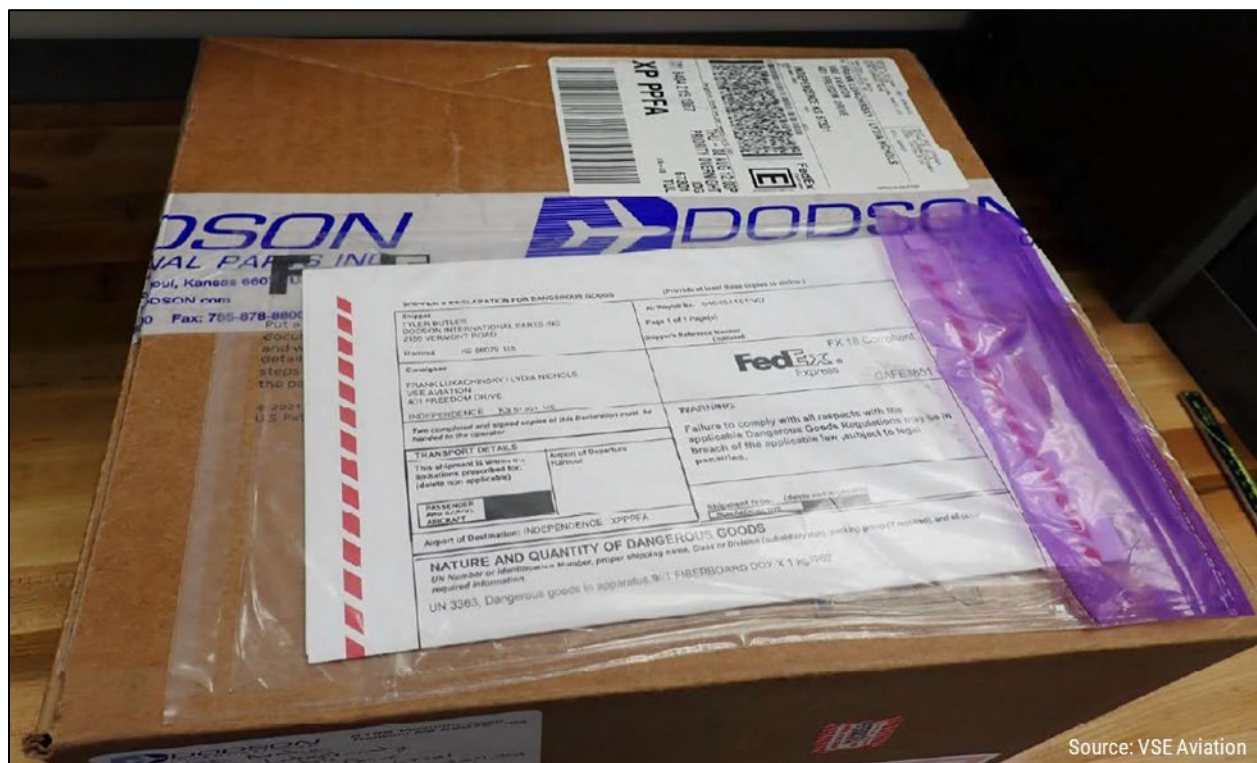
**Figure 33:** FCU shipment as-received by VSE Aviation

The accident engine's FCU and flexible P3 air supply line were sent in a cardboard box from the Dodson International Parts facility in Rantoul, Kansas to the VSE Aviation facility in Independence, Kansas for examination and testing on September 10, 2024. Participants from FAA attended this examination (Figure 33).

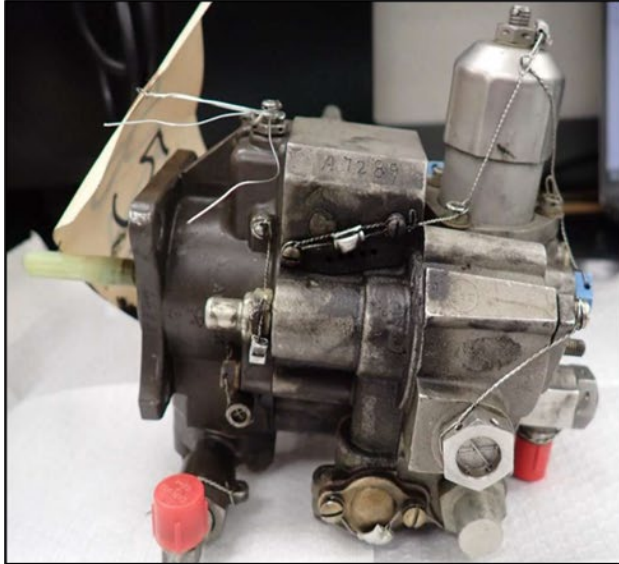
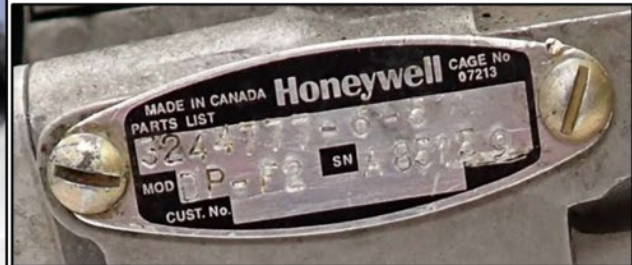
**Figure 34:** Unboxed FCU (left) and data plate (right)

According to the data plate, the FCU was a Honeywell model DP-F2, PWC p/n 3244777-6-5, s/n A85159 (Figure 34). See Attachment 1 and Attachment 2 for examination results.
