## Investigation Report

VSE MFG010

| Unit Type | Fuel Control Unit |

| Location: | Covert, KS | Accident Number: | CEN24LA193 |

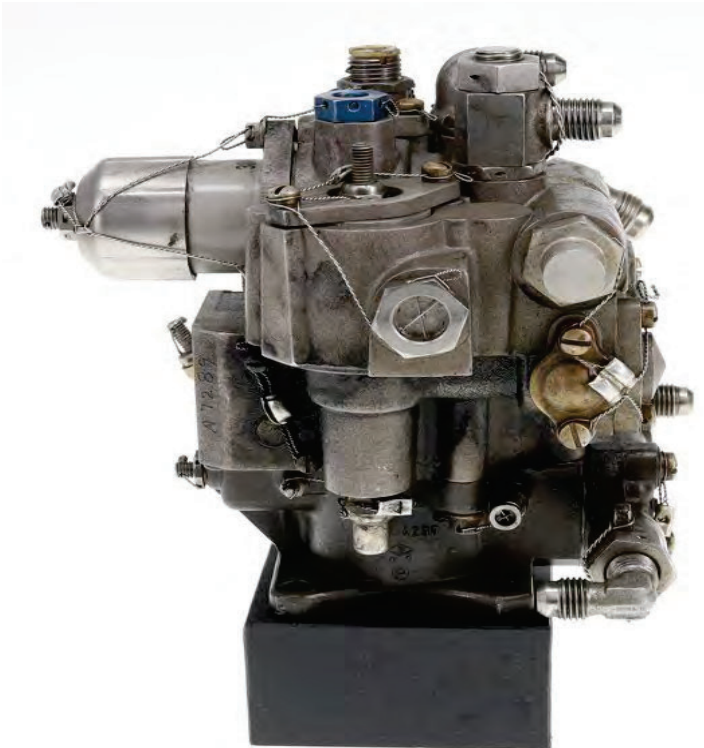
Photo 7A

- F. Visually inspected fuel and air fittings, found to be clear, no debris.
  - G. Photographed Safety wire and Seal Arrangement. Reference Photos 7A, 7B, 7C, 7D, 7E, 7F, 7G, 7H, 7I, 7J, 7K, 7L, 7M, 7N, 7O, 7P, 7Q, 7R.
