# National Transportation Safety Board

CEN24LA239

## **POWERPLANT**

Group Chair's Factual Report

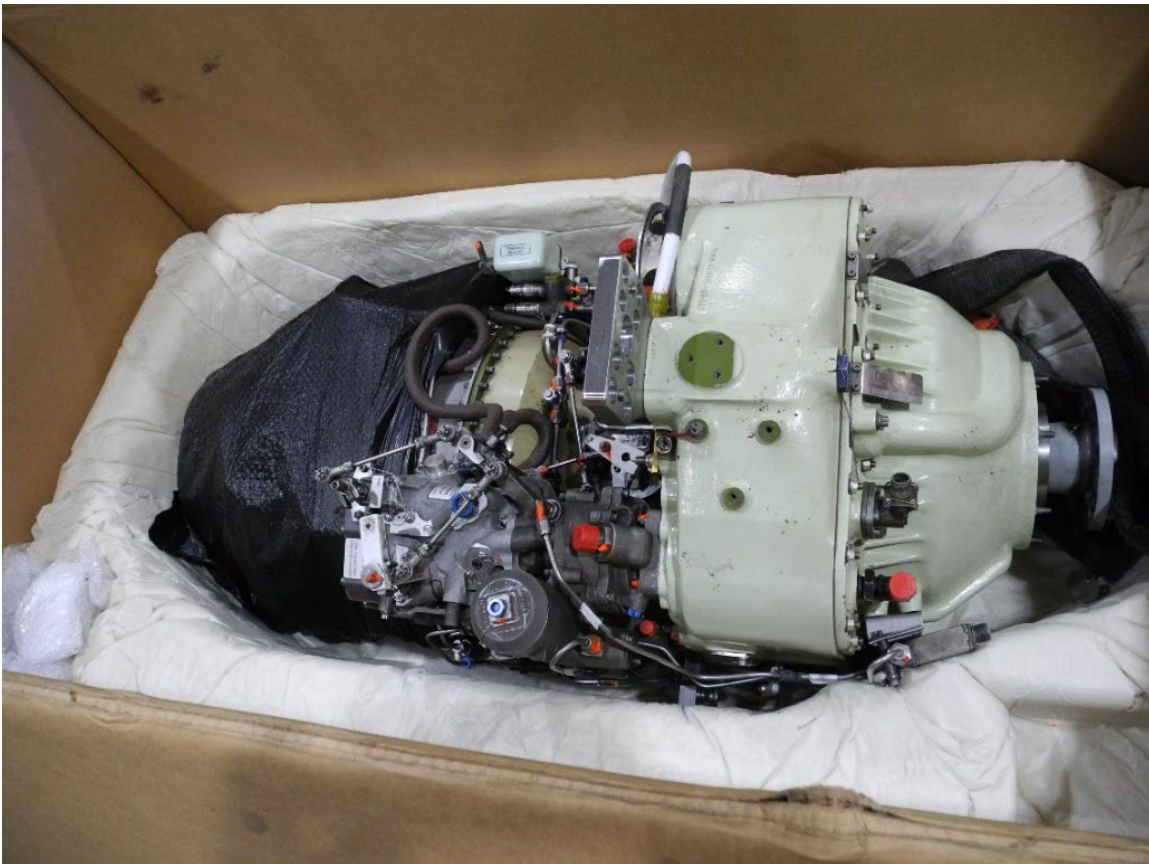
The engine was secured in a Honeywell shipping box (Figure 2) and opened for the examination when the investigation team arrived on October 21, 2024. The engine logbook, various fuel samples from different locations of the airframe, and an oil sample from the oil tank were also found in the shipping container. The starter-generator was not returned with the engine.

**Figure 2.** TPE331-10-511M Engine - As Received

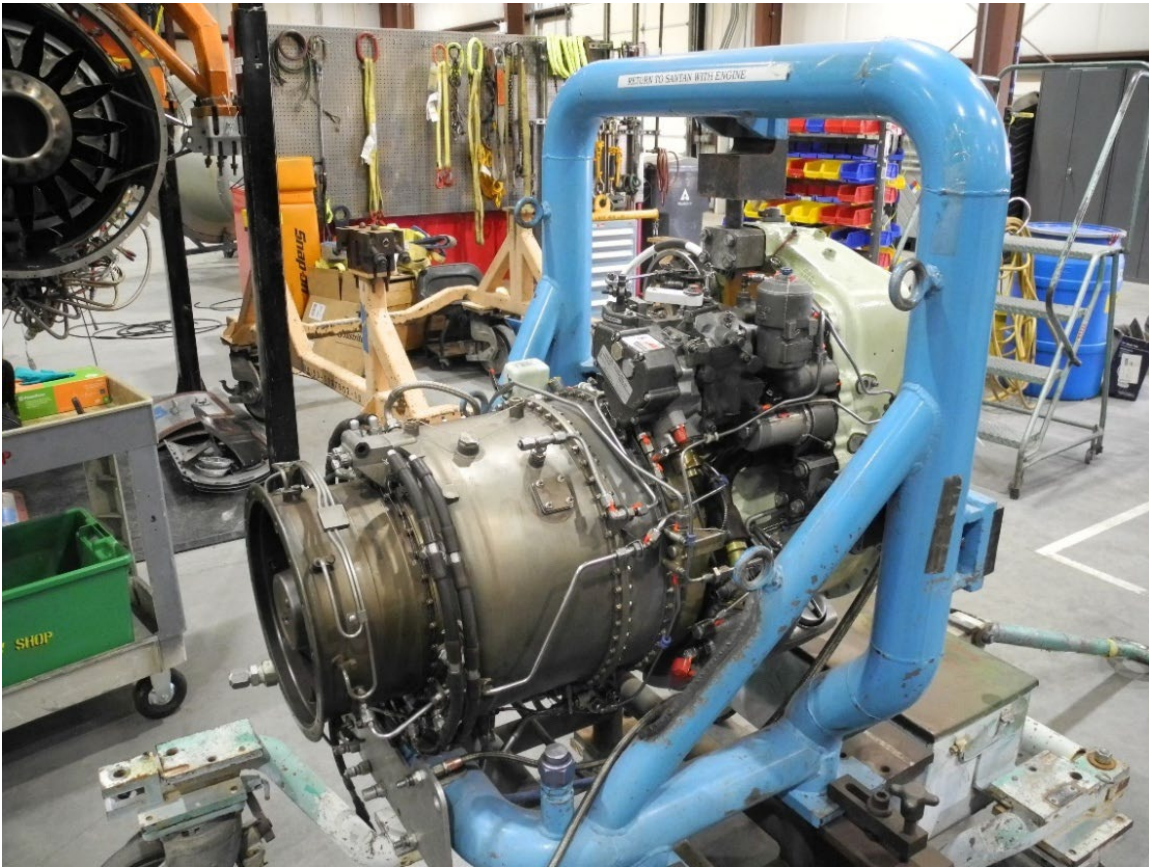
The engine was removed from the shipping box and placed into a propeller stand mount frame (Figure 3) before the visual examination was performed. The engine was generally intact and undamaged.

**Figure 3.** Engine Placed into the Propeller Stand Collar

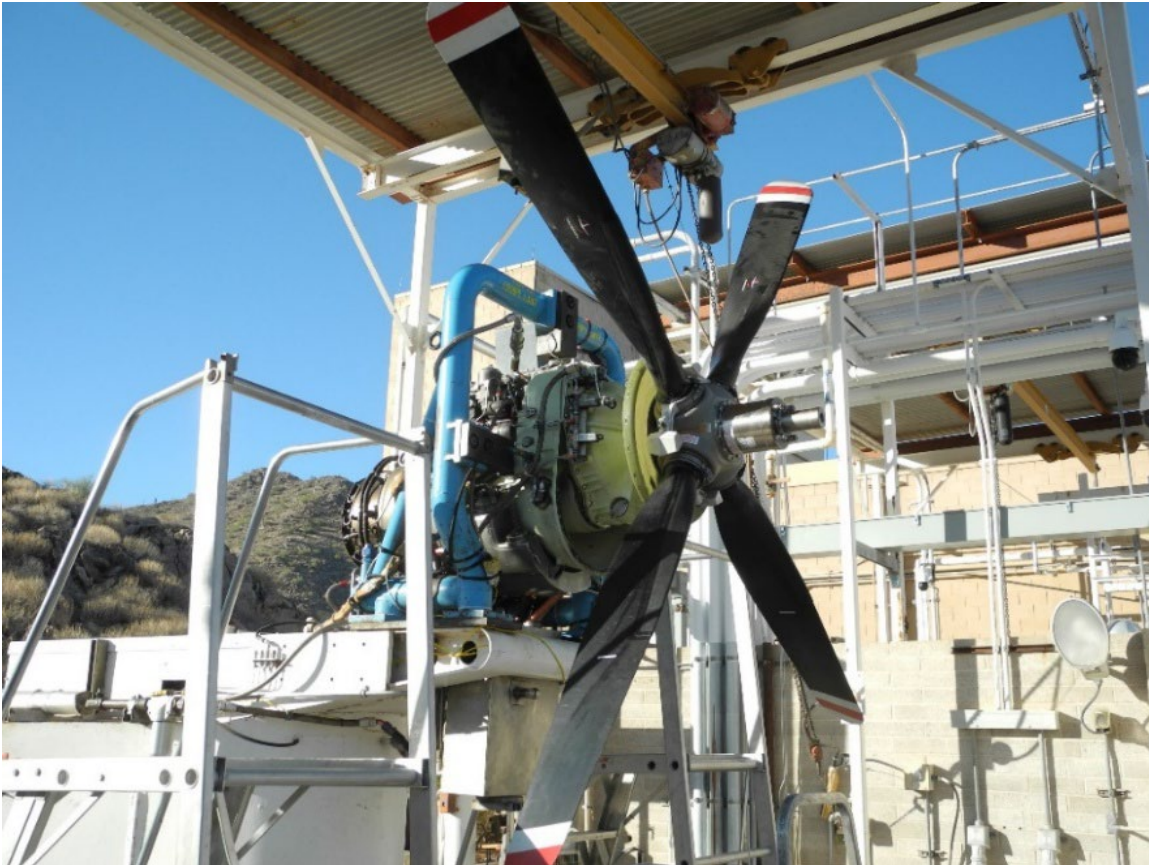
**Figure 10.** TPE331 Event Engine in Propeller Stand

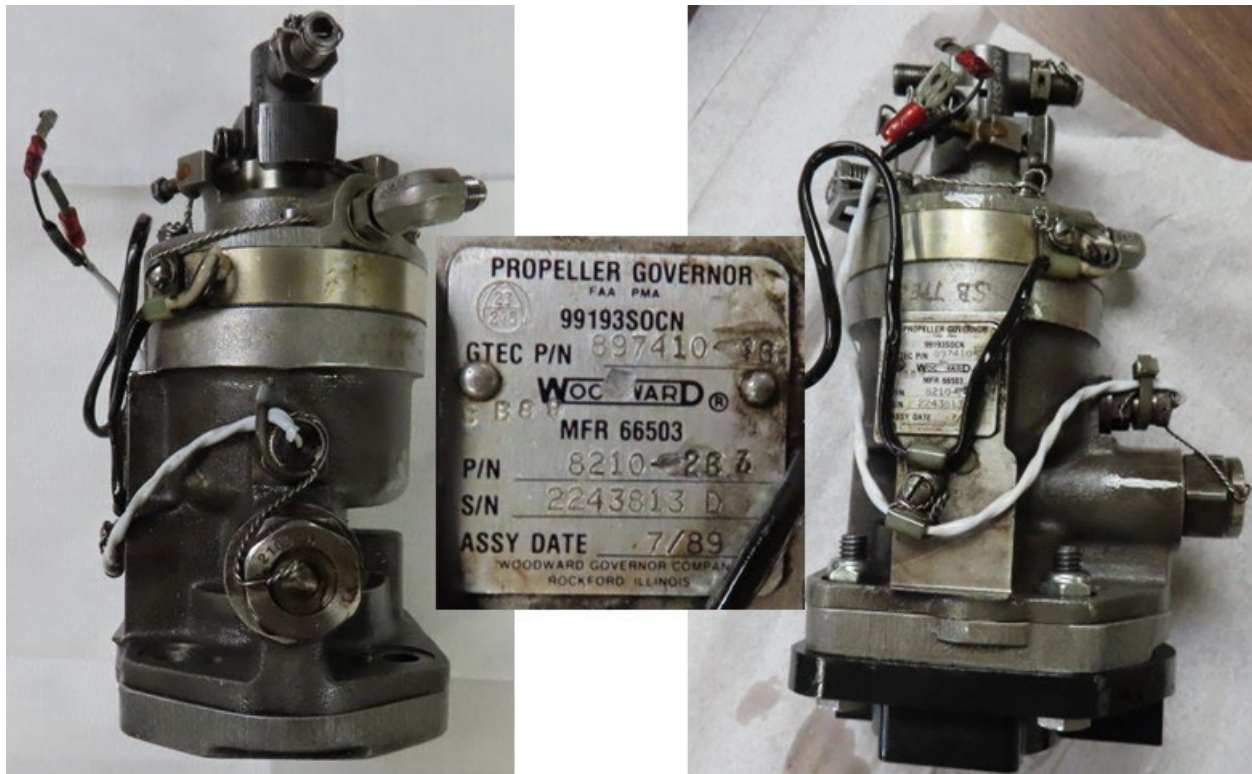
The PG was secured in the original cardboard shipping box when the investigation team arrived for examination on December 9, 2024. The PG was inspected and documented by Woodward personnel; the PG was found to be undamaged and in a testable condition.

**Figure 12.** Woodward PG S/N 2243813 - As Received

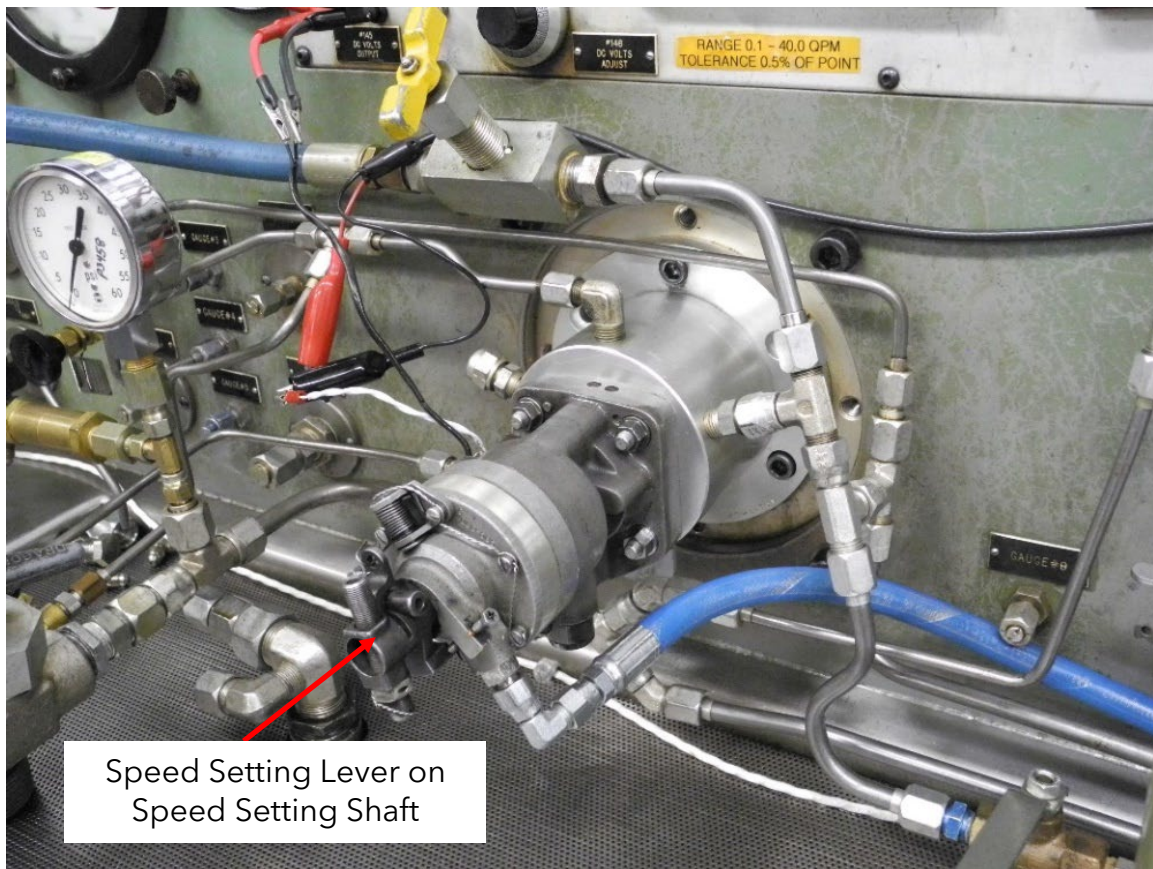
**Figure 15.** PG Mounted onto Test Stand

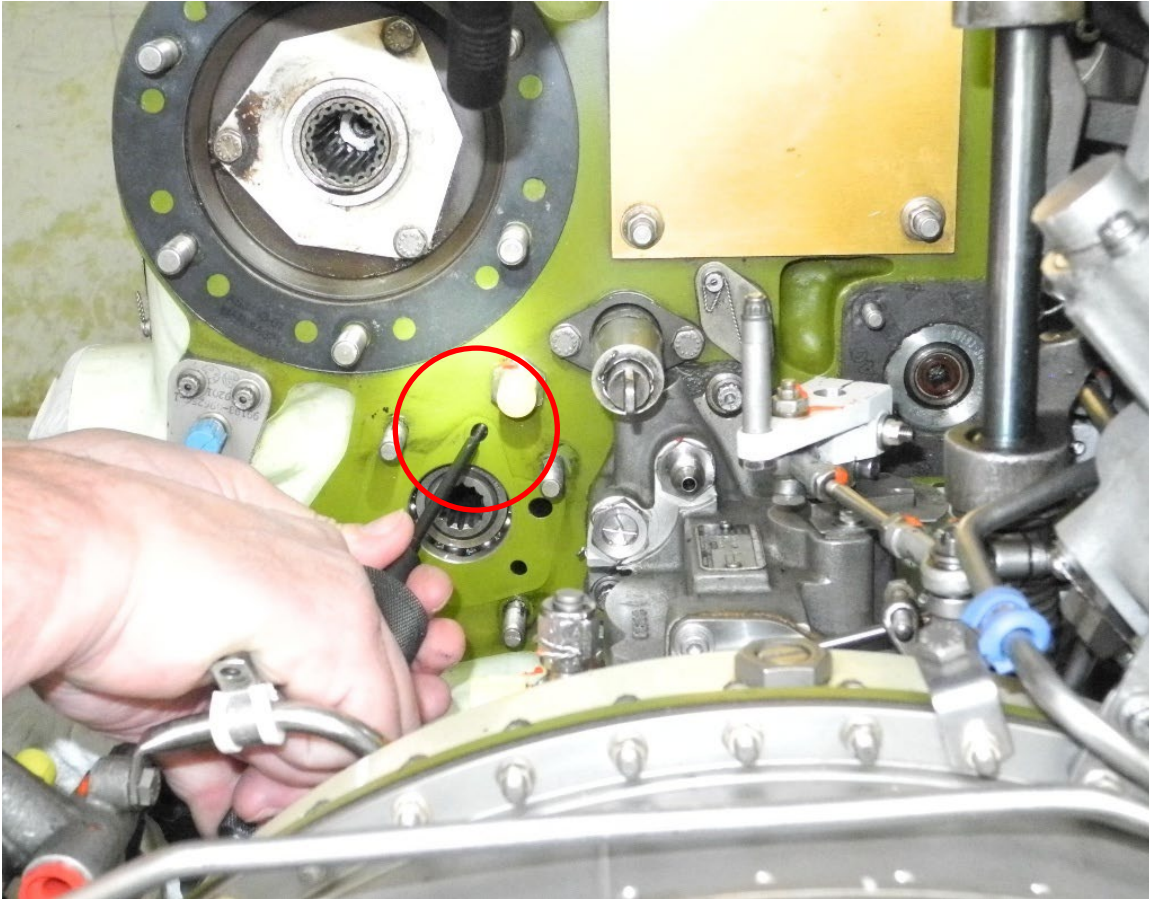
The PG reset orifice (Honeywell P/N 897026-2) (Figure 27) was unscrewed and removed with no difficulty from its recess in the AGB (Figure 26) and found to be clean.

**Figure 24.** PG Reset Orifice Being Removed with Tool

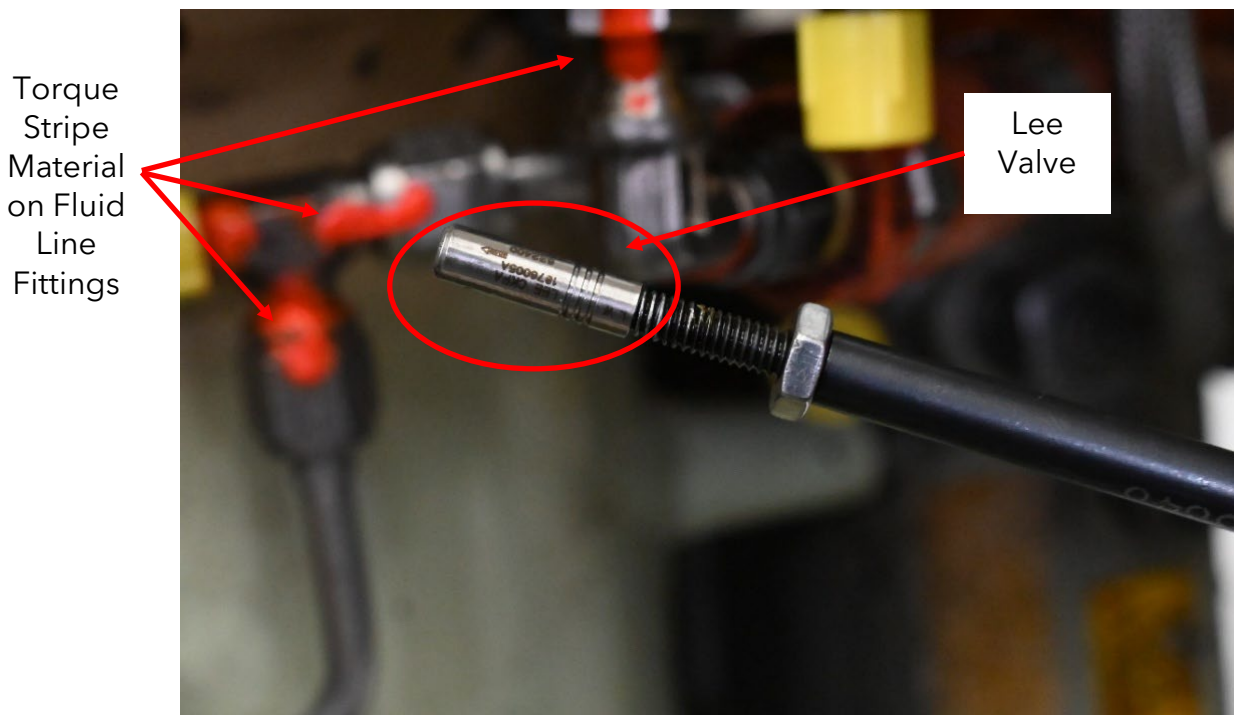
**Figure 28.** Lee Valve - Withdrawn from AGB

The Lee valve was examined using a microscope, which confirmed a small red-colored irregularly shaped foreign object inside the barrel of the valve that appeared to be captured between the ball and seat of the valve (Figure 31); however, because of the small size and shape of the Lee valve, it was not impossible to confirm this observation. Therefore, the Lee valve was sent to the Honeywell CT lab to confirm the location of the debris.

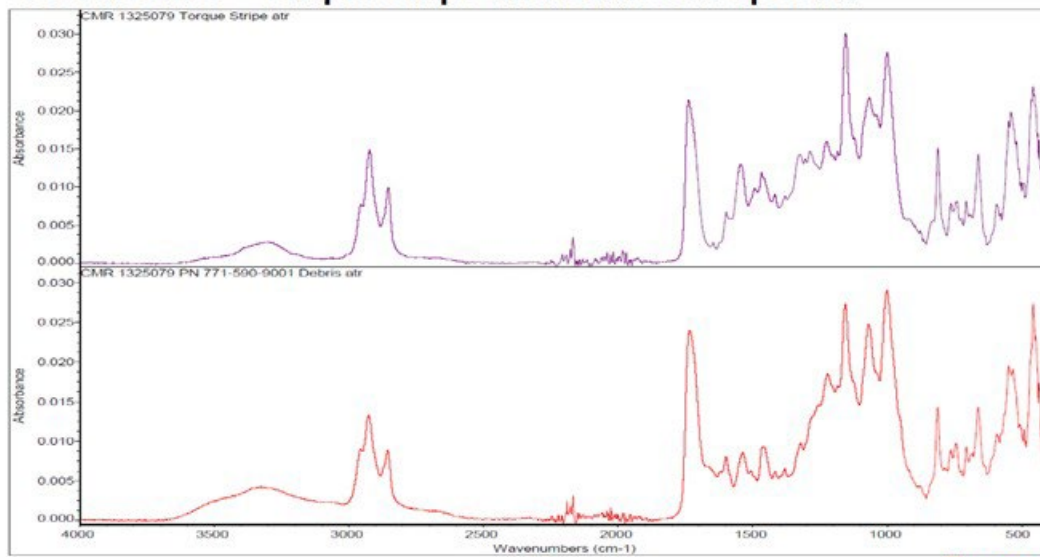
### Test Results – Torque Stripe and Debris atr spectra

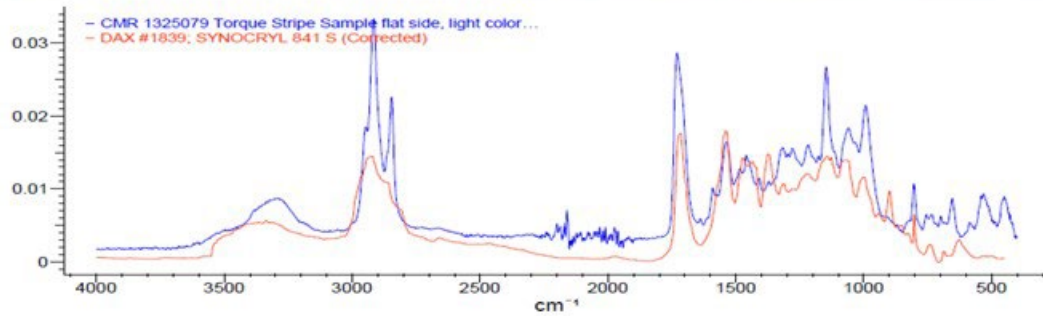
### Test Results – Torque Stripe atr spectrum similar to an Acrylic Resin spectrum WILEY
