**Beechcraft**

## Air Safety Investigations Aircraft Incident/Accident Technical Report

| Aircraft Incident/<br>Accident Information | Year: 2007 | Make: Beechcraft | Model: Hawker 900XP |
| Senior Air Safety Investigator: Ernest C. Hall | | Report #: ASI-24-CA-T | Report date: 02-03-25 |

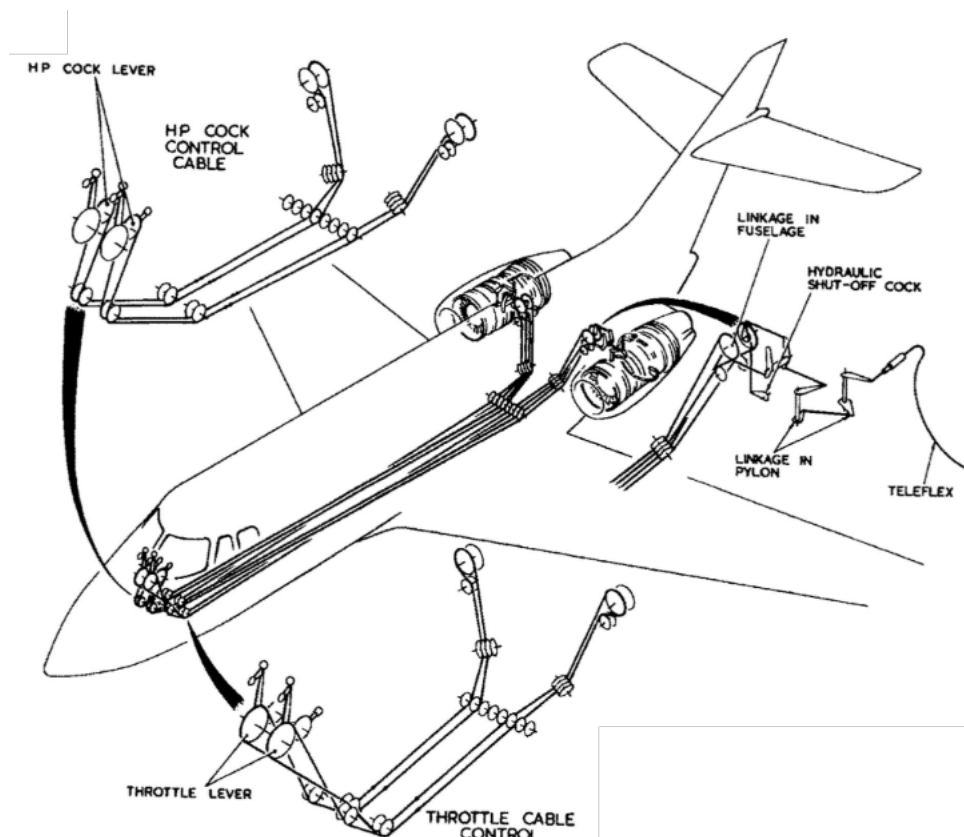
Cropped – AMM 76-10-00, Figure 1, Sheet 1 - Power Controls

Two LP COCKS levers, located on the cockpit pedestal, are each connected mechanically to their respective valve by cables and control rods. Each lever moves within a gated quadrant and before a selection can be made, the knob on each lever must be pulled out against spring pressure; releasing the knob locks the lever in the selected position.

The HP and LP lever cables run along the inside belly of the aircraft from the cockpit pedestal aft to their respective control; LP cables run to their respective LP valve located in each wheel well and the HP cables continue through the aft pressure bulkhead then to their respective engine fuel control unit.

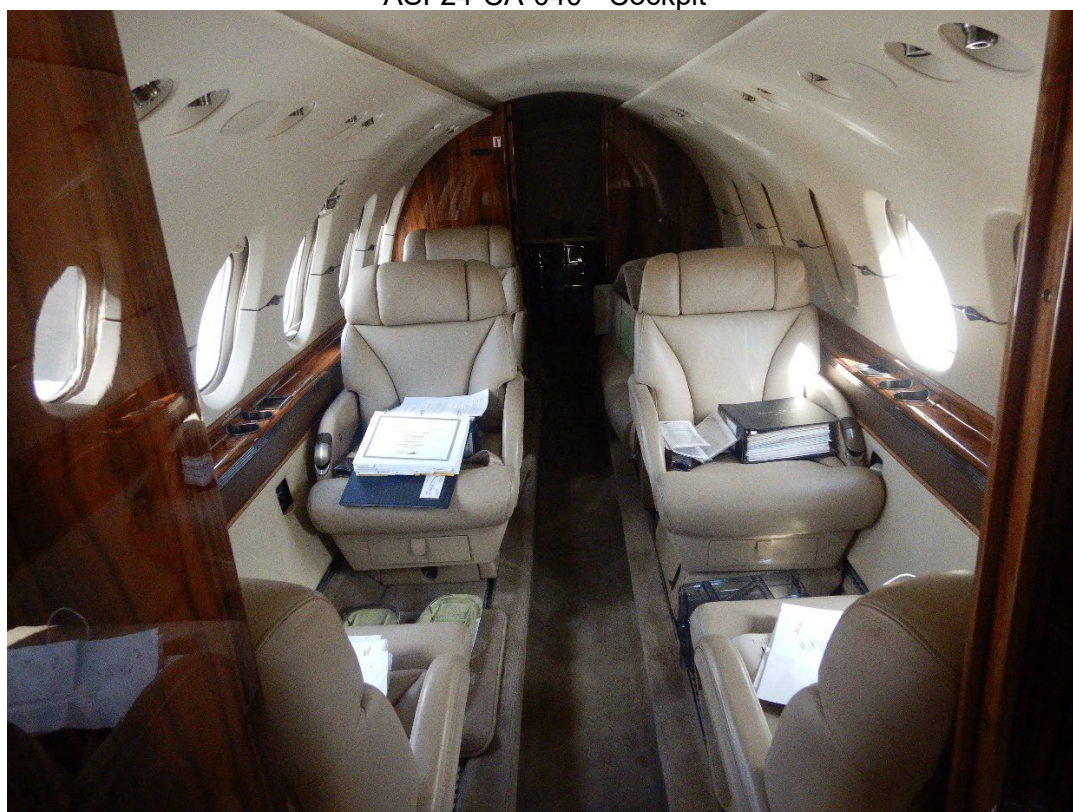
ASI-24-CA-095 – Cabin

A couch in the left aft cabin consisted of seats 7, 9, and 10. The lavatory was seat 11.
