National Transportation Safety Board  
Office of Aviation Safety  
Washington, DC 20594

CEN25FA019

## **OPERATIONS GROUP FACTUAL REPORT**

Location: Houston, Texas  
Date: October 20, 2024  
Time: 1951 central daylight time  
0051 Coordinated universal time (October 21, 2024)  
Helicopter: N881KE / Robinson R-44 Raven II

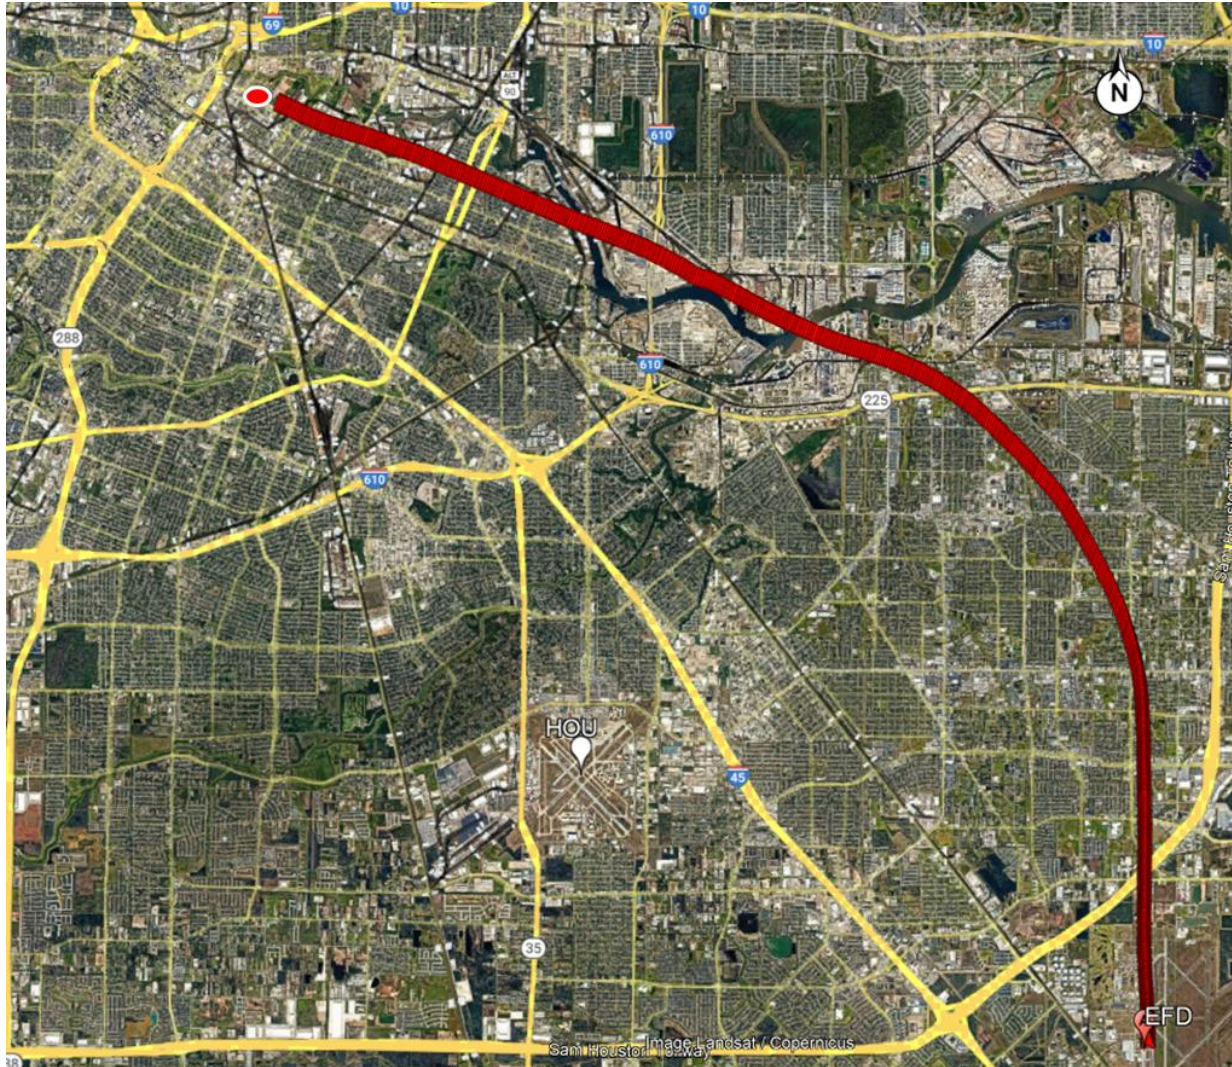
Automatic dependent surveillance-broadcast (ADS-B) data showed the helicopter departed from Ellington Airport (EFD) Houston, Texas, about 1942 from near the Signature Aviation fixed base operator (FBO) parking ramp. The helicopter departed straight-out to the north. When the helicopter was about 4 miles north of EFD, it turned left and continued to the northwest. The helicopter climbed to an altitude of about 850 ft mean sea level (msl). The helicopter passed about 3,300 ft north of the Sidney Sherman Bridge that supported the Interstate 610 freeway (I-610). After passing the bridge, the helicopter turned slightly left and continued northwest toward the east side of the city of Houston at an altitude of about 850 ft. The last ADS-B data point, captured at 1951:19, recorded the helicopter about 850 ft msl, or about 568 ft above ground level (agl), and about 44 ft southeast of a guyed radio tower (figure 1).

Figure 1. Google Earth image showing the accident flight route in red. The red circle indicates the location of the radio tower.

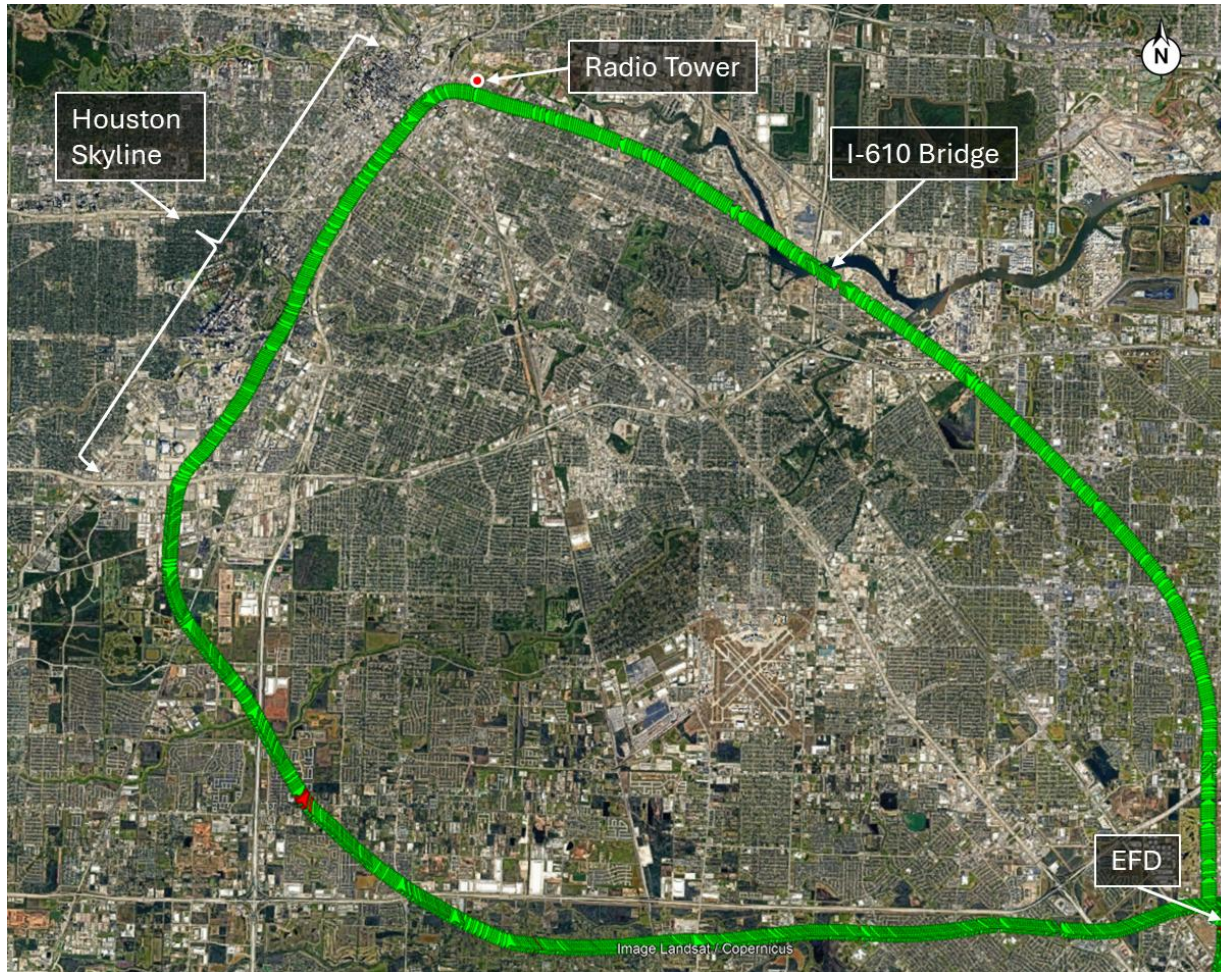
All seven flights generally followed the same path as shown in figure 5.

Figure 5. Illustration of the EFD to Houston to EFD local flight known to the NHS pilots as the Downtown Loop.

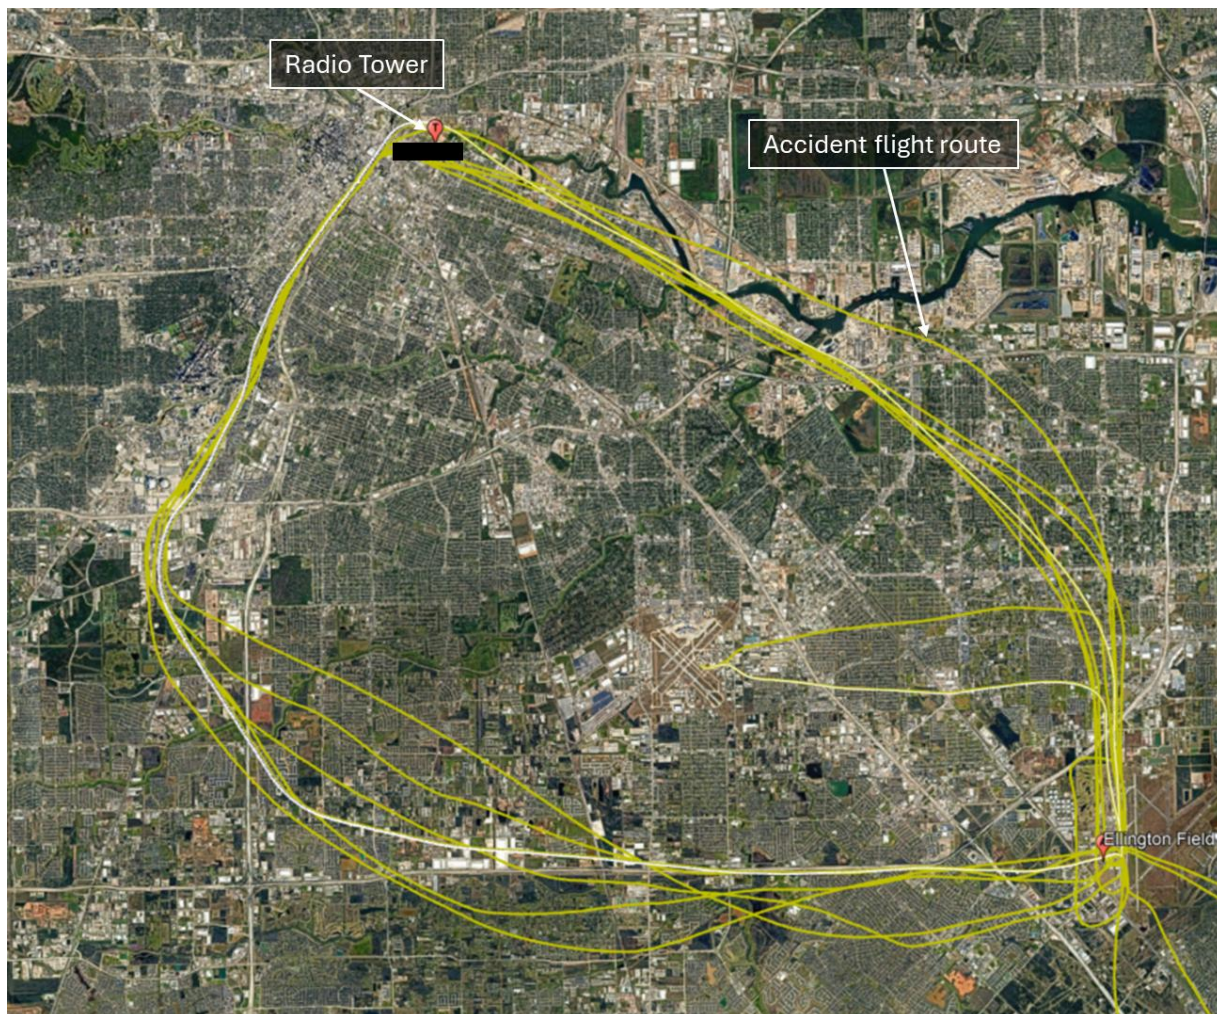
Flight 7. The flight was conducted from about 19:42 to 19:51 in night conditions. After departing EFD the helicopter flew a path that was as far as one mile east of the previous six flights to the Houston skyline. The helicopter passed east of the Sidney Sherman bridge then turned to the east side of the Houston skyline. The helicopter was about 825 ft when it struck the radio tower. According to a recorded conversation between the accident pilot and HOU tower controller, the tower controller reported company traffic to the accident pilot, followed by the accident pilot's response and an audible gasp.

Figure 6. Google image showing the seven flights to Houston made from EFD. The accident flight route is identified.

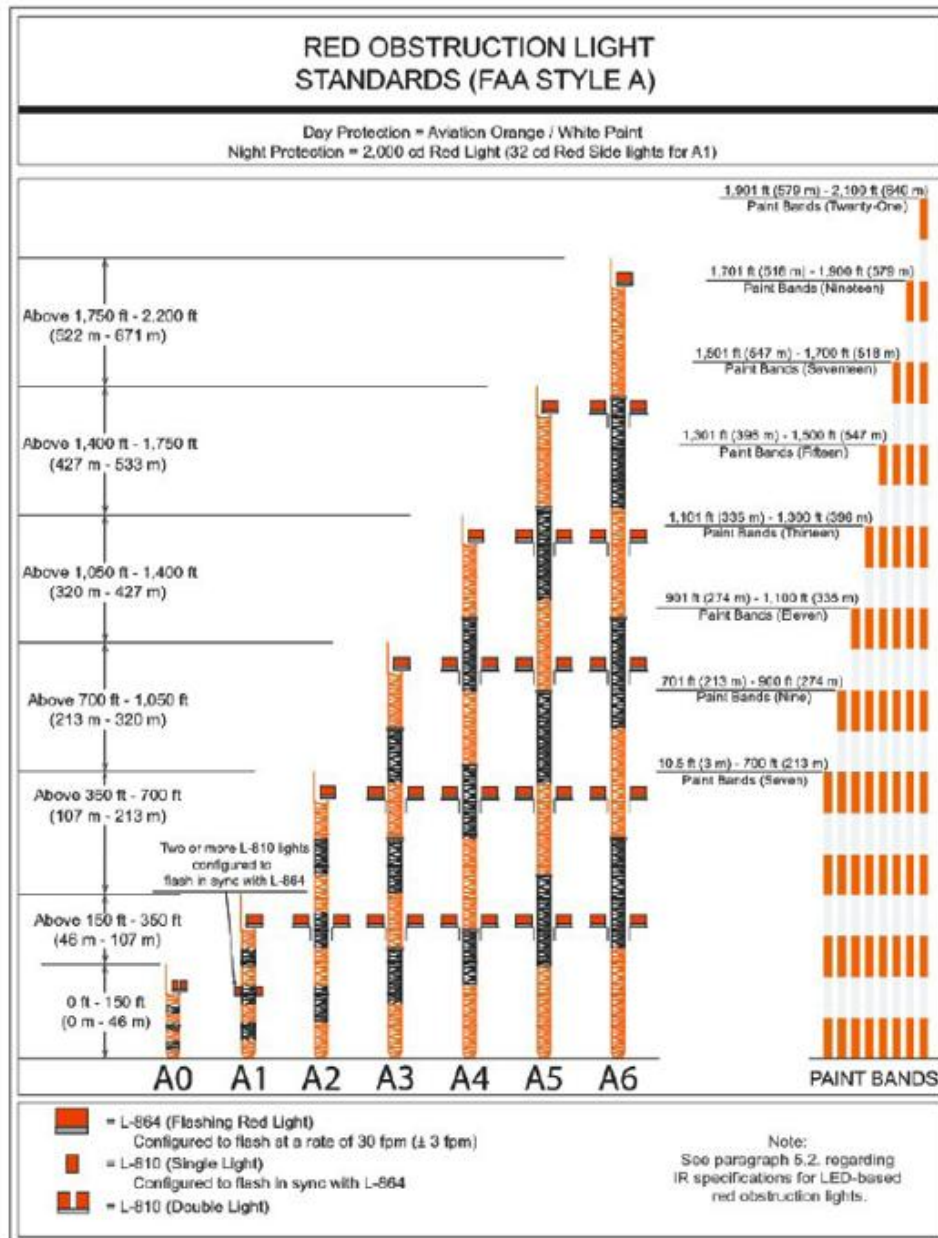
Figure 10. Excerpt from FAA Advisory Circular AC70/7460-1M

A review of FAA Figure A-6 revealed that radio towers above 700 ft -1050 ft fall under the A3 section of the chart and would require a top light and two sets of intermediate lights. All lights would be L-864 (flashing red lights) configured to flash at a rate of 30 flashes per minute (FPM) (+/- 3 FPM) (figure 10).

According to the MIR, the radio tower had beacons at 340 ft, 639 ft, and 1,000 ft levels. The lights were Hughey & Phillips, type: L-864 Flash Head. Examination of the radio tower debris revealed shattered red and white glass debris but no intact lamps. Multiple videos revealed that the top beacon at 1,000 ft, and the intermediate beacon at 639 ft, illuminated and flashed red, in unison, at a rate of about 30 times per minute. The intermediate beacon at 340 ft was not seen in the videos.

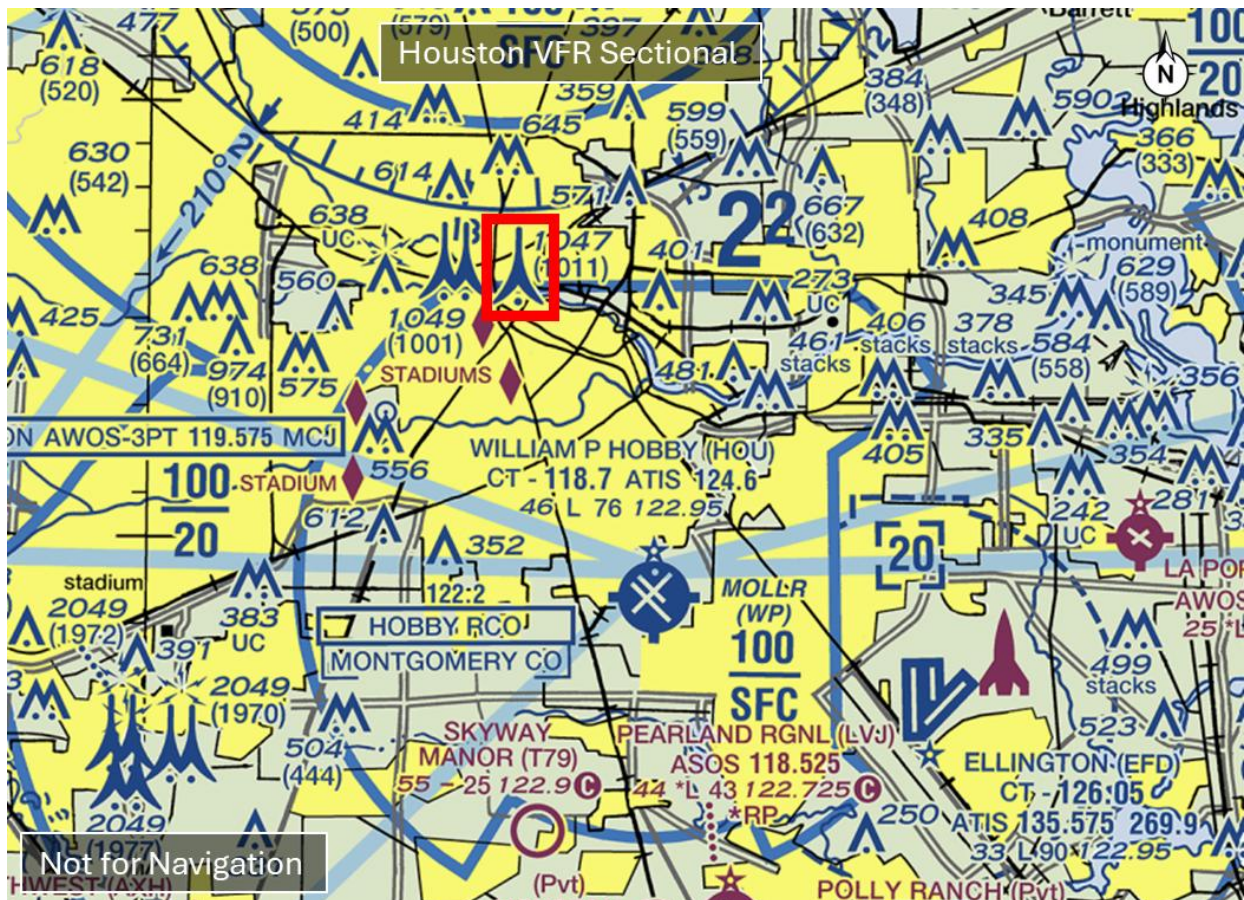
Figure 13. Excerpt from the Houston VFR Sectional showing the accident radio tower.

Both the VFR sectional and the terminal area chart identified the radio tower as an obstruction, 1,000 ft or higher above ground level (agl) that may be lit or unlit. Both charts indicated that the radio tower was 1,047 ft mean sea level (msl) and 1011 ft agl.

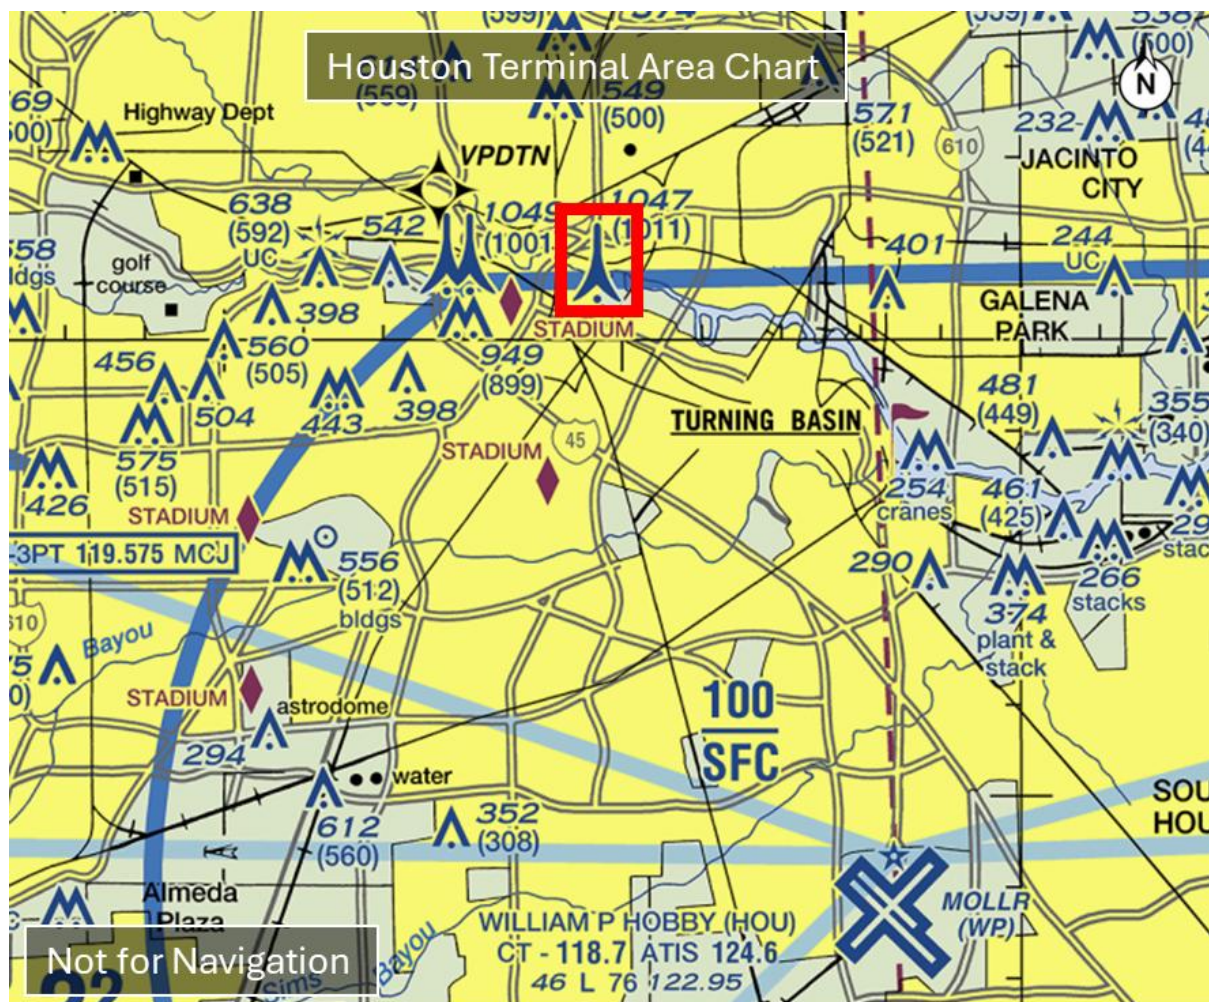
Figure 14. Excerpt from the Houston Terminal Area Chart showing the accident radio tower.
