# National Transportation Safety Board

CEN24LA007

## **WRECKAGE EXAM**

Location: Richmond, TX  
Date: October 8, 2024  
Time: 1235 CDT  
1735 UTC  
Airplane: Mooney M20E

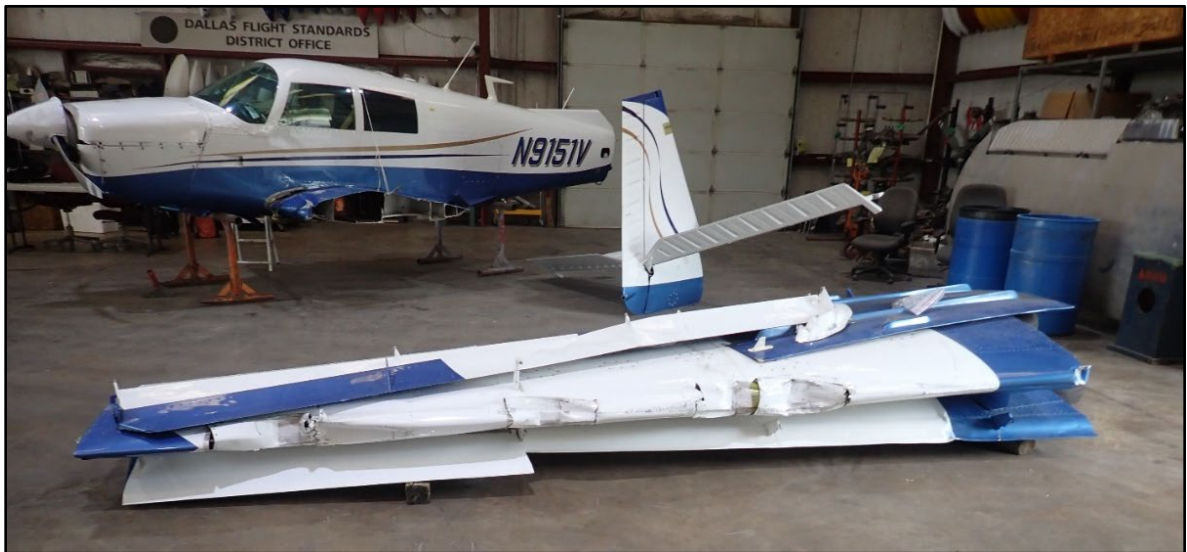
**Figure 2.** Wreckage at ASOD before examination started.

The wings were cut off near their roots and the fuselage had been set up on stands. The empennage had been cut off also and was sitting on the shop floor with the wings.

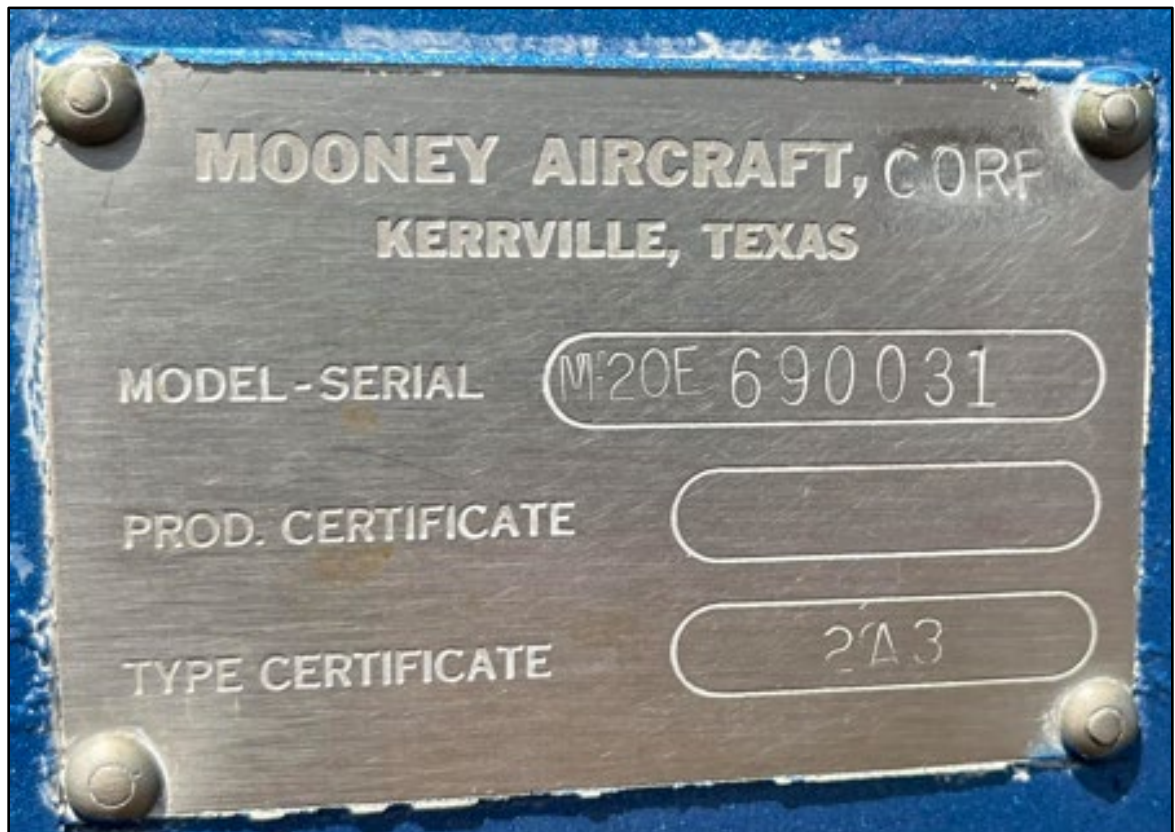
**Figure 3.** Fuselage data plate (photo courtesy of FAA).

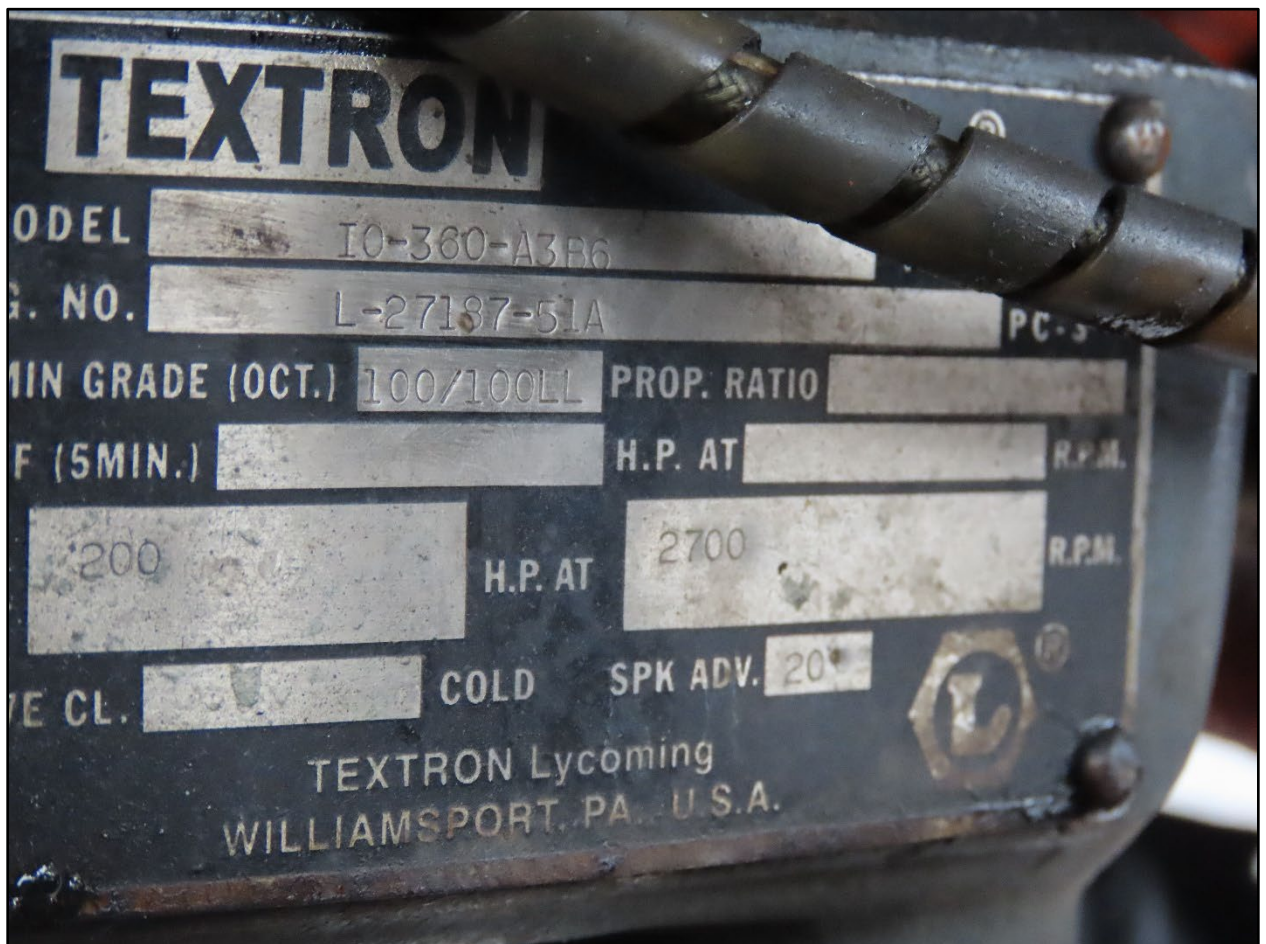
The accident airplane was equipped with a Lycoming IO-360-A3R6 (200 hp) engine that was installed in 1997 and had accumulated 854 hours since new. It's last annual inspection was on May 17, 2024, and had accumulated 98 hours of use since inspection. No notable maintenance entries were found when the engine and airframe logs were reviewed.

**Figure 10.** Engine data plate.

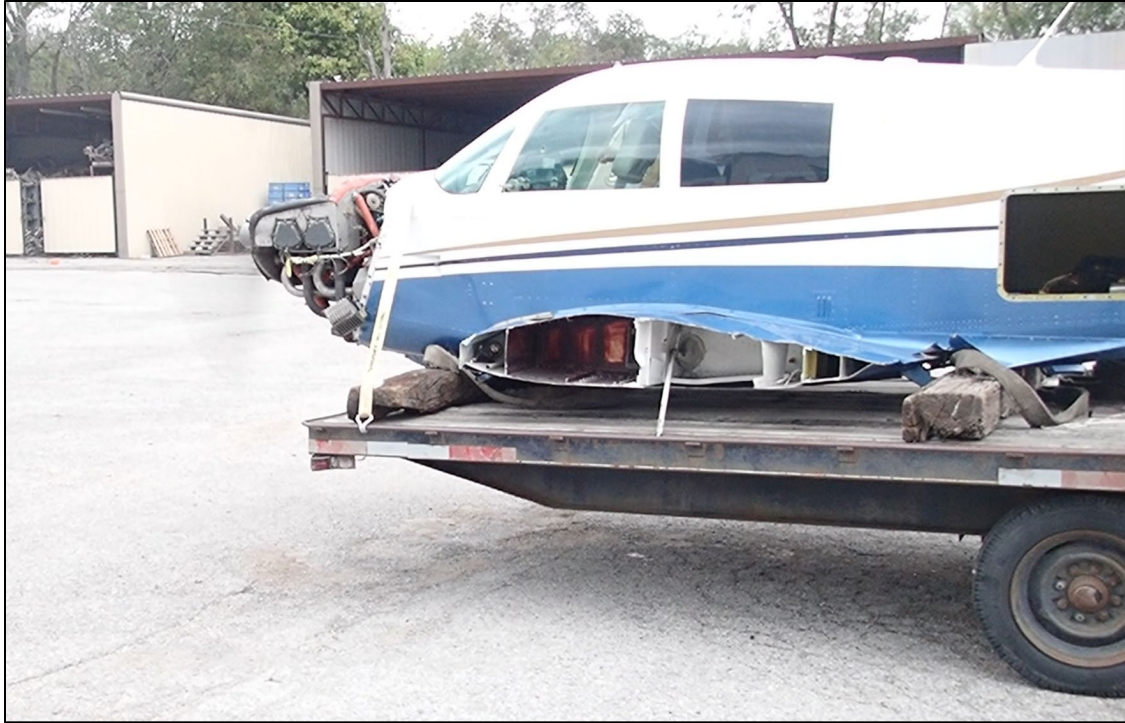
The accident airplane was strapped to a gooseneck trailer for its test run and the trailer was secured so it couldn't move.

**Figure 11.** Accident airplane with engine running on a trailer.

The first engine test run was conducted at low rpm, estimated to be about 800-900 rpm for about two minutes before the engine was shut down and leak checked; no leaks were present. The boost pump operated normally, and the propeller cycled without any anomalies noted.
