NATIONAL TRANSPORTATION SAFETY BOARD  
OFFICE OF AVIATION SAFETY  
WASHINGTON, D.C. 20594

**POWERPLANTS GROUP CHAIRMAN'S FACTUAL REPORT**

NTSB ID No.: DCA12IA114

Location: Charleston International Airport, Charleston, South Carolina  
Date: July 28, 2012  
Time: About 1600 eastern daylight time  
Aircraft: Boeing 787-8, radio call sign Boeing 238

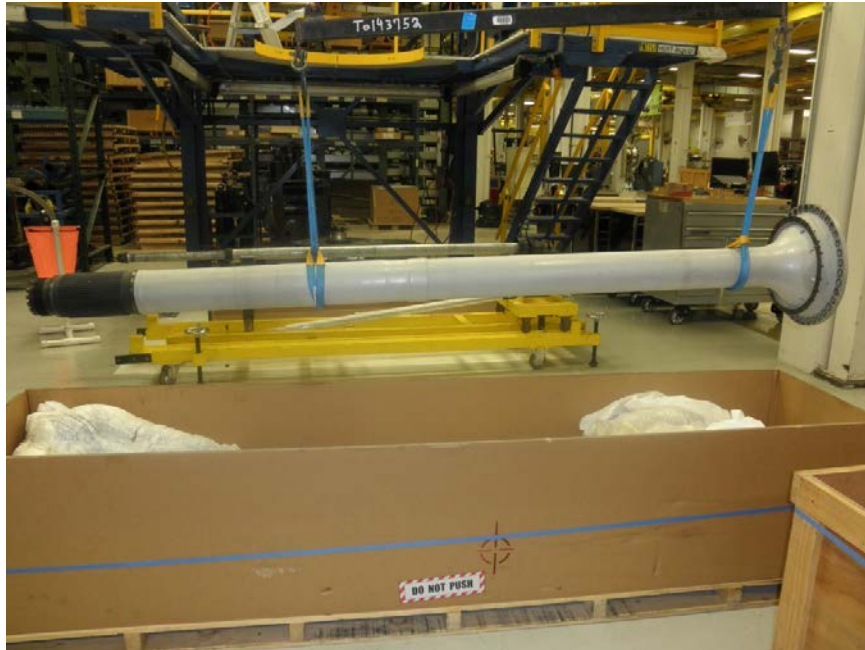
In comparison to an exemplar FMS, the incident FMS was fractured circumferentially about 5-inches aft of the forward face of the wrenching lugs. The remainder of the FMS did not have any rub marks or discolorations. (Photos Nos. 3 and 4) The fracture face at the forward end of the FMS was smooth and flat with a ratchet mark.<sup>7</sup> The fracture surface had two distinct colorations; a light, gray-colored area that appeared to radiate radially outward from the bore and a darker, gray-colored area that appeared to radiate inward from the outer diameter (OD). (Photo No. 5)

Photo No. 3: Exemplar fan mid shaft.

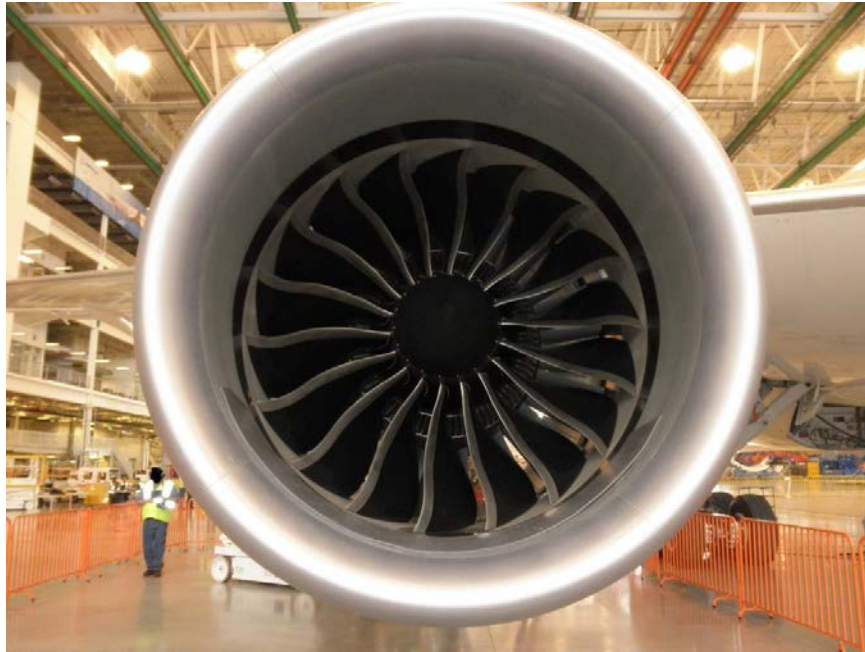
The engine's inlet lip and inlet duct did not have any damage or marks. (Photo No. 6)  
The exterior of the engine's cowls did not have any impact marks, dents, or thermal distress.  
(Photos No. 7 and 8) The examination of the interior surfaces of the engine's cowls did not  
reveal any impact marks or thermal distress. (Photos Nos. 9 and 10) The blowout doors were in  
the normal closed position.

Photo No. 6: View of engine's inlet lip and duct showing no damage.  
Also shown are the fan blades with no damage or marks.

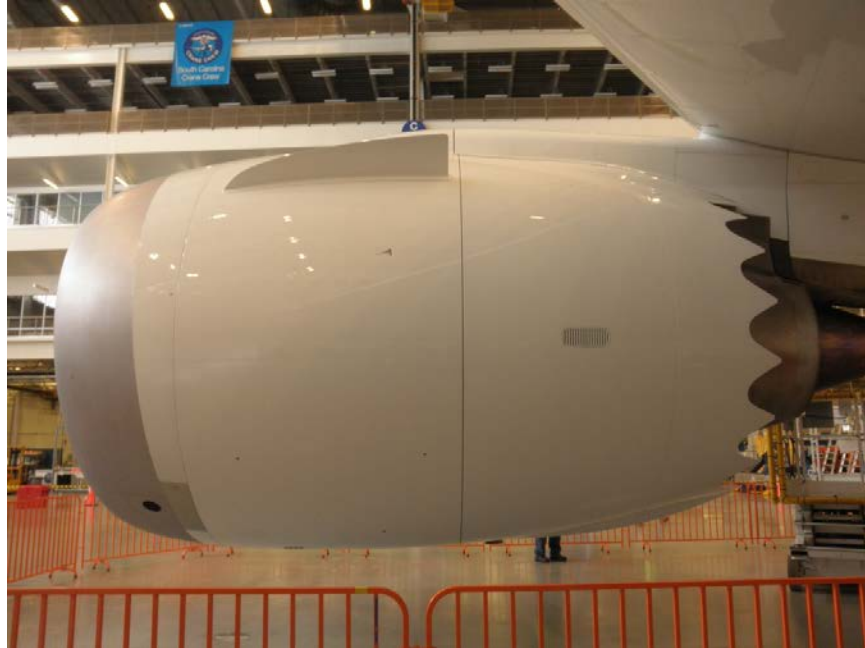
Photo No. 7: Left side of engine cowl showing no damage or heat distress.

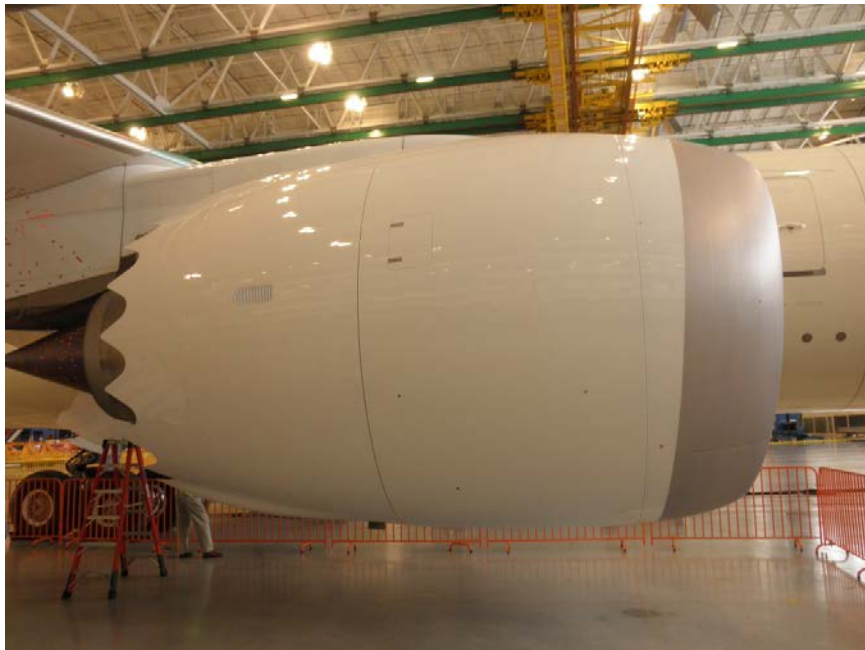
Photo No. 8: Right side of engine cowl showing no damage or heat distress.

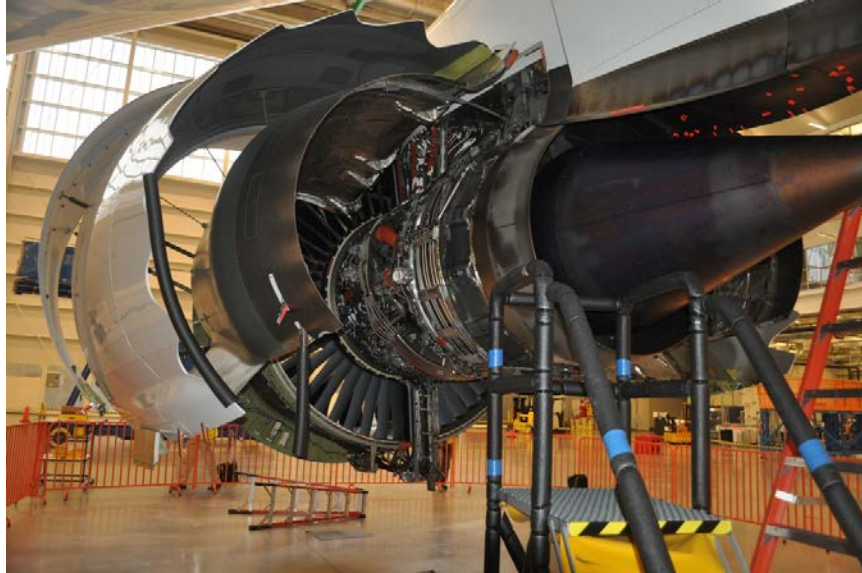
Photo No. 9: Left side of engine with cowls open showing no damage to the inner surfaces of the cowls and no soot or fire damage to the engine. (GE)

The engine did not have any indication of an undercowl fire or a case rupture. (Refer to Photos Nos. 9 and 10.)

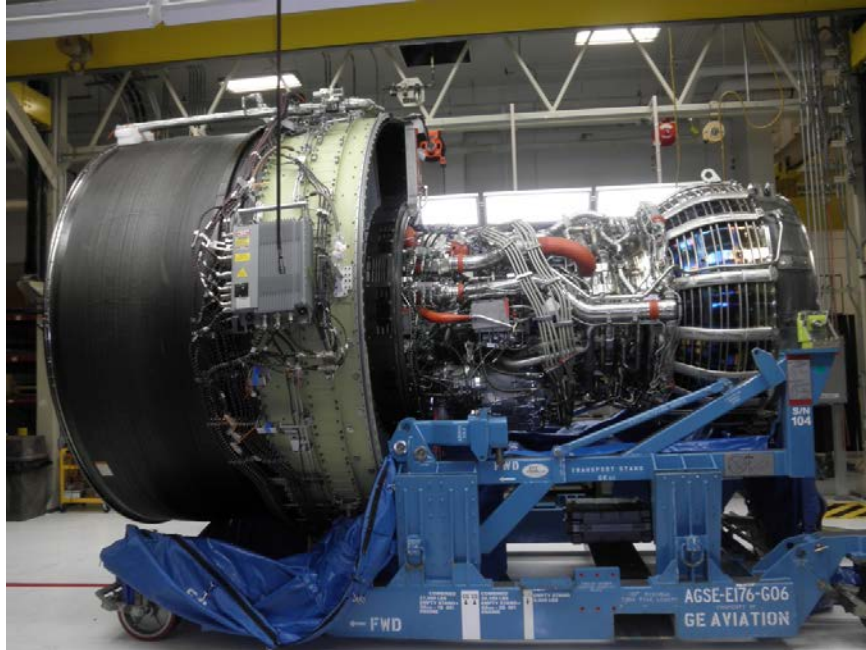
The engine was complete from the fan case front flange to the TRF rear flange. The FMS with the CVT had been removed from the engine and sent to GE for metallurgical examination prior to the shipment of the remainder of the engine. The engine did not have any indications of any uncontainments, case ruptures, or undercowl fires. (Photos Nos. 12 and 13)

Photo No. 12: Left side of engine showing no uncontainments, case ruptures, or fire damage.

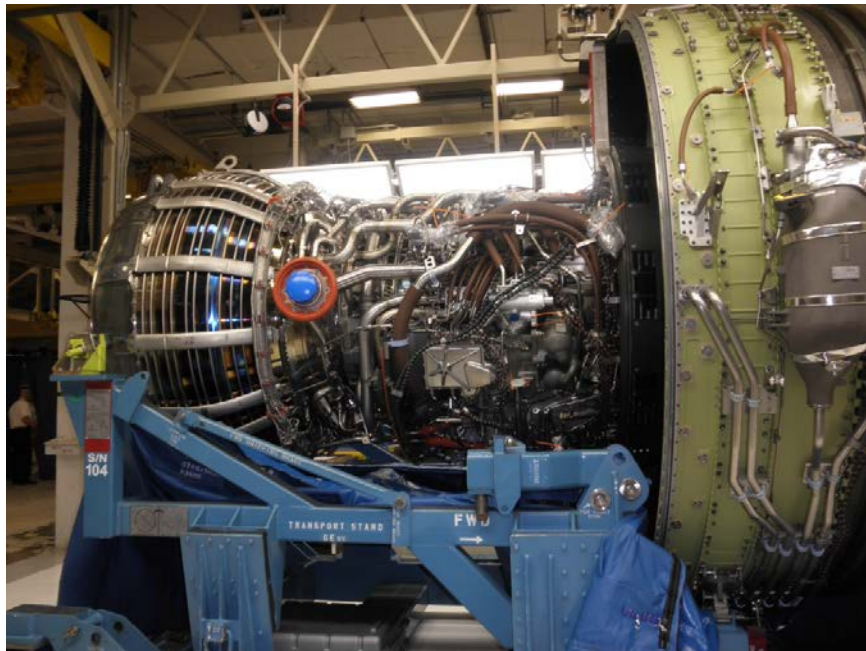
Photo No. 13: Right side of engine showing no uncontainments, case ruptures, or fire damage.

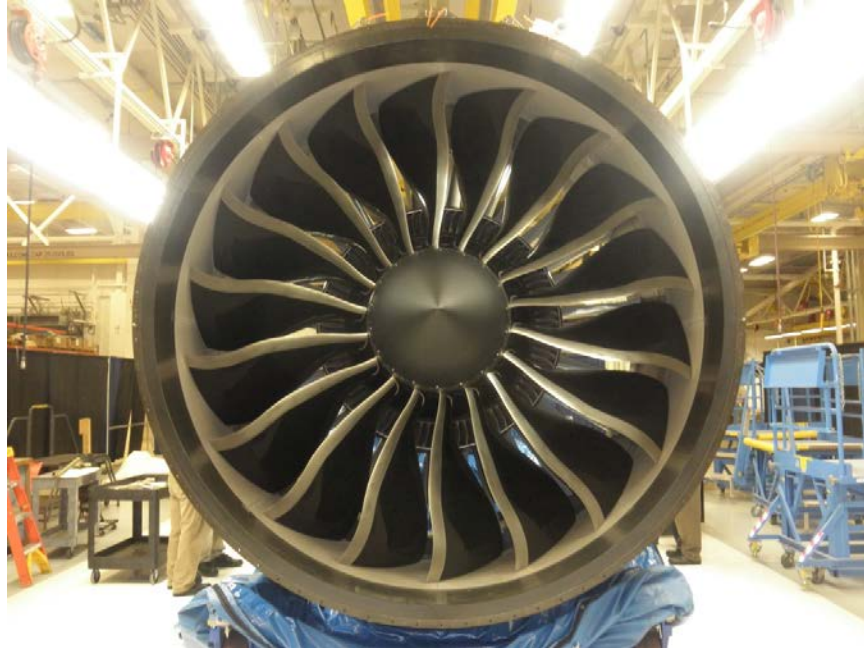
The fan disk was intact. All of the fan blades and fan blade platforms were in place. The fan blades did not have any marks or impact damage on the leading edges, trailing edges, or airfoils. (Photo No. 14) The fan blade platforms did not have any apparent damage. The fan case abrasion rub strip did not have any circumferential rub marks. (Refer to Photo No. 14)

Photo No. 14: View of fan blades showing all are present and undamaged. Also shown is the fan blade rub strip showing no circumferential rub marks.

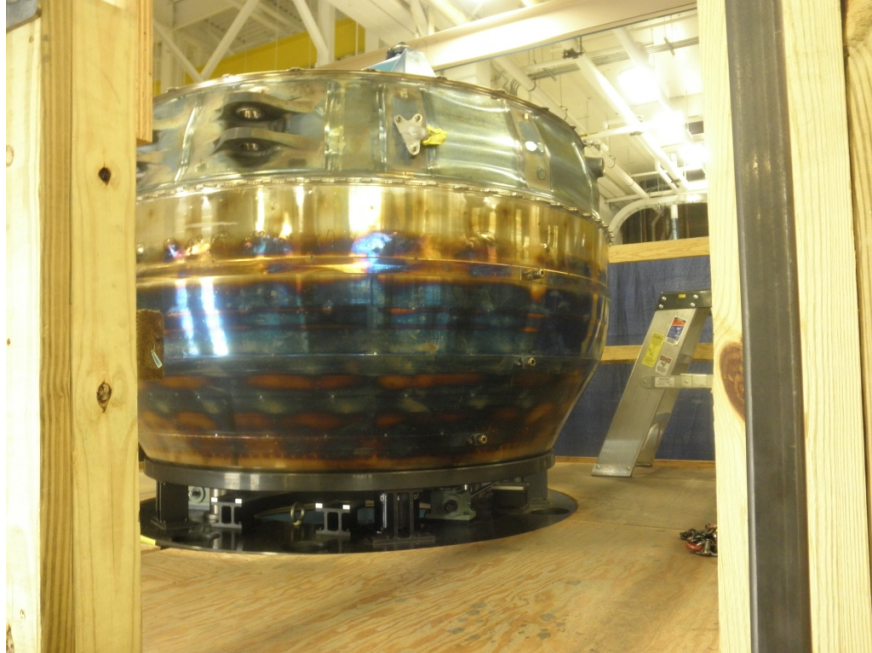
The LPT case was intact. (Photo No. 15) The exterior of the LPT case had numerous outward dents around its circumference in the plane of the LPT stage 6 rotor between about 4.5- and 6-inches forward of the rear flange. The LPT case had an approximately 0.94-inch wide circumferential by an approximately 0.88-inch long axial hole with a tab of metal bent up on the counterclockwise side of the hole at about 12 o'clock, 5-inches forward of the rear flange. (Photo No. 16) The OD of an LPT stage 6 shroud was visible through the hole. There was an approximately 0.25-inch long split at about 2 o'clock, about 4.63-inches forward of the rear flange and an approximately 0.5-inch split at about 6 o'clock, about 5.63-inches forward of the rear flange. (Photos Nos. 17 and 18, respectively)

Photo No. 15: View of exterior of the LPT case showing it is intact.

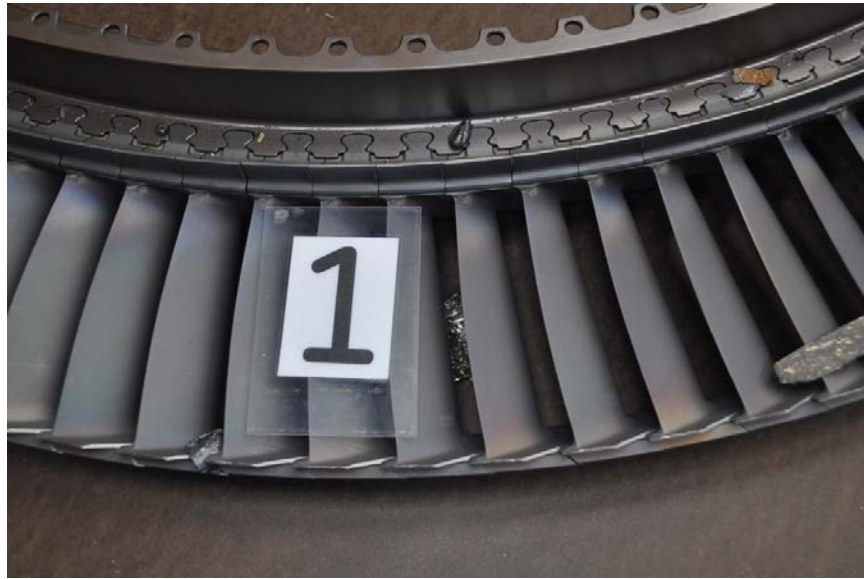
The LPT stage 1 disk was intact. The LPT stage 1 blades were all in place and there was no apparent damage to the airfoils. (Photo No. 19) The aft edge of the LPT stage 1 blades' angel wings were against the front of the LPT stage 2 nozzle support front face. The LPT stage 1 blades' angel wings had heat discoloration along the aft edge that corresponded to the circumferential rub mark on the front face of the LPT stage 2 nozzle support. The rear face on all of the LPT stage 1 blades had a circumferential rub mark with heat discoloration that corresponded to the circumferential rub marks on the forward flow guide on the LPT stage 2 nozzles. (Photo No. 20)

Photo No. 19: View of LPT stage 1 disk and blades showing no damage. (GE)

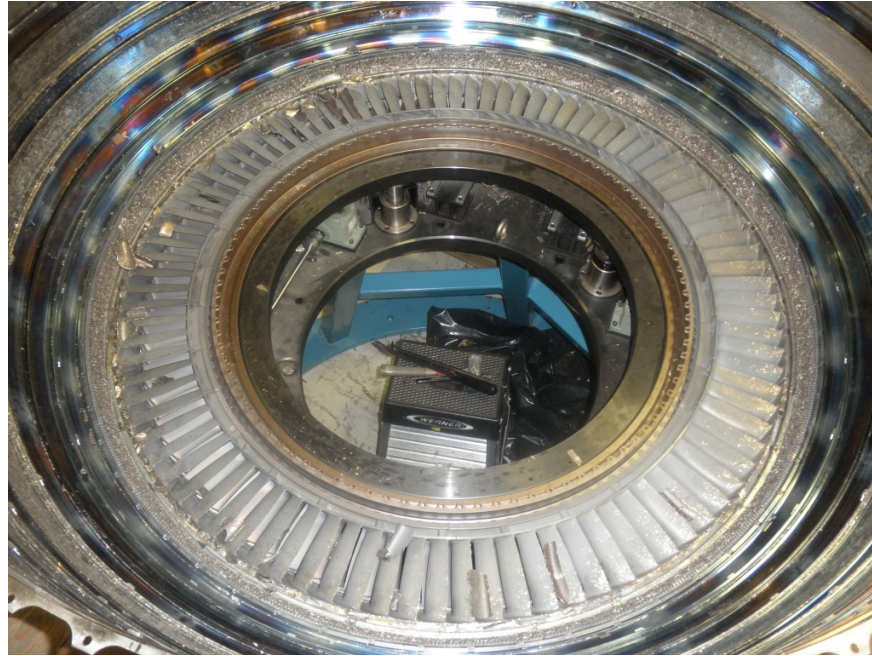
All of the LPT stage 2 nozzles were in place in the LPT case. (Photo No. 21) All of the LPT stage 2 nozzle airfoils had minor nicks and dents on the suction side of the airfoil from the midspan area outboard. (Photo No. 22)

Photo No. 21: View of LPT stage 2 nozzles showing all of the nozzles are in place.

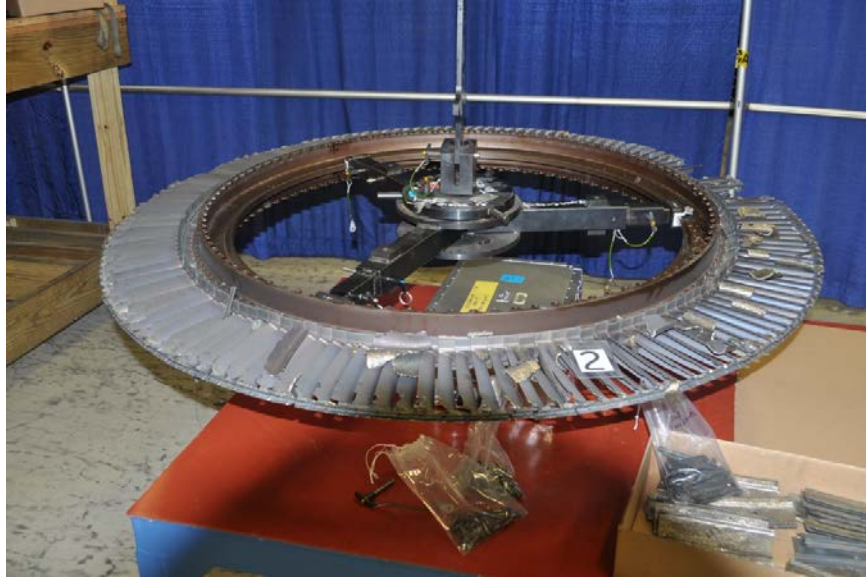
The LPT stage 2 disk was intact. The LPT stage 2 blades were all in place. (Photo No. 22) There were two LPT stage 2 blades that were fractured across the airfoil about 5 inches above the blade root platform and were missing the tip shroud. All of the LPT stage 2 blades had the blade tip trailing edge corners missing. All of the LPT stage 2 blades had minor nicks and dents on the suction side<sup>21</sup> of the blade. All of the LPT stage 2 blades had a circumferential groove in the rear face of the blade root and in the airfoil at the trailing edge fillet radius that corresponded to the circumferential rub marks on the front face of the LPT stage 3 nozzle honeycomb support and the front face of the nozzle inner platform, respectively. All of the LPT stage 2 blades aft angel wings had circumferential rub marks that corresponded to the circumferential rub marks on the front face of the LPT stage 3 nozzle honeycomb support. (Photo No. 23)

Photo No. 22: View of LPT stage 2 disk and blades after they were removed from the engine showing the disk is intact and all of the blades are in place in the disk.

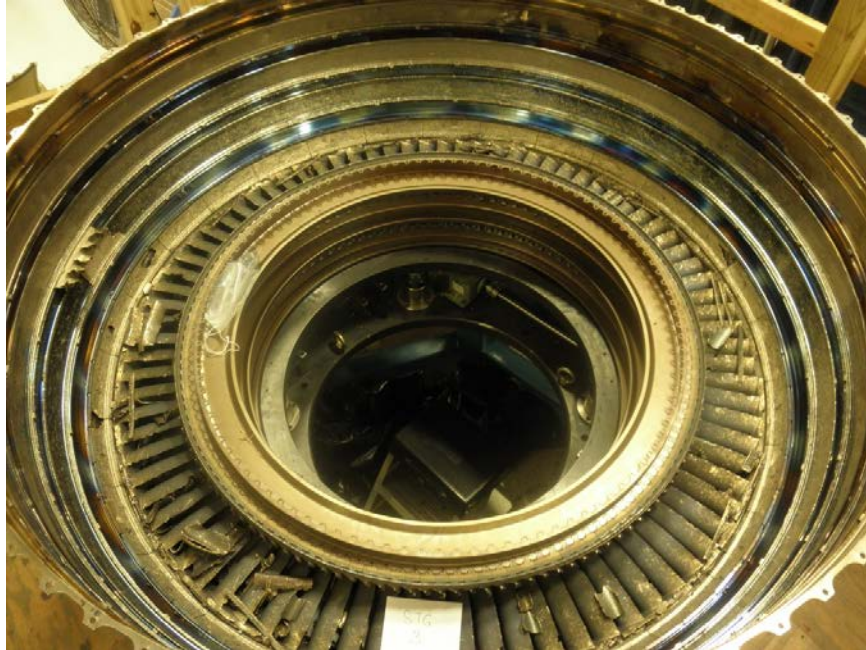
The LPT stage 3 disk was intact and did not have any apparent damage. All of the LPT stage 3 blade roots were in place in the disk. All of the LPT stage 3 blades except one were fractured transversely across the airfoil adjacent to the blade root platform. (Photo No. 25) There was one LPT stage 3 blade that was fractured across the airfoil about 1.5-inches above the blade root platform. The suction side of that airfoil had nicks and dents. The rear face of all of the LPT stage 3 turbine blade roots had an approximately 0.13-inch wide circumferential groove on the rear face that cut through the skirt. There was also a groove on the trailing edge that corresponded to the circumferential rubmarks on the LPT stage 4 nozzle honeycomb support. (Photo No. 26)

Photo No. 25: View of LPT stage 3 disk showing it is intact and all of the LPT stage 3 blade roots are in place. Also shown are all of the LPT stage 3 nozzles and LPT stage 3 shroud segments are in place in the LPT case.

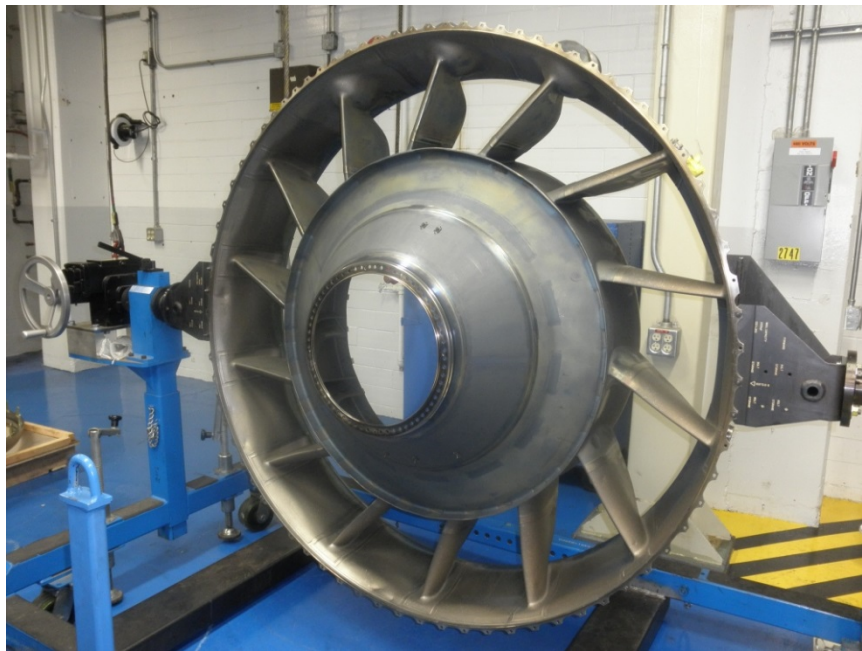
The TRF was intact. (Photo No. 35) The inner diameter of the outer case had numerous nicks and dents. All of TRF struts were in place and there were no visible cracks on the inner or outer ends of the struts where they join with the inner duct or outer case, respectively. All of the struts had numerous nicks and dents, primarily on the convex side. There was one strut, strut No. 5<sup>22</sup> at about 3:30 o'clock, that had an approximately 0.25-inch wide radial by 0.88-inch long axial hole about 0.63-inches aft of the leading edge adjacent to the outboard fillet radius. (Photo No. 36)

Photo No. 35: View of turbine rear frame showing that it is intact.
