# NATIONAL TRANSPORTATION SAFETY BOARD

## MATERIALS LABORATORY FACTUAL REPORT

Report No. 13-086

Place : Charleston, South Carolina  
Date : July 28, 2012  
Vehicle : Boeing 787-8, ZA238  
NTSB No. : DCA12IA114  
Investigator : Dave Helson, AS-10

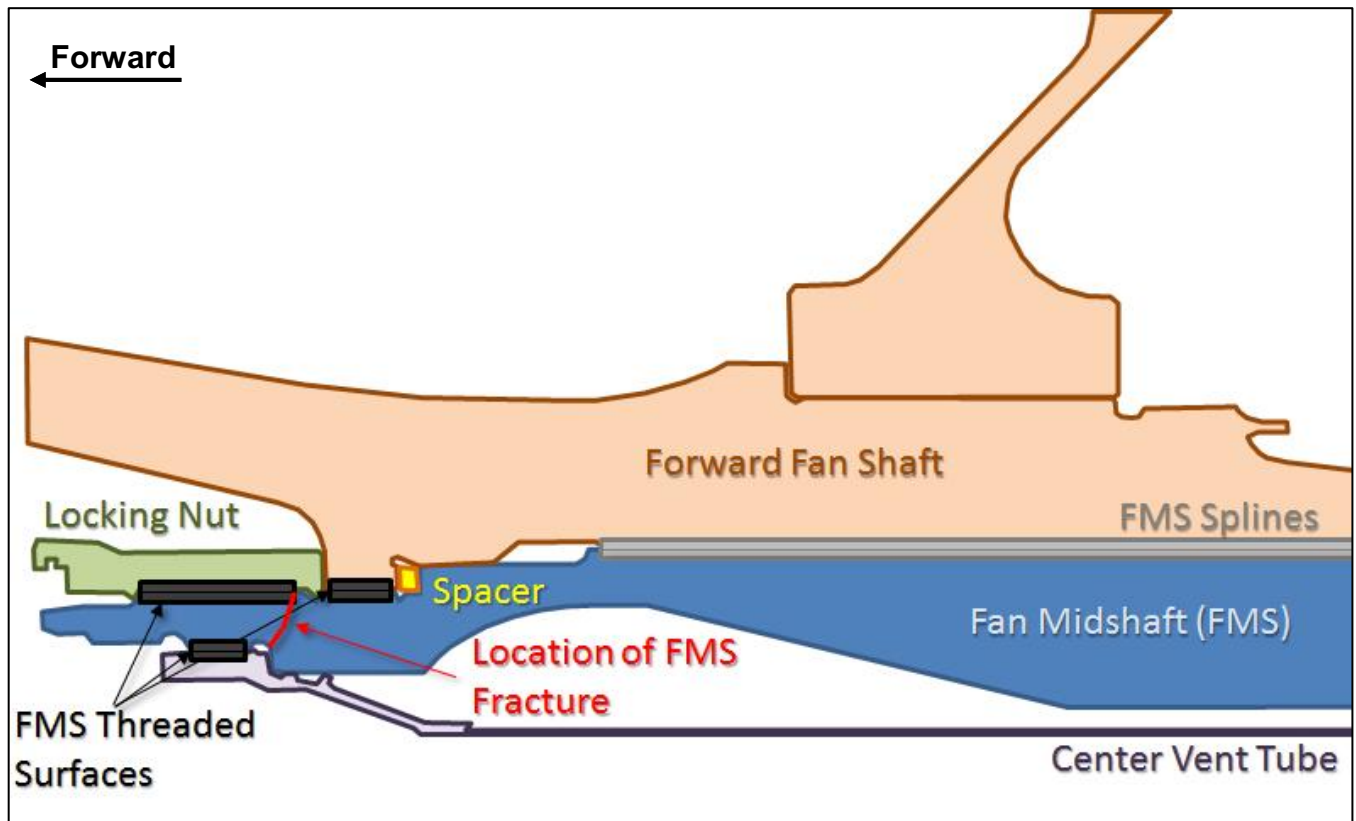
Figure 1 – Schematic illustration of the configuration of the fan midshaft in relation to forward adjacent components. The FMS has threaded connections with the forward fan shaft, center vent, tube, and the locking nut. The FMS also connects to the forward fan shaft via splines on the FMS outer surface further aft.

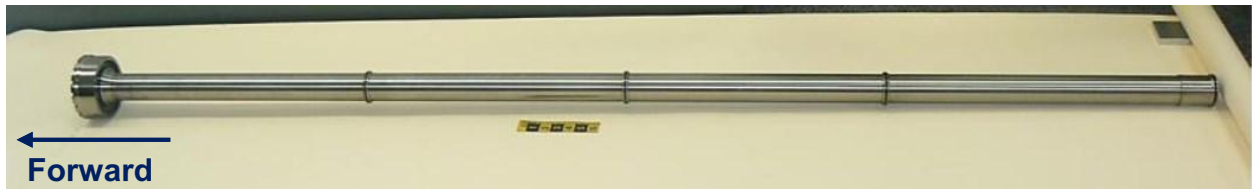
Figure 5 illustrates the forward segment of the fan midshaft and lock nut still attached to the center vent tube after the assembly was removed from the engine. The center vent tube was sectioned approximately 5 inches aft of the fracture to examine the forward fracture face of the FMS. Figure 6 shows the forward FMS fracture in a lightly cleaned condition with the lock nut attached. The lock nut appeared to have been properly secured. The fracture surface was cleaned with a light methanol and acetone rinse to remove residual engine oil and small wear debris. No evidence of fretting, wear, or abnormal contact damage was observed on the contact faces. Per the applicable drawings, all forward FMS threads and lock nut threads were coated with Everlube 9002 dry film lubricant with a subsequent application of graphite grease used to aid assembly.

Figure 5 – The fan midshaft forward segment in the coupling nut attached to the center vent tube (CVT).

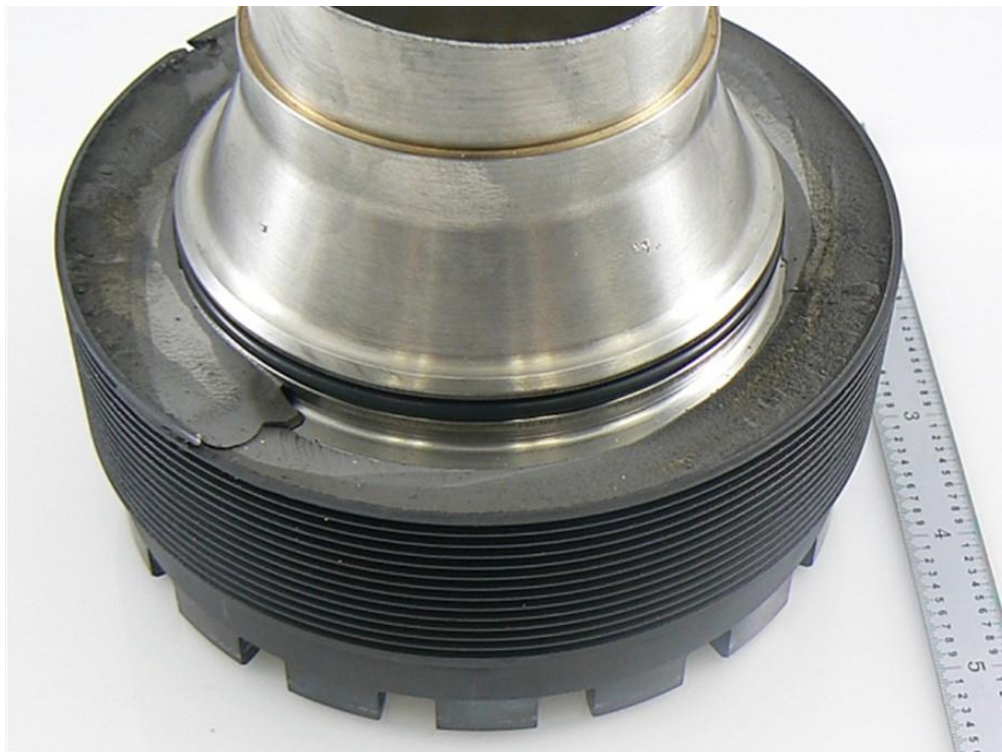
As shown in Figure 6, two fracture origins were identified on the FMS fracture surface—these origin regions were labeled A and B for the purpose of this investigation. This view shows the progressive fracture regions, which contained visible crack arrest and ratchet marks. Figure 7 and Figure 8 show the forward FMS fracture segment after removal of the lock nut. The fracture emanated from the aft most thread root progressing primarily through the thicker (~0.6 inch) cross-section portion. After more extensive cleaning, the forward FMS fracture face showed a discolored region encompassing ~85% of the FMS cross-section (see Figure 9). Comparable fracture features were noted on the aft FMS fracture surface (see Figure 4).

Figure 7 – The forward fan midshaft section illustrated in Figure 6, after removal of the coupling nut with the center vent tube still attached.

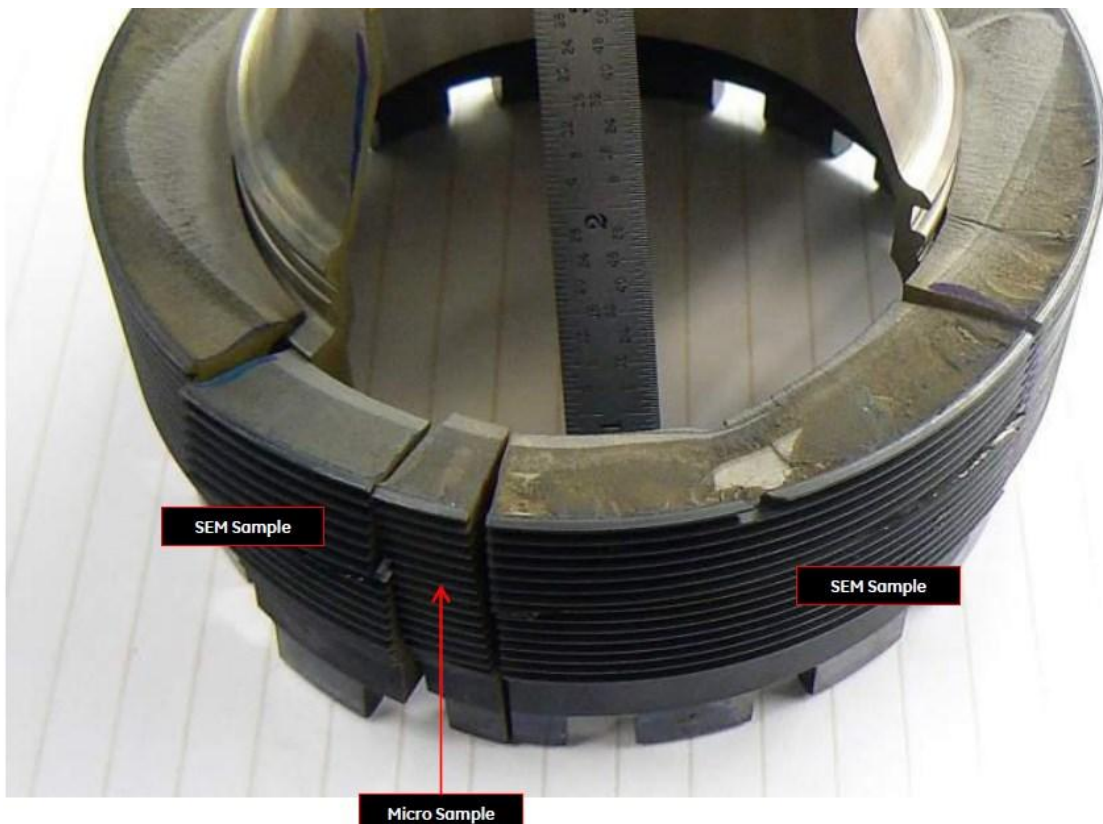
The forward FMS was sectioned in order to examine the fracture surface using scanning electron microscopes (SEM), as shown in Figure 18. Evidence of faceted, quasicleavage fracture was observed emanating from the aft most thread root region as shown in Figure 19. These facets showed small cleavage “tongues” which generally faced inward, but in some locations were oriented in sporadic directions. Similar fracture morphology along with prevalent secondary surface cracking was observed just inboard of the thread root region. This fracture morphology was consistent with environmentally assisted cracking (EAC) in certain ultrahigh strength steels, such as the fan midshaft material, GE1014.<sup>6</sup> No evidence of fatigue striations was found.<sup>7</sup> Inspection using energy dispersive X-ray spectroscopy (EDS) found the FMS material to be consistent with GE1014.<sup>8</sup> No evidence of any corroding elements, namely chlorine and other halogens, was detected on the fracture surface. Major levels of carbon and oxygen were commonly detected on the discolored fracture surface.

Figure 18 – The forward fan midshaft segment after sectioning areas of interest for further analysis.
