**NATIONAL TRANSPORTATION SAFETY BOARD**  
**Office of Aviation Safety**  
**Washington, D.C. 20594**

**POWERPLANT GROUP CHAIRMAN'S FACTUAL REPORT**

**NTSB No: DCA-13-MA-121**

Aircraft: de Havilland DHC-3 'Otter', Registration No. N93PC

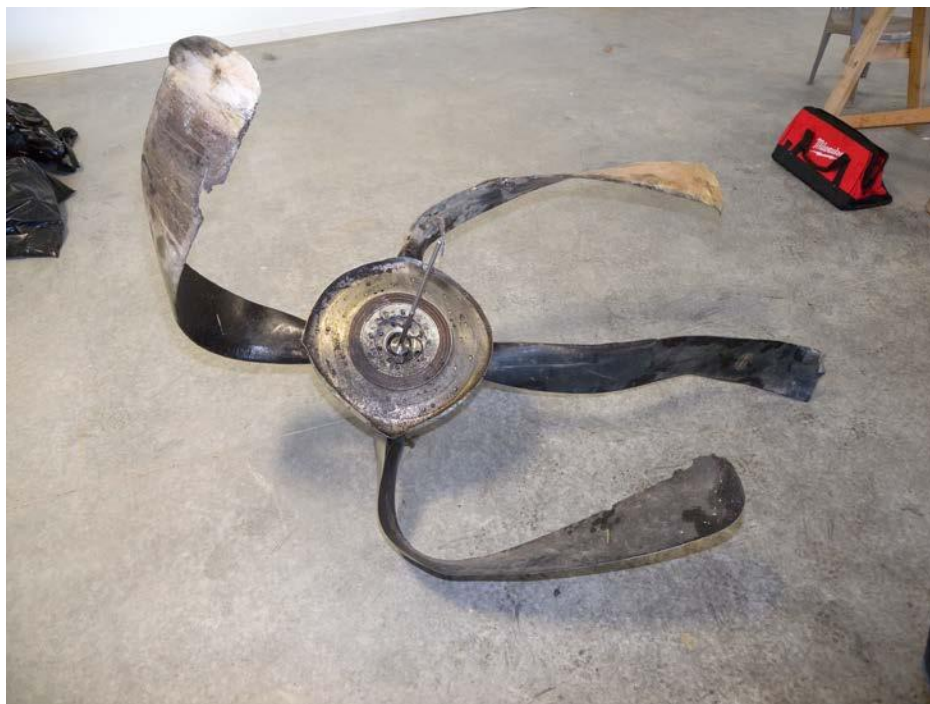
On-scene, the engine was found within the main wreckage still contained within the nacelle/firewall engine mount frame and 'horse-collar' which had rolled on its right side. The engine exhibited extensive fire damage due to the post impact fire but none of its cases exhibited evidence of an un-containment or breach. All four propeller blades were present, attached to the propeller hub, and exhibited rotational scoring on the front surfaces, dents on the leading edges and torn tips.

Figure 4 – Propeller – General View in Hangar

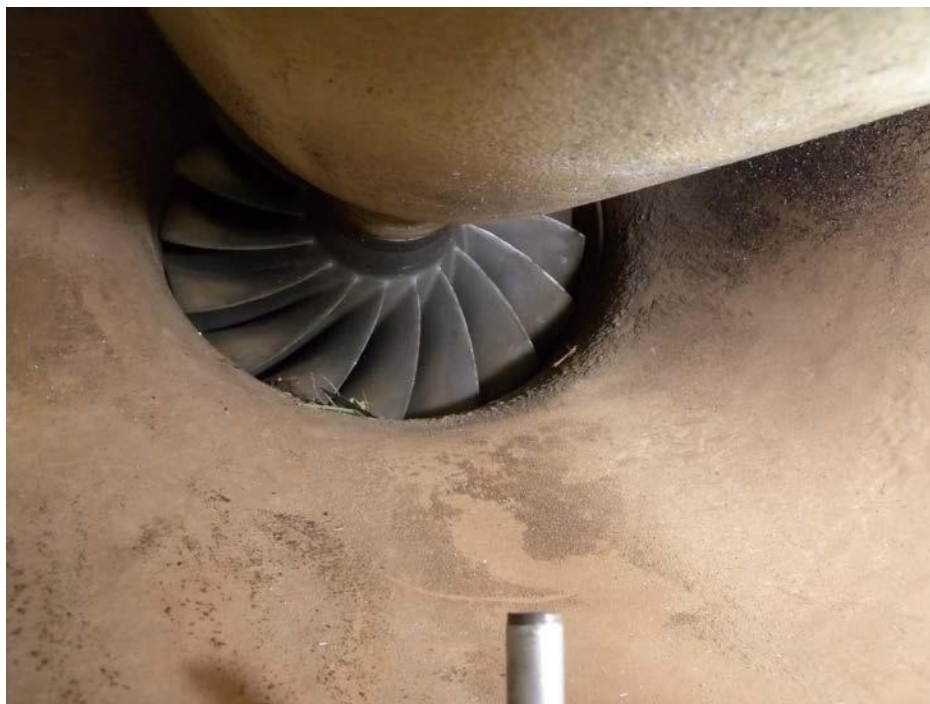
Figure 8 – 1<sup>st</sup> Stage Impeller – Intact

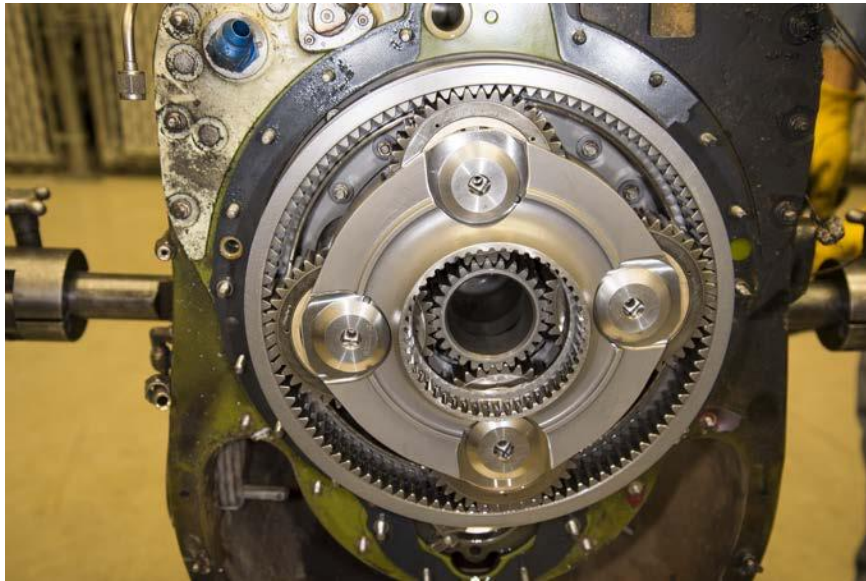
The propeller shaft coupling was intact and undamaged. The planetary gear assembly (Figure 17) was intact and undamaged and all the planet gears were free to rotate.

Figure 17 – Planetary Gear Set – Intact and Undamaged

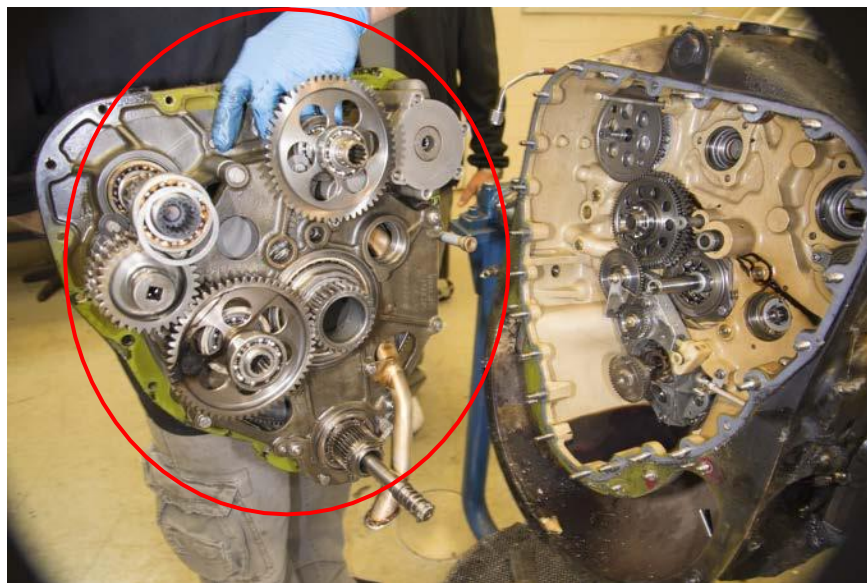
bearings were undamaged (Figure 20). The bull gear and the high-speed pinion assembly rotated, meshed smoothly and were undamaged. No further diaphragm assembly components were disassembled or examined.

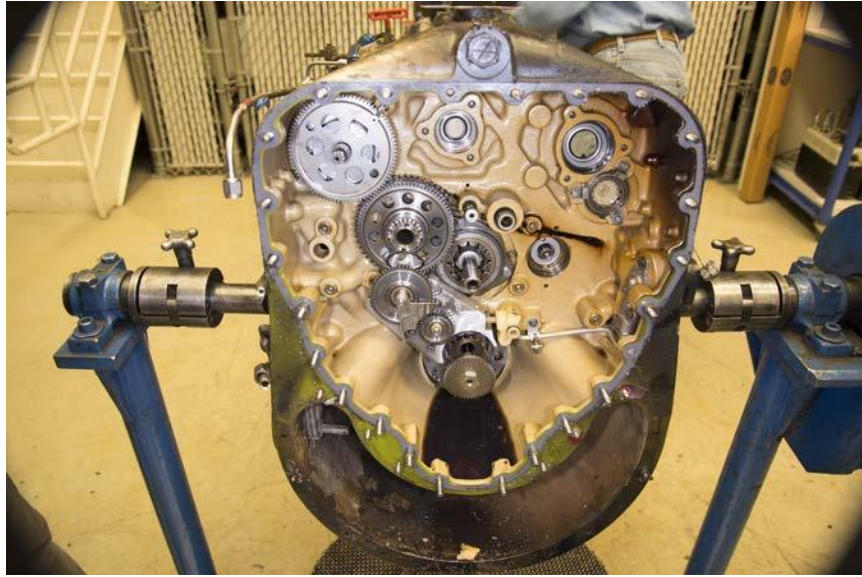
Figure 21 – Gearbox Housing Components

All the components in the gearbox housing were oil wetted (Figure 21). The direct drive fuel control (DDFC) assembly, oil pressure pump, FCU/fuel pump gears and bearings were undamaged. The high-speed pinion and high-speed pinion coupler were undamaged. Rotation of the 3<sup>rd</sup> stage turbine wheel resulted in the corresponding rotation of all the gearbox housing gearset components.

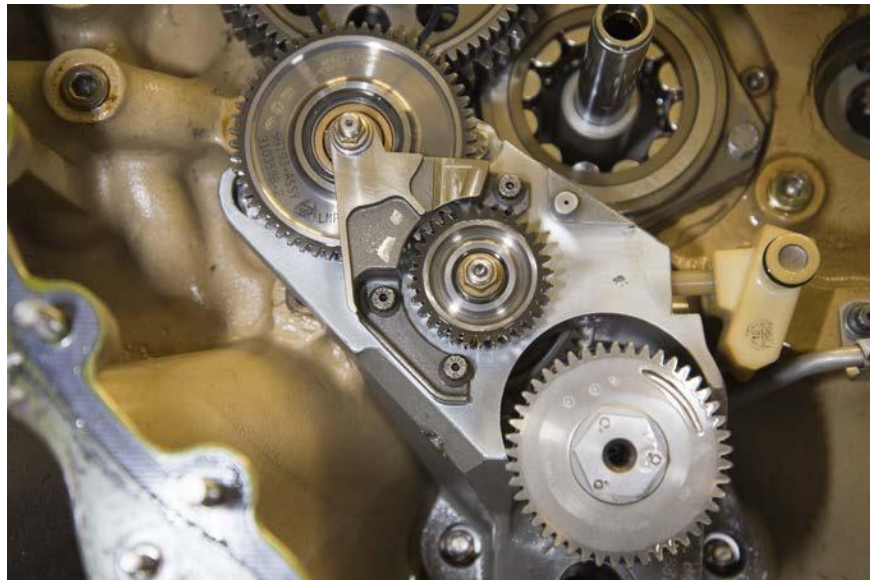
Figure 22 – Torque Sensor

The torque sensor external gears were undamaged (Figure 22). The helical cam gear was easily removed from the torque sensor assembly, revealing an undamaged cam gear mesh. The torque sensor assembly was undamaged. No further diaphragm components were dis-assembled or examined.

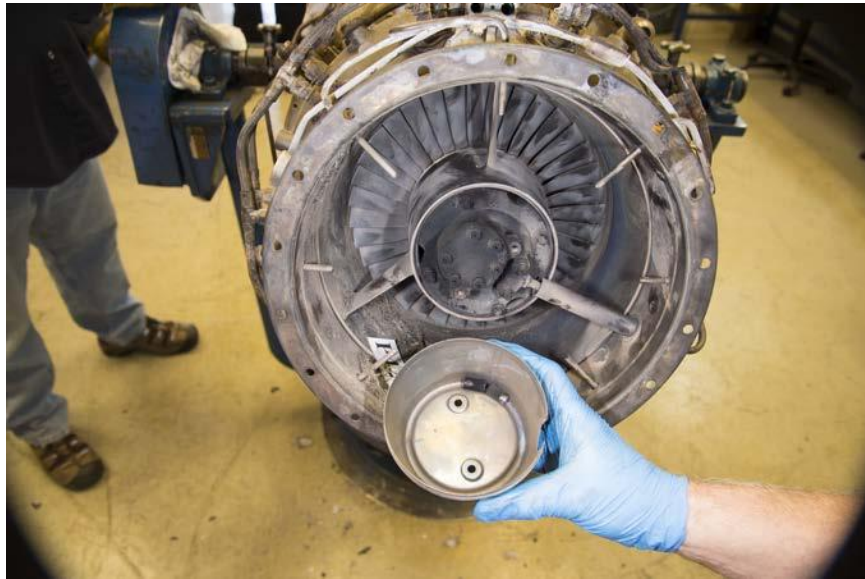
Figure 23 – Rear Turbine Bearing Housing

The rear turbine bearing housing was undamaged and the rear bearing was oil wetted and darkened, consistent with normal operation (Figure 23). The rear oil scavenge pump was removed from the rear bearing turbine housing and was undamaged. The front internal and aft external splines of the torsion shaft were undamaged; however, the torsion shaft itself was sheared just forward of the aft external spline, consistent with a rotating engine sustaining a sudden propeller stoppage (Figure 24).

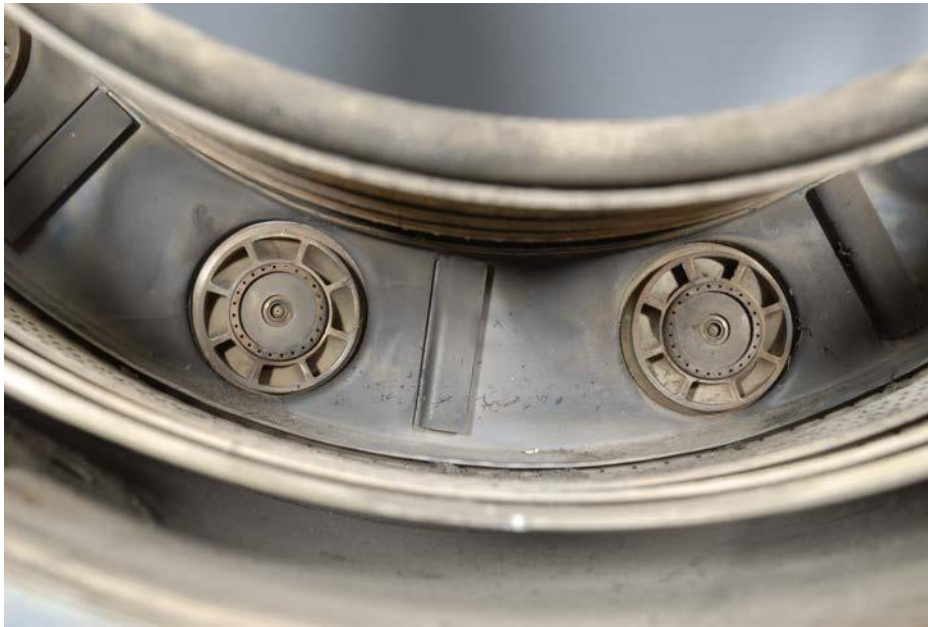
Figure 31 – Fuel Nozzles

The combustor and combustor housing were coated with a light-gray powdery material but were otherwise intact and undamaged (Figure 30). The fuel nozzles were intact and undamaged (Figure 31). The combustor was not further disassembled.

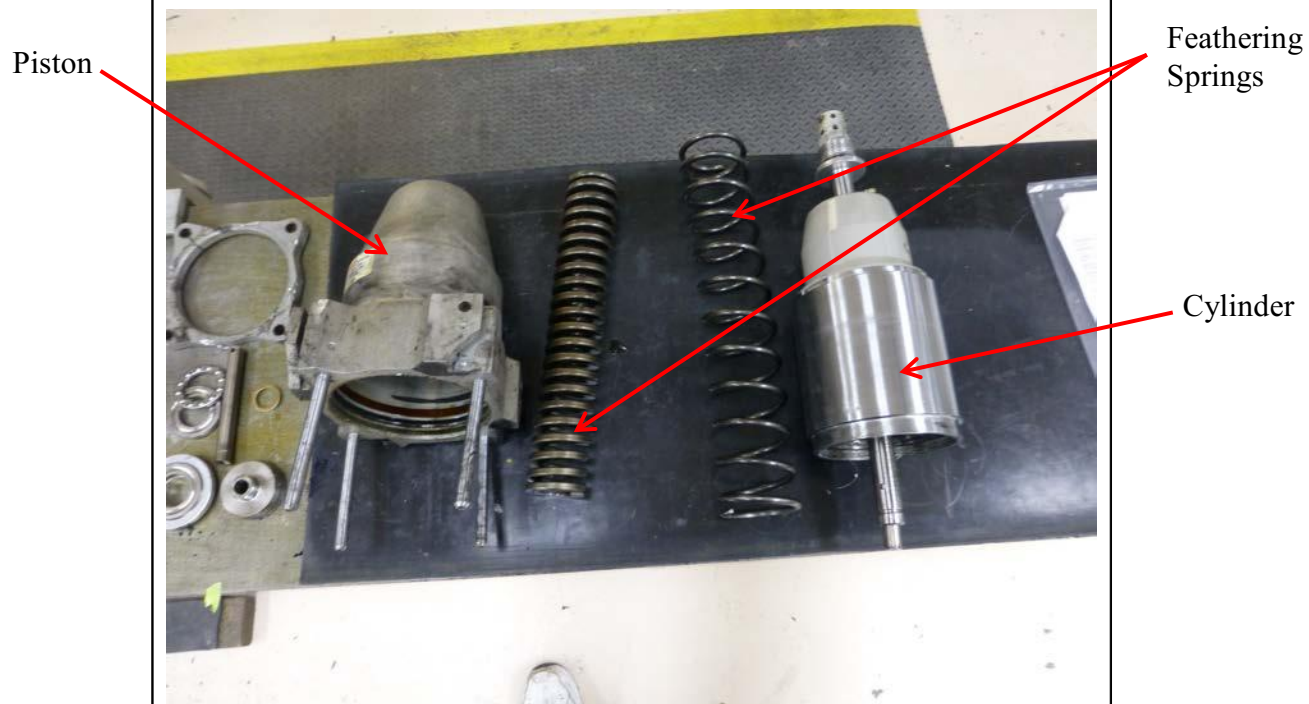
Figure 35– Pitch Change Components – Laid Out on Bench

The piston and cylinder assembly was stripped from the hub thread (Figure 33) and was held in place only by the link arms. Additionally, the cylinder base was fractured near one of the guide rod sleeve holes (Figure 34). The guide rods were intact, however they were bent. The pitch change rod was bent and could not be removed from the piston. The link arms were intact. The feathering spring and guides were intact (Figure 35).
