# American Airlines 1851

## Airbus A321 N564UW

# Walk-Around Inspection

August 16, 2015

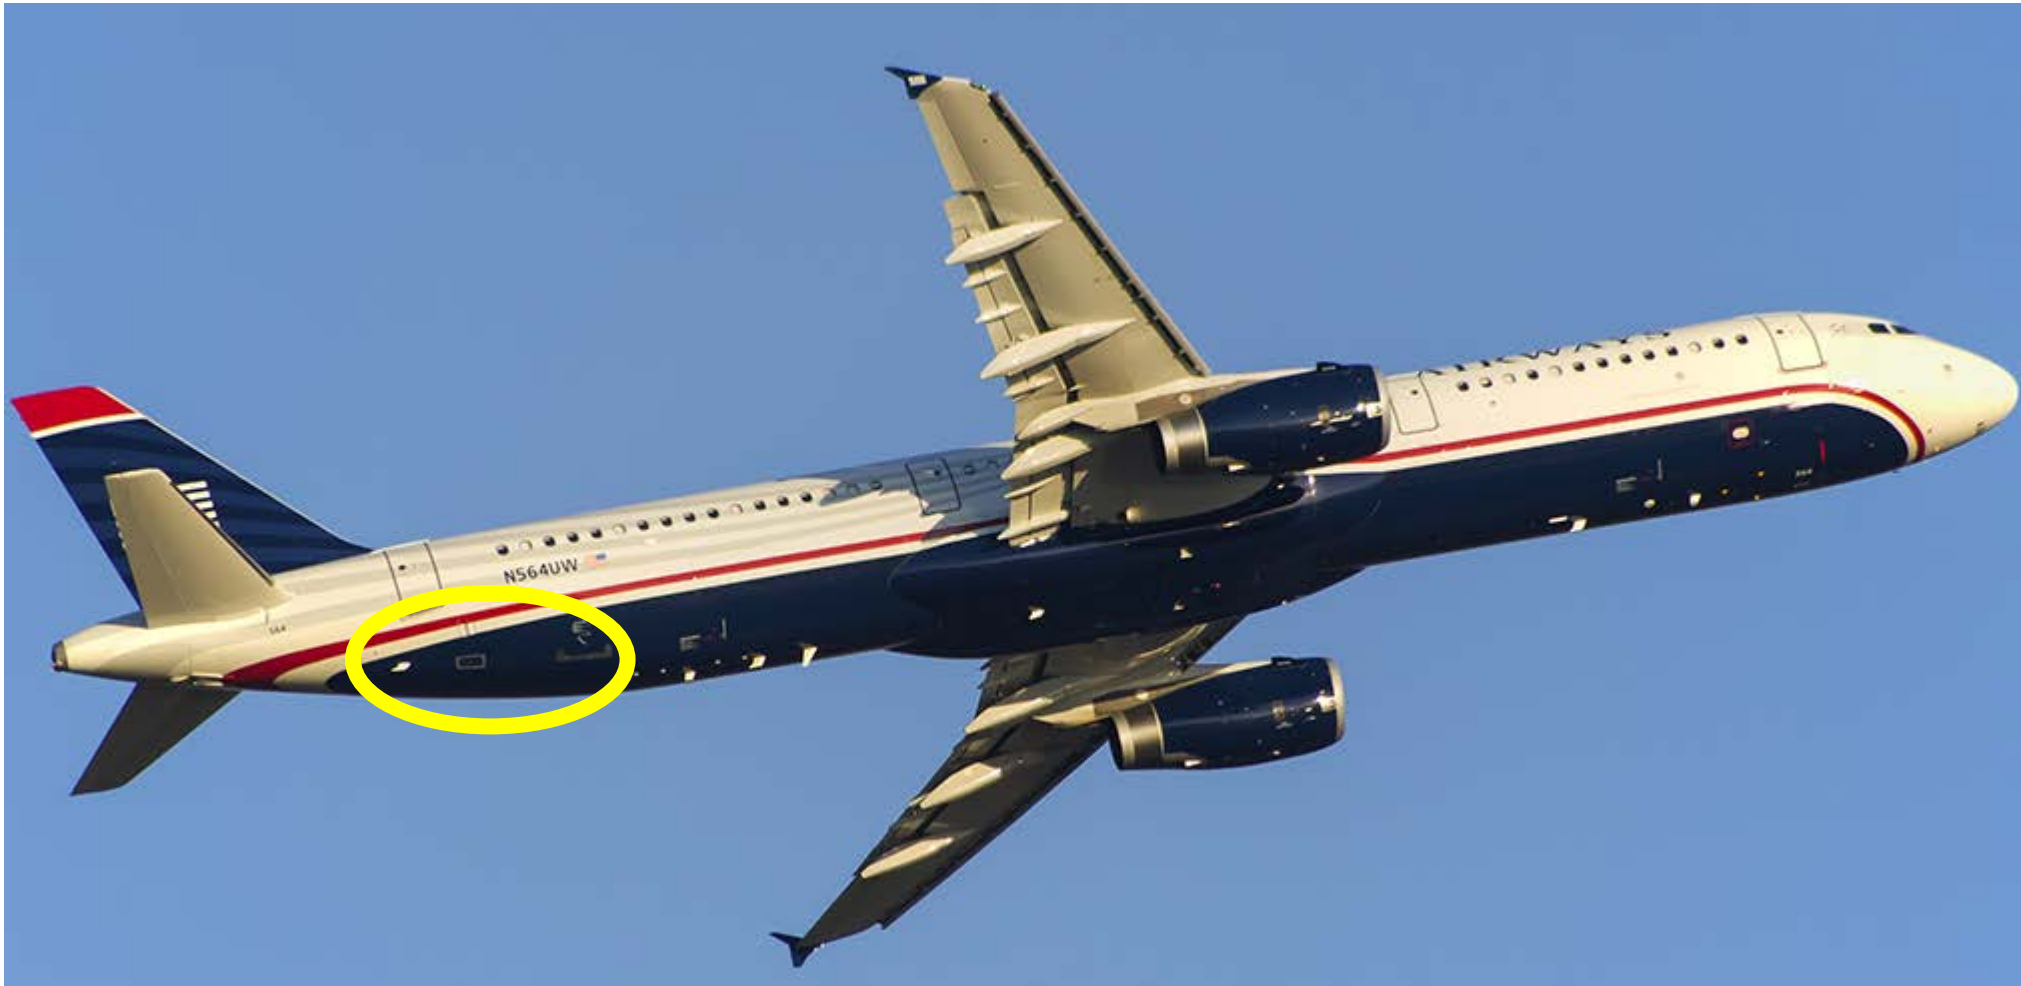
# Damage Area

A walk-around general inspection of American Airlines N564UW found damage isolated to the aft lower section of the fuselage aft of the bulk cargo compartment door as well as damage to the main landing gear tires.

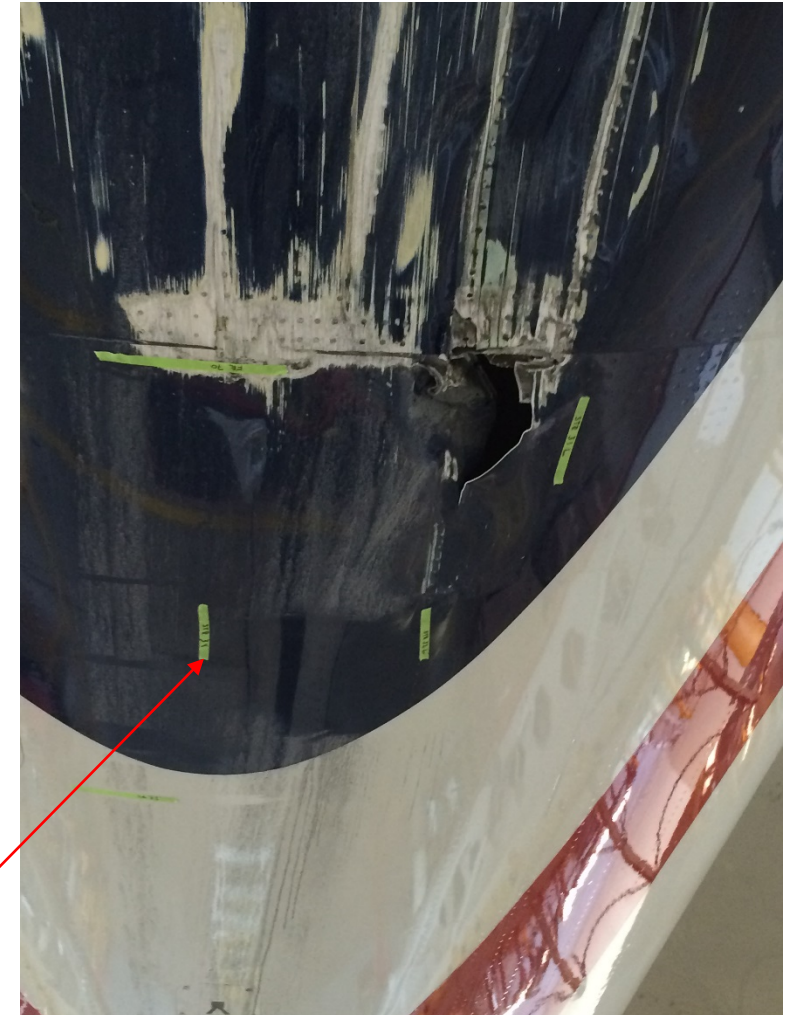
External Damage begins  
at around Frame 70

External Damage  
ends at Frame 22

View looking aft
