# Runway 36L Inspection Data

## American Airlines 1851

Charlotte Douglass International Airport  
Charlotte, North Carolina

August 16, 2015

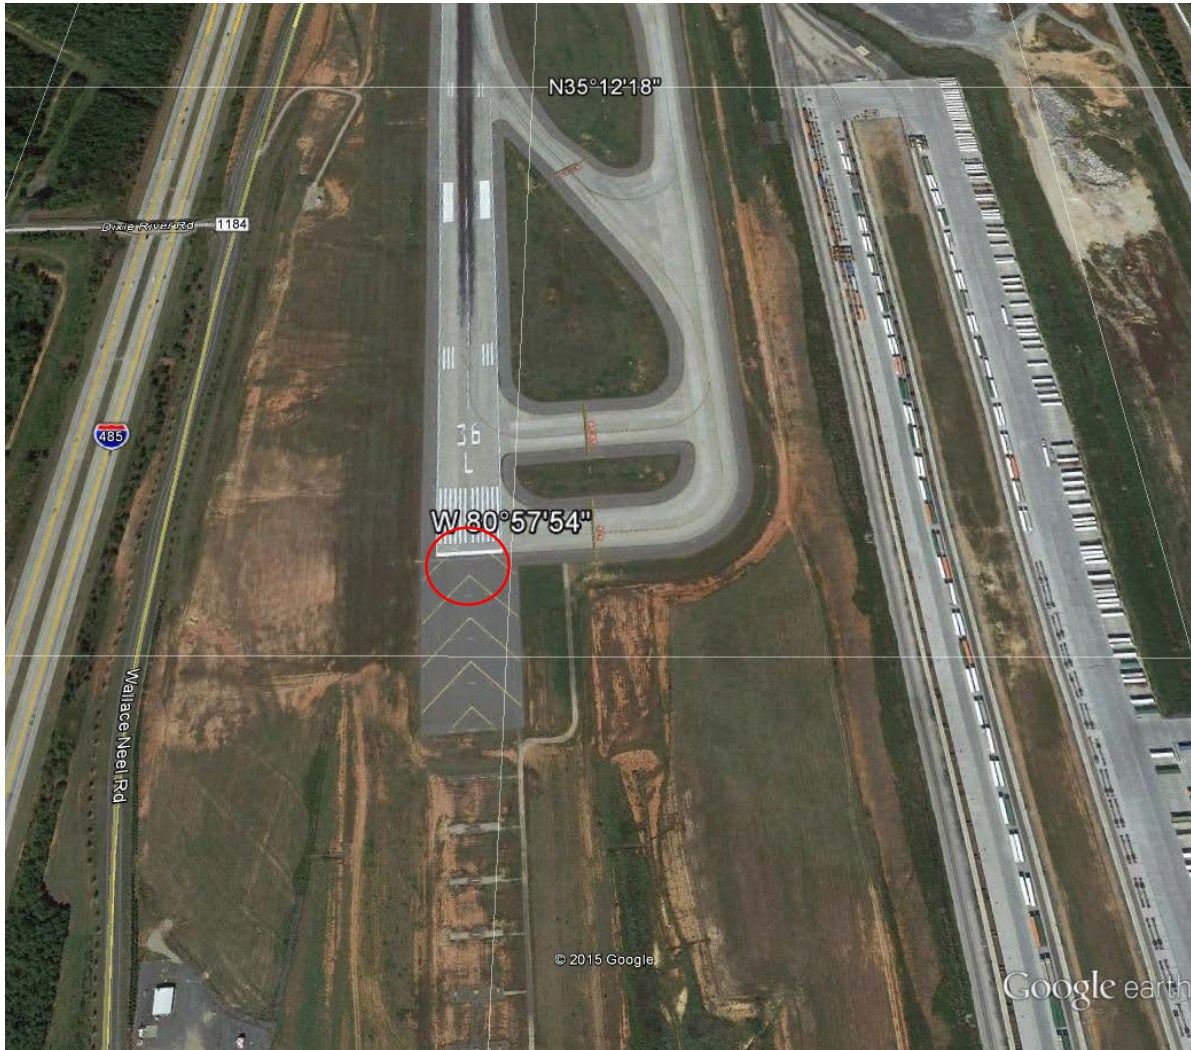
# Area of Runway Inspection – RWY 36L

- **Runway** - Hardsurface concrete 9000'X150' grooved surface
- **Markings:** Good Condition
- **Surface:** Good Condition
- **Under-run** – Asphalt
- **Lighting** – Good Condition
