## **NATIONAL TRANSPORTATION SAFETY BOARD**

### **Factual Report**

# **METEOROLOGY**

DCA17FA076

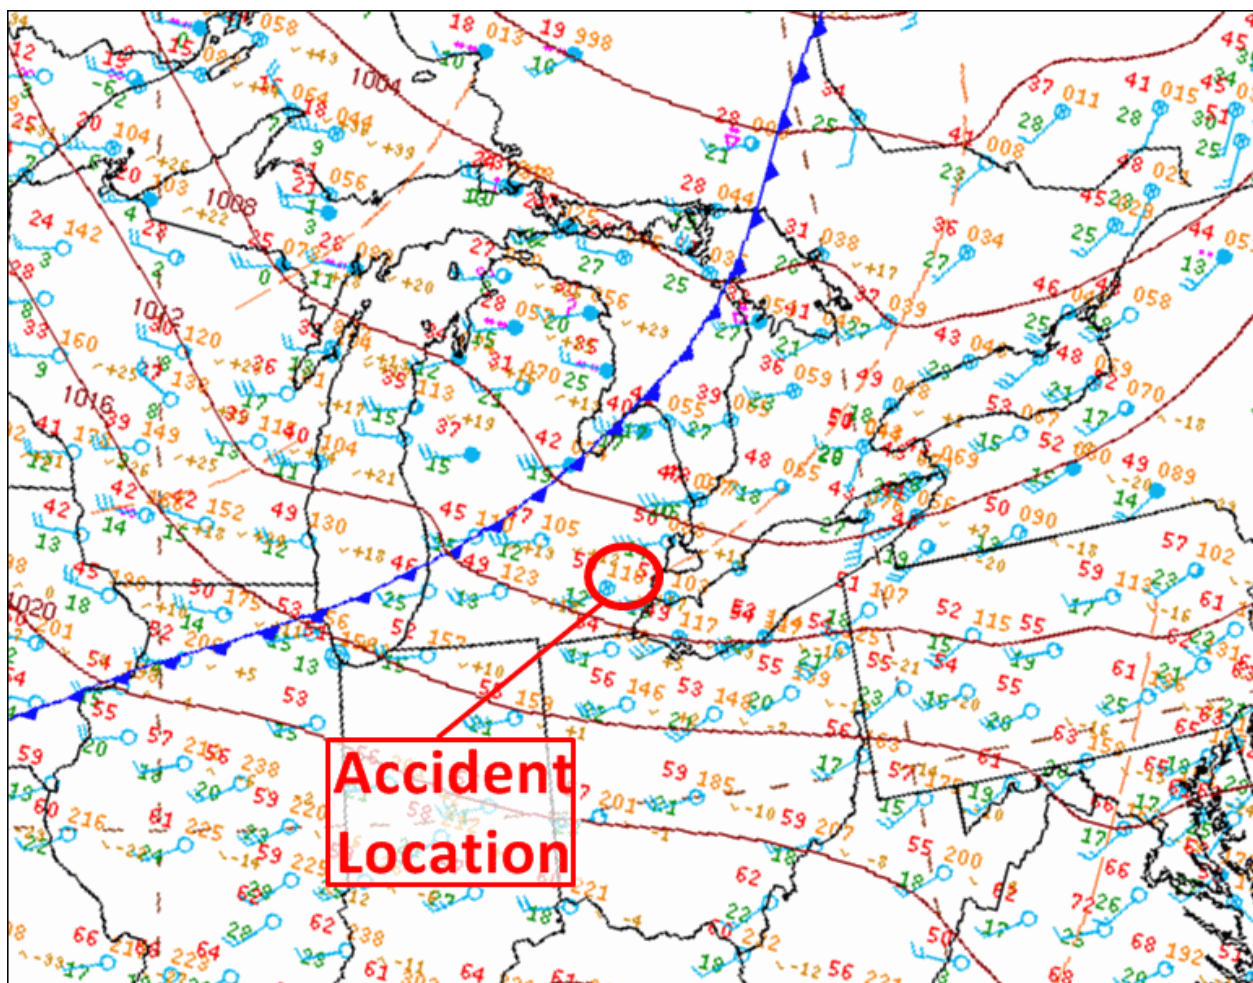
The northcentral portion of the National Weather Service (NWS) Surface Analysis Chart for 1600 EST is presented in figure 1. The surface analysis chart identified a northeast-southwest oriented cold front over central lower Michigan that was advancing southeast.<sup>2</sup> A trough<sup>3</sup> extended southwest from Ontario, Canada, into the accident region. Temperatures ahead of the cold front in Michigan, northern Ohio and northern Indiana were generally in the 50's Fahrenheit (F), with temperatures behind the cold front in northern lower Michigan in the high 20's F to mid-40's F. Winds ahead of the cold front across lower Michigan, northern Ohio and northern Indiana were generally from the west or west-southwest, with many station models depicting winds magnitudes at or above 25 knots.

**Figure 1** - NWS Surface Analysis Chart for 1600 EST.

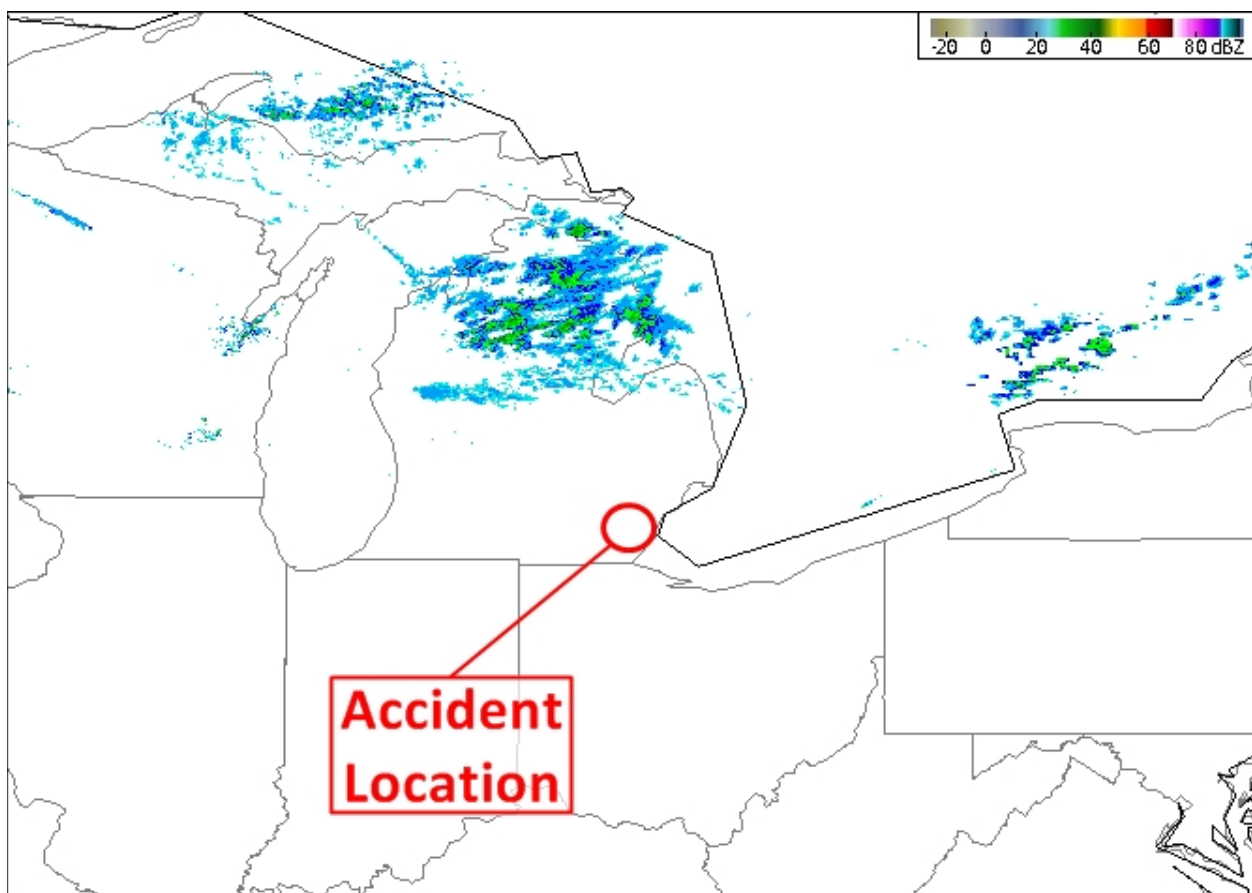
A WSR-88D regional radar composite reflectivity mosaic obtained from the National Centers for Environmental Information (NCEI) for 1445 EST (figure 2) did not depict any echoes across the accident region.

**Figure 2** – NCEI WSR-88D mosaic from 1455 EST.

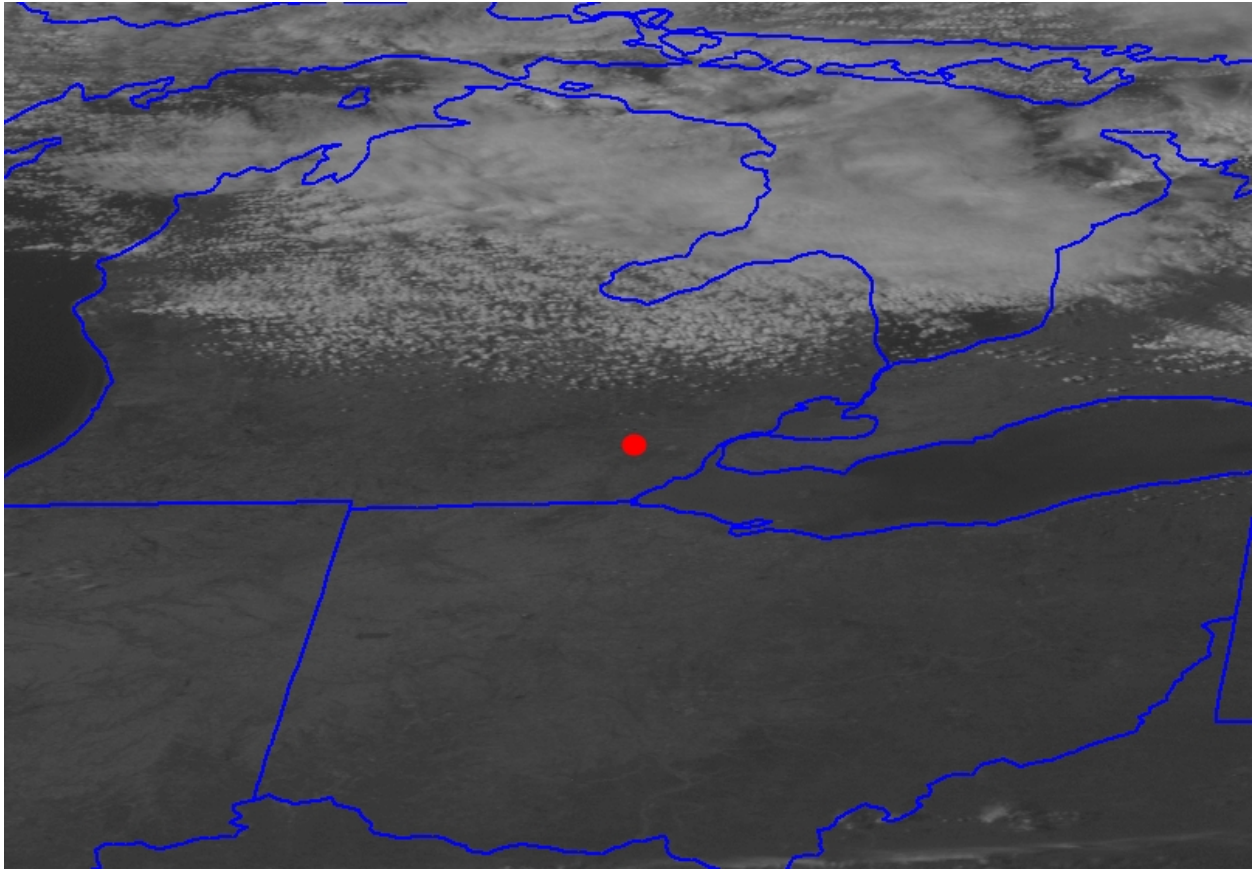
Geostationary Operational Environmental Satellite (GOES)-13 visible ( $0.63\mu\text{m}$ ) data were obtained from an archive at the Space Science Engineering Center at the University of Wisconsin-Madison. Imagery from 1445 EST is presented in figure 3. No clouds were identified over the accident site at the accident time.

**Figure 3** – GOES-13 0.63  $\mu\text{m}$  (visible) imagery from 1445 EST. Red dot denotes accident location. Image is not corrected for any parallax error.

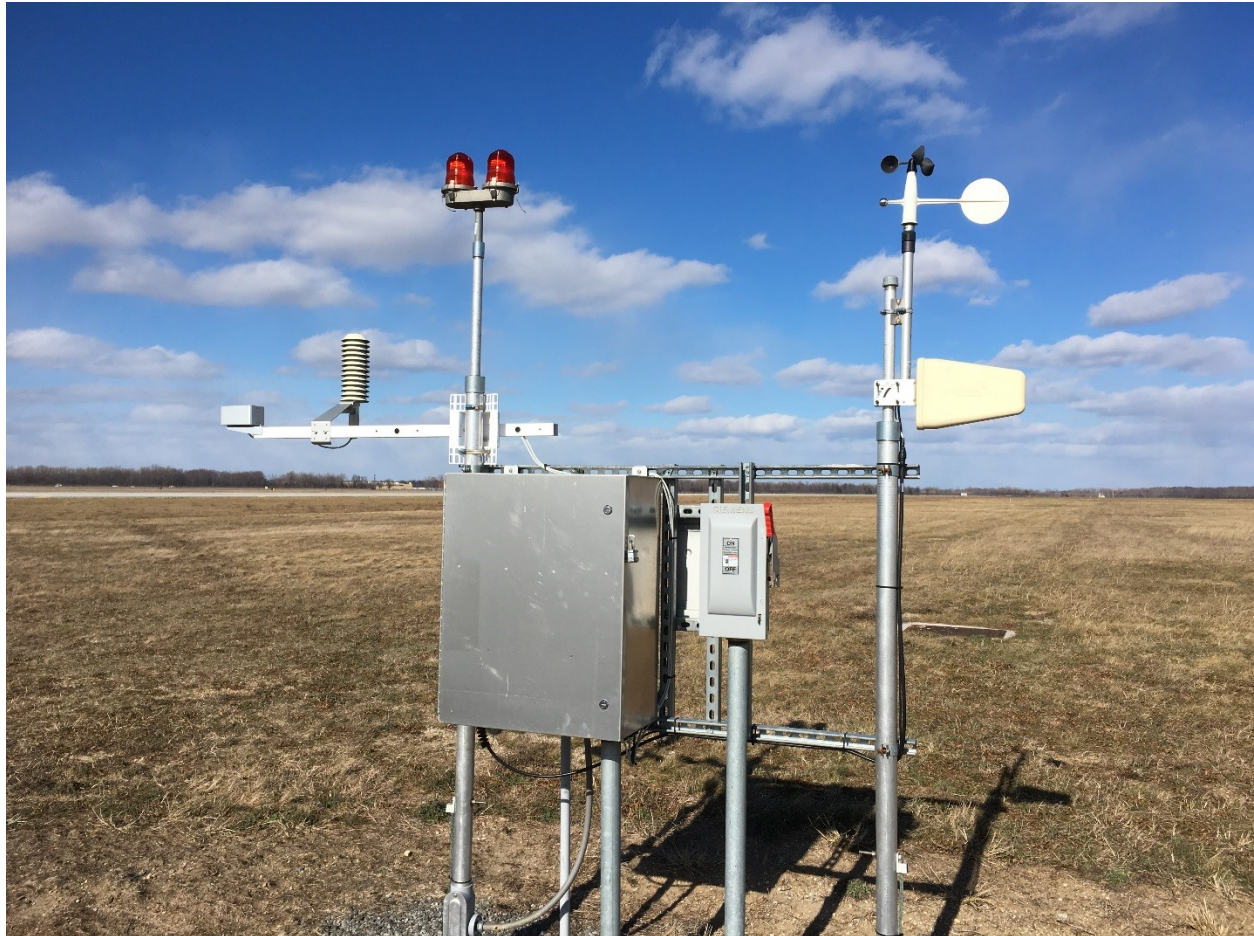
**Figure 5 – YIP RWIS 5R/TD RPU.**

The Wayne County Airport Authority owned and operated several Vaisala Pavement Runway Weather Information System (RWIS) at YIP that recorded measurements of runway surface temperature. One of the Remote Processing Units (RPU) for these sensors, which was located near the touchdown zone for runway 5R (5R/TD; see figures 5 and 7), contained a suite of atmospheric sensors that observed various parameters including air temperature, wind speed and wind direction (anemometer height was 9-10 feet agl). These sensors continued to record data after power to the ASOS DCP was lost. According to the airport authority, “design plans confirm RPU power is fed from [the] FAA transformer at [the] 5R glide slope shelter.” Data from these sensors were not publicly available, and according to the airport authority these data were “collected from the pavement sensors and RPUs and transmitted to the Vaisala website. The site is customized to our airport and is login protected. Only the [Airport Operations/Security Manager], the Airport Director and Maintenance Manager have log-ins.”

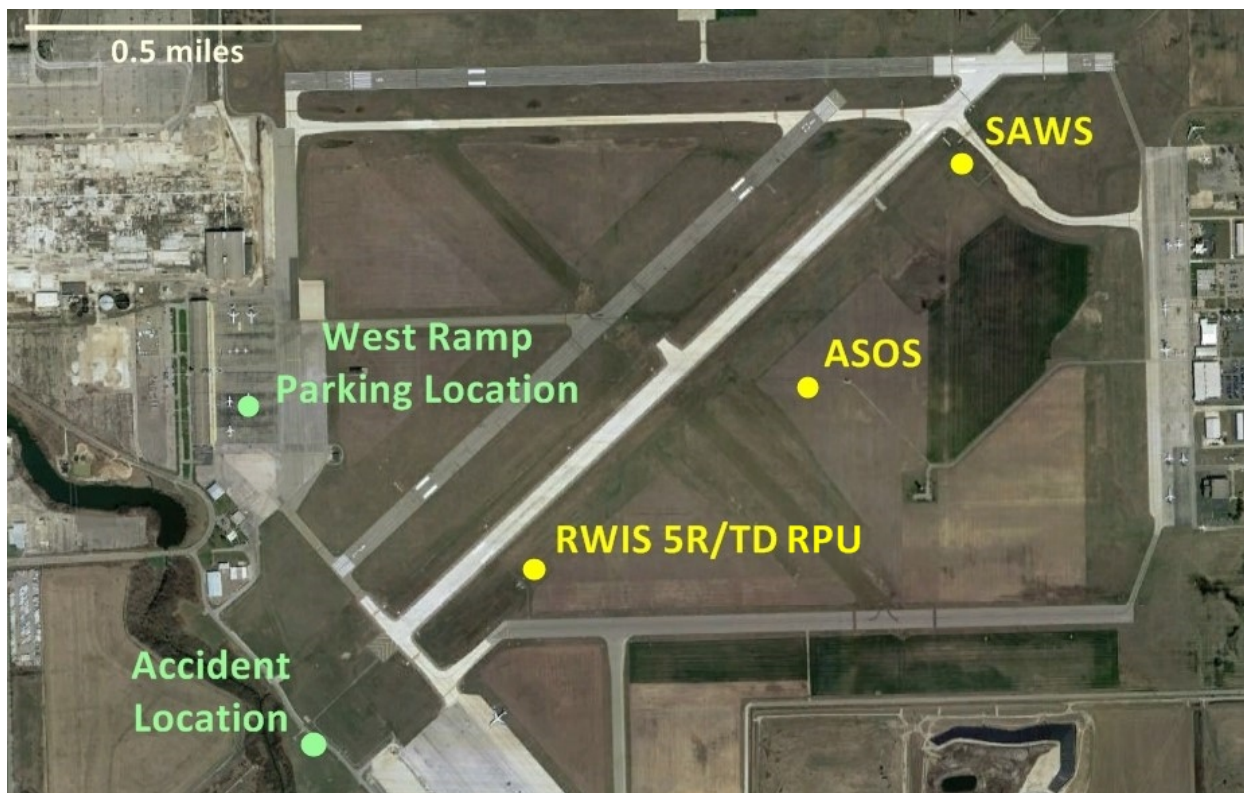
There was an FAA-owned and operated Stand Alone Weather Station (SAWS) operating at YIP on the accident day (see figures 6 and 7). The SAWS sensor suite includes an anemometer and provided “backup” weather information to the ASOS. The YIP anemometer pole height is 35 feet agl. Realtime data from the SAWS are sent to the air traffic control tower via ultra-high frequency radio link, however these data are not archived. According to the FAA, no formal archiving of SAWS data exist across the national airspace system. According to the FAA (see Attachment 6), the YIP SAWS went out of service at 1138 EST on March 8, 2017, due to a “power outage caused by high winds.” The YIP SAWS had no backup source of power.

**Figure 7** – Map of YIP surface observation stations along with accident location and accident aircraft's parked location on the west ramp prior to the accident.

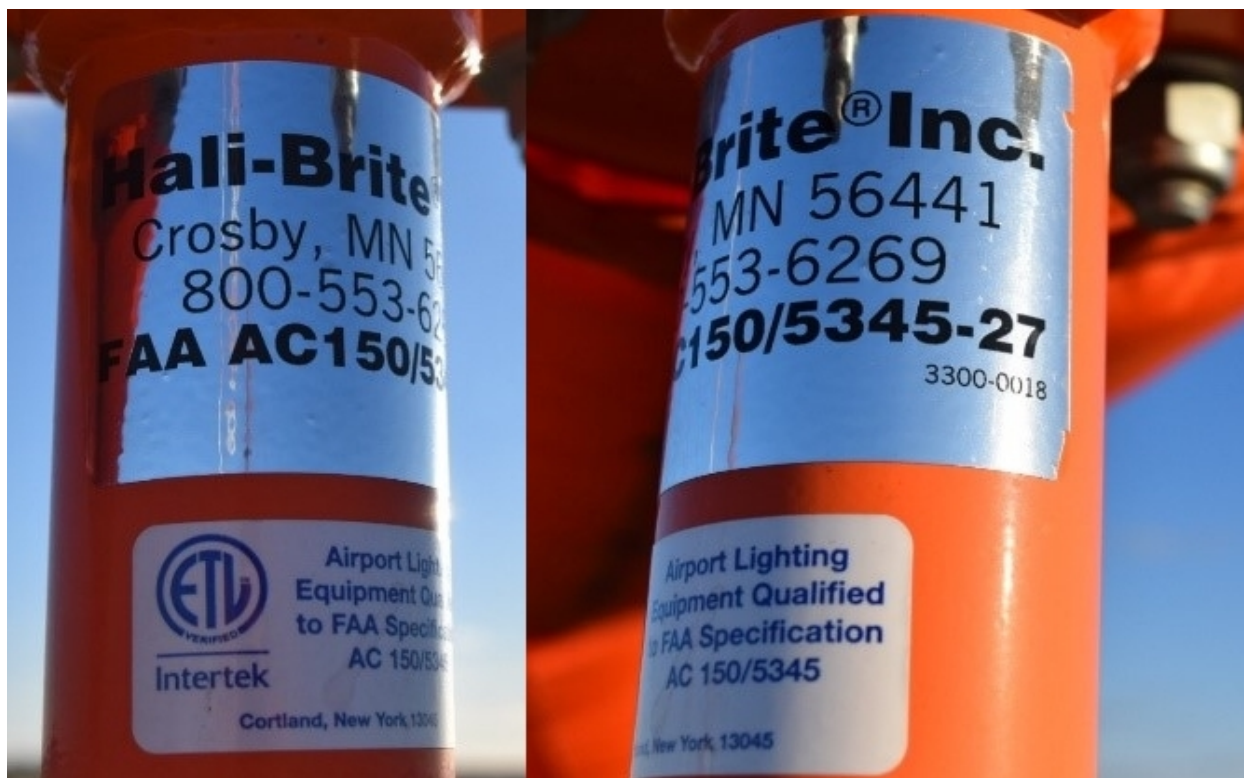
**Figure 9** – Manufacturer’s stickers located on the YIP Runway 23L Approach supplemental windsock pole.

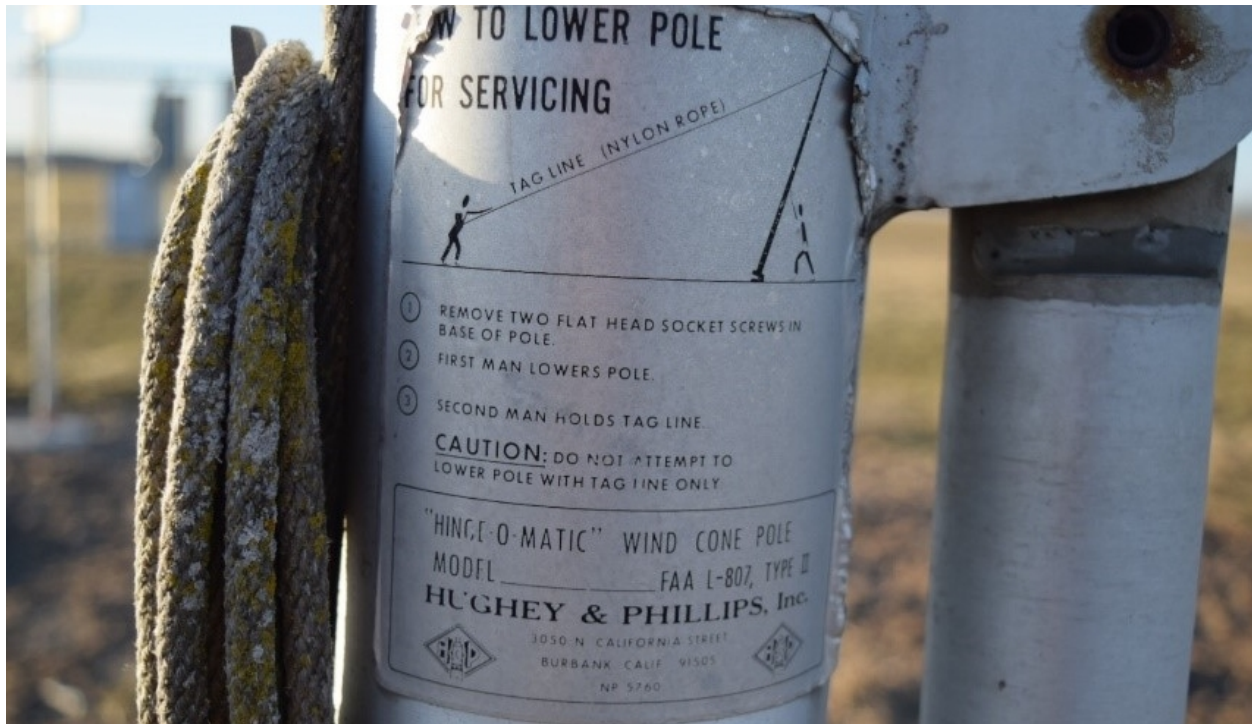
With regard to the midfield windsock (see figures 10 and 11), according to the airport authority, “...windsocks are universal and used on all of our windcones. They are FAA certified...”

**Figure 11** – Manufacturer's stickers located on the YIP Runway 5R/23L Midfield primary windosck pole.

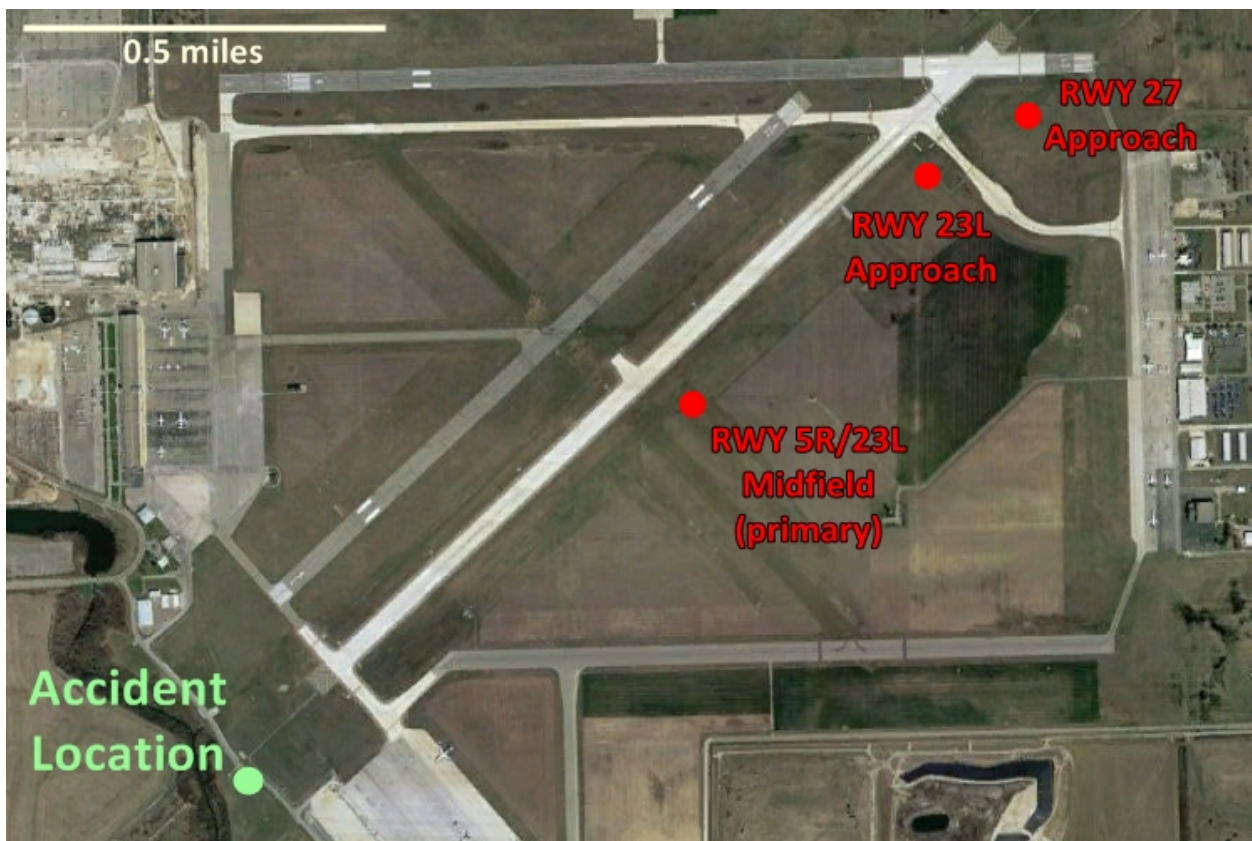
Figure 12 provides the locations of windsocks<sup>15</sup> closest to the accident aircraft during its taxi and departure roll on runway 23L immediately prior to the accident, which include the midfield “primary” windsock and two “supplemental” windsocks. Figure 9 identifies the runway 23L

**Figure 12** – Map of YIP windcones discussed in this section along with the accident location.
