----- **SYSTEMS GROUP CHAIRMAN'S FACTUAL REPORT** -----

**1 ACCIDENT:**

Location: Willow Run Airport, Ypsilanti, Michigan  
Date: March 8, 2017  
Time: about 1452 EST  
Aircraft: Boeing MD-83  
Serial Number: 53123  
Registration: N786TW

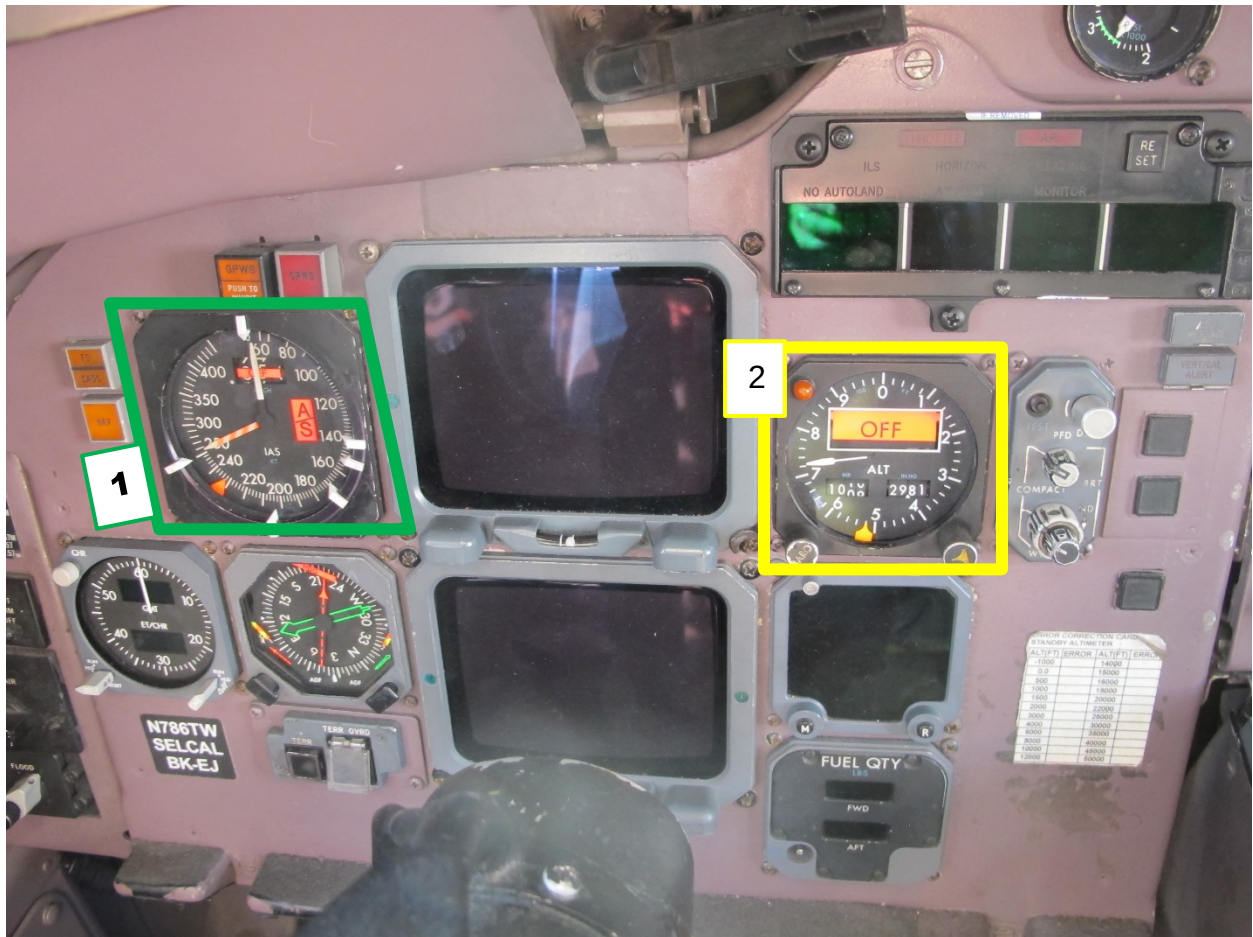
**Figure 2 – Captain's Instrument Panel**

The Captain's altimeter (area 2 in yellow box, Figure 2), was reading of approximately 722 feet and the Kollsman window<sup>1</sup> was set to 29.81 inHg.

The Captain's airspeed indicator (area 1 in green box, Figure 2), was reading 0 knots and the various white bugs were positioned on the airspeed scale at: 136, 148, 162, 198, 249 knots IAS.

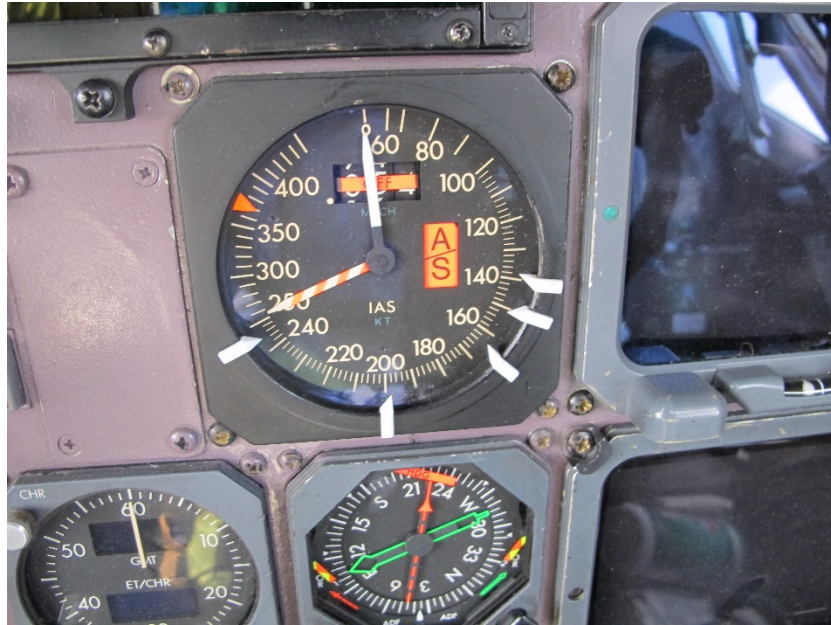
**Figure 3 – First Officer's Airspeed Indicator**

The First Officer's altimeter was reading of approximately 470 feet and the Kollsman window setting was 29.81 inHg.

The First Officer's airspeed indicator (Figure 3), was reading 0 knots and the various white bugs were positioned on the airspeed scale at: 138, 152, 164, 198, 245 knots IAS.

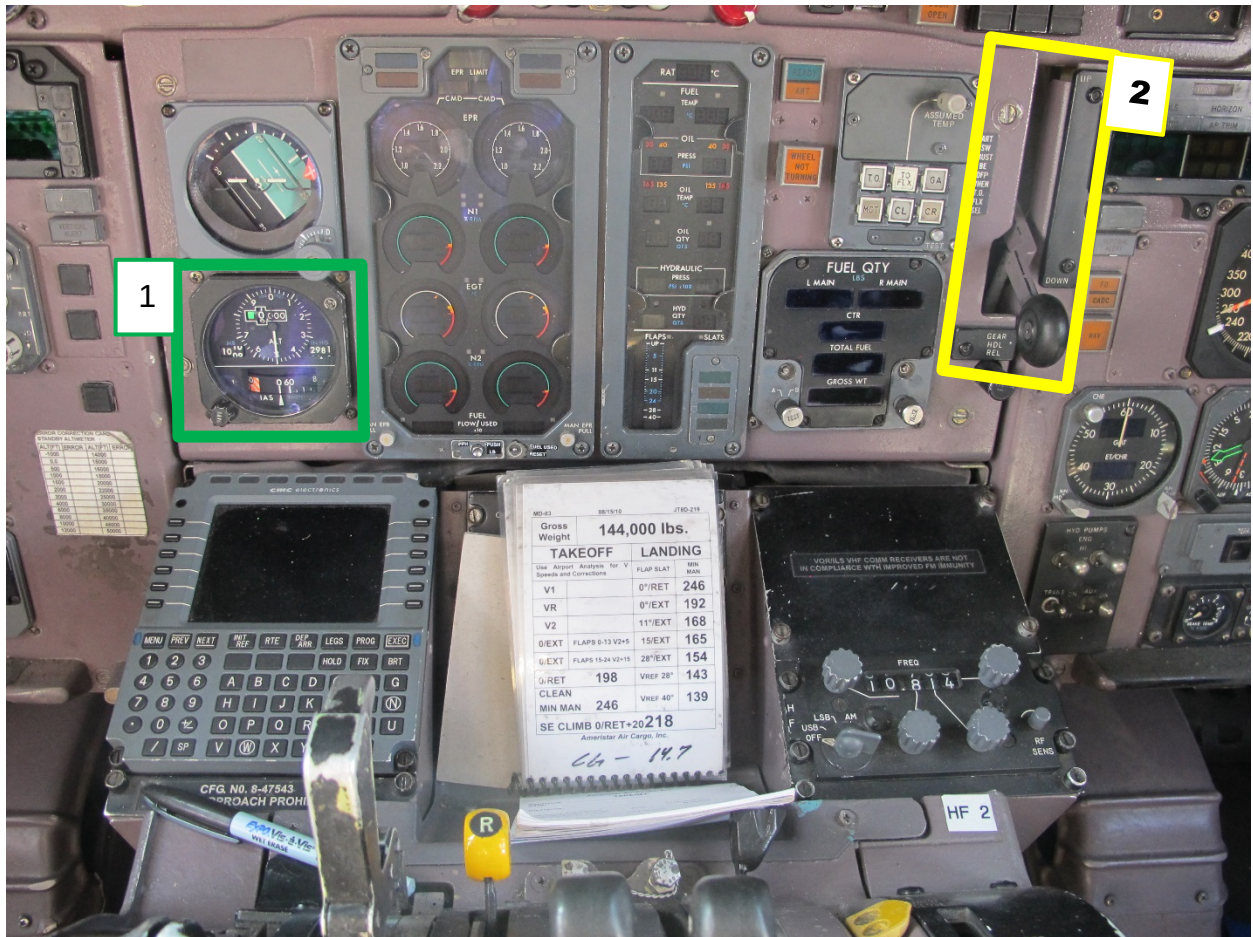
**Figure 4 – Center Instrument Panel and upper portion of the control pedestal**

The standby altimeter/airspeed indicator (area 1 in green box, Figure 4), was reading of approximately 500 feet and the Kollsman window was set to 29.81 inHg. The airspeed indicator reading was 0 knots.

The landing gear handle (area 2 in yellow box, Figure 4), was found in the DOWN position.

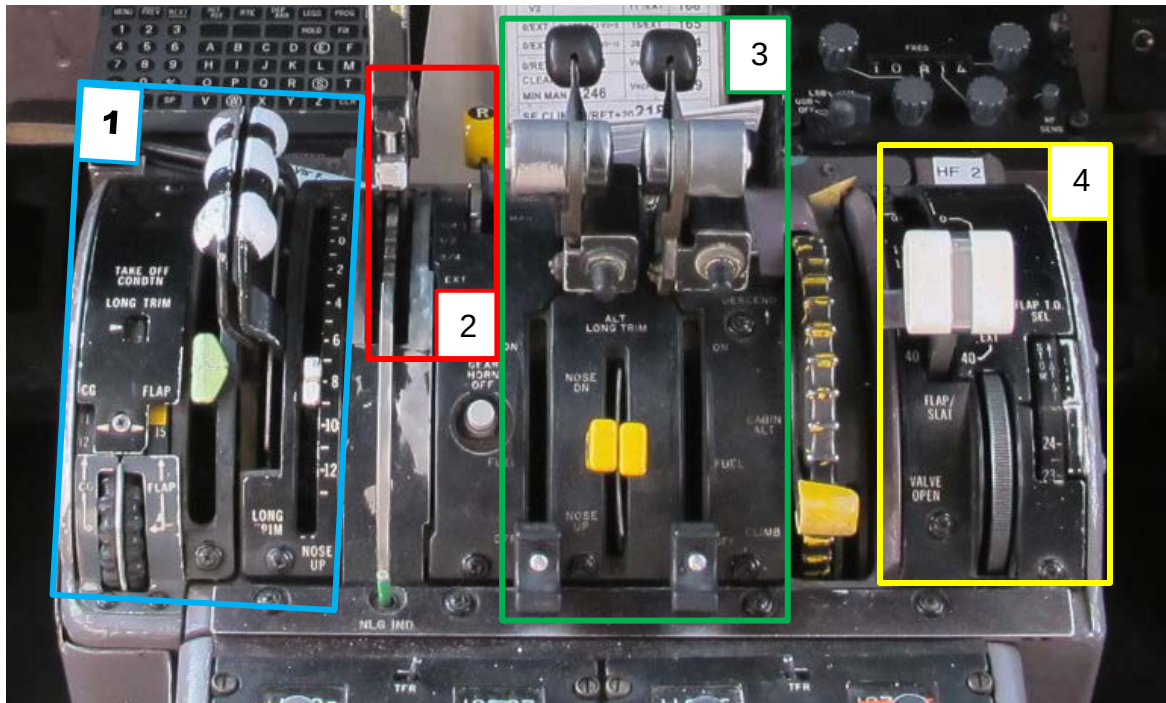
**Figure 5 – Control Pedestal section with engine controls.**

Refer to Figure 5, area 1 in the blue box for the takeoff condition computer and longitudinal trim handles/setting.

The takeoff condition computer, labelled “TAKE OFF CONDTN”, is located on the left-hand side of the control pedestal next to the longitudinal trim control handles. The “CG” setting was found approximately halfway between 11 and 12 and the “FLAP” setting was 15. The reading for “LONG TRIM” was approximately halfway between 7 and 8. The “Long Trim” Position setting was at 8, Aircraft Nose Up.

Refer to Figure 5, area 2 in the red box for the speedbrake/ground spoiler and rudder hydraulic shutoff valve controls.

The speedbrake/ground spoilers are controlled by the speedbrake control lever mounted on the control pedestal and labeled, “SPD BRK”. The speedbrake lever was found in the “RET” position.

The rudder hydraulic shutoff valve is controlled by a lever mounted on the control pedestal in between the speedbrake control lever and the engine controls and labeled, “RUD HYD CONT”. The lever was found in the “PWR” position.

Refer to Figure 5, area 3 in the green box for the engine, fuel and alternative longitudinal trim controls.

The engine throttles were found full aft in the idle stop position and the thrust reverser levers were found stowed. Both the left and right fuel control levers were found in the “OFF” position.

The slat/flap control handle is located on the right-hand side of the control pedestal next to the cabin pressure control wheel. The handle had detents at the 0, 11, 15, 28 and 40 positions. The flap/slat handle was found in the 40 detent. Refer to Figure 5, area 4 in the yellow box for the flap control handle.

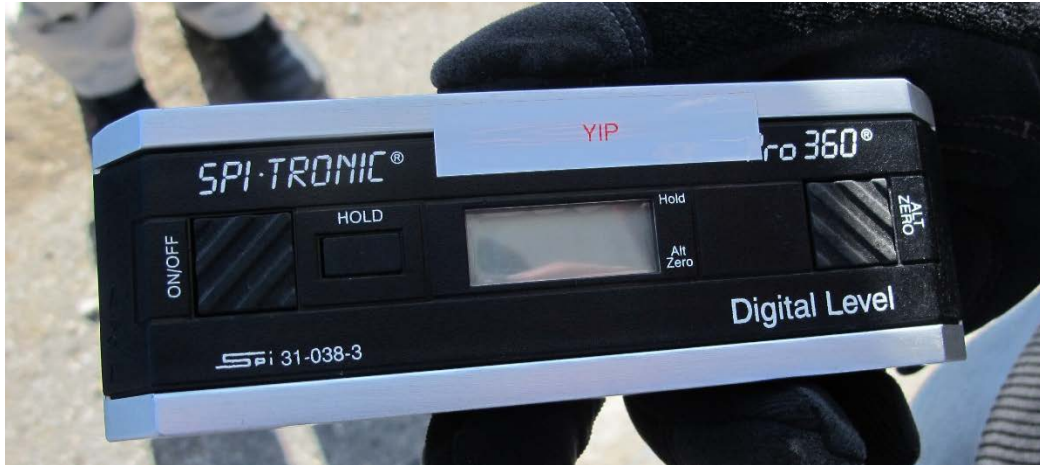
**Figure 19 - Digital inclinometer used for travel checks**

The total quantity of control tab travel specified in the AMM is  $42^{\circ}$  to  $50^{\circ}$ .<sup>3</sup> The total travel measured for the right elevator control tab was  $44.2^{\circ}$  ( $25.2^{\circ}$  TED and  $19.0^{\circ}$  TEU). The total travel measured for the left elevator control tab was  $45.9^{\circ}$  ( $25.9^{\circ}$  TED and  $20.0^{\circ}$  TEU).

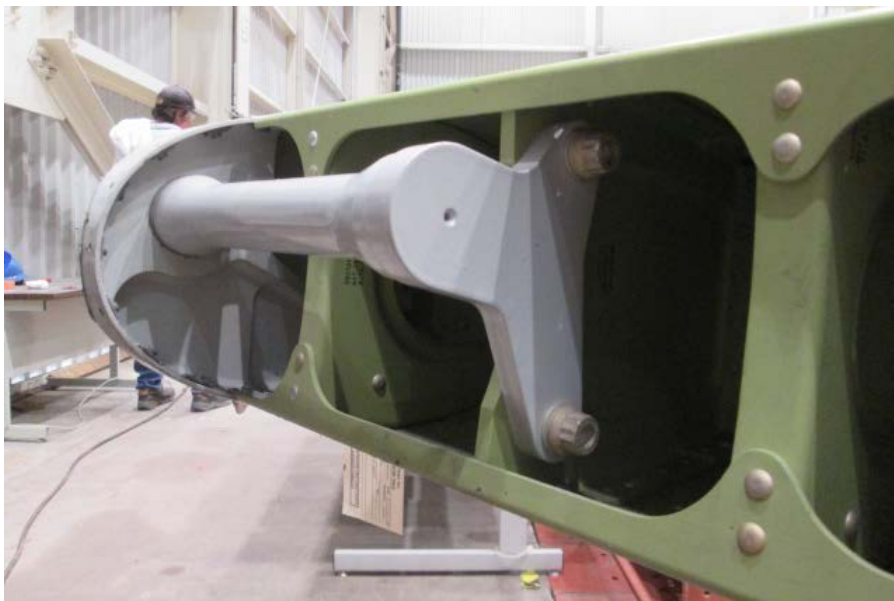
**Figure 24 - Torsion bar installation on LH elevator**

The elevator nose cap was removed to allow for inspection of the torsion bar, Figure 24. No signs of visible damage to the torsion bar was noted. The torque stripes on the mounting hardware were present and showed no signs of displacement.

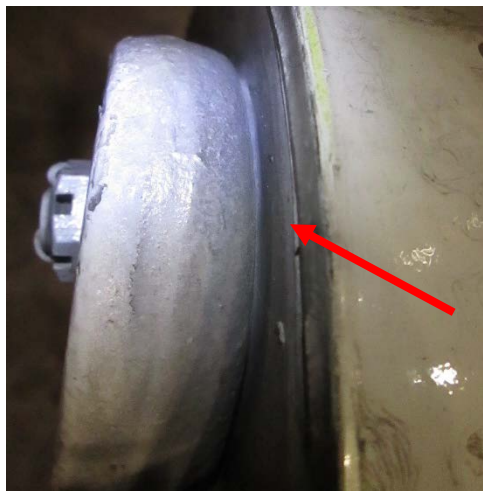
**Figure 27 - Sealant between the RH elevator stop arm and closeout rib (noted by red arrow).**

A visual inspection was conducted of the stop arm and the sealant that is located between the stop arm and the closeout rib. No visible sealant cracking, similar to what was present on the left elevator was found, Figure 27.

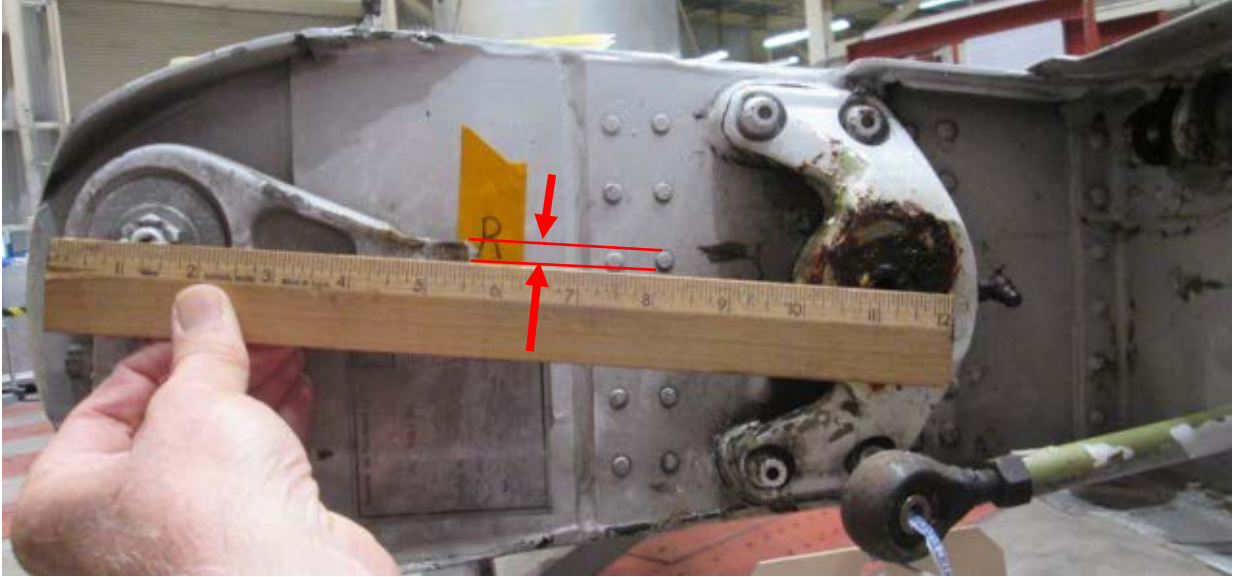
**Figure 28 - Alignment check of the RH stop arm with respect to the elevator hinge point**

A measurement was taken from the straight edge to the upper surface of the stop arm, Figure 28. For the right elevator the measurement was approximately 0.30 inches. The measurement was consistent with the manufacturer's drawing.

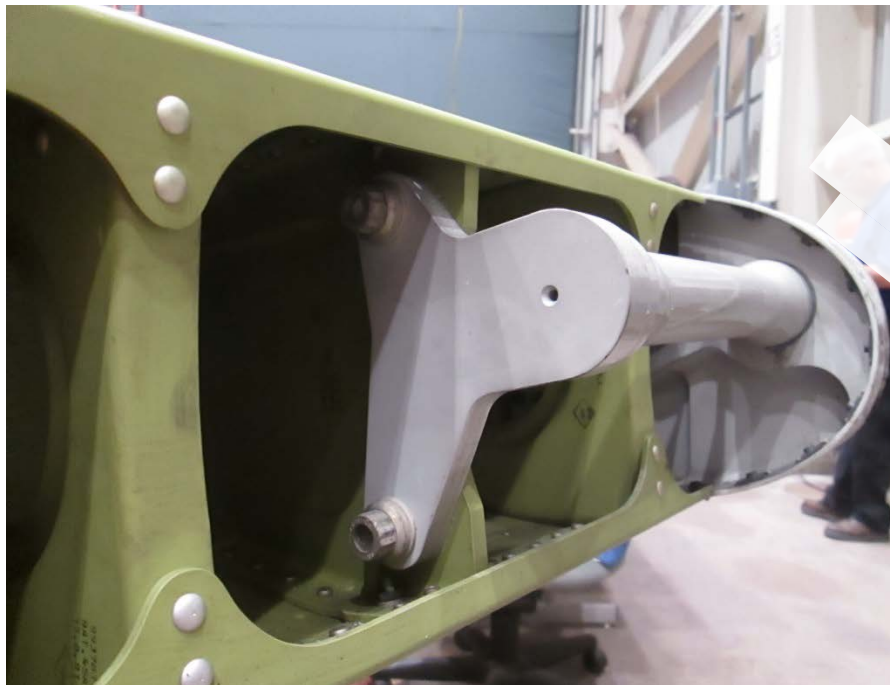
**Figure 31 – Torsion bar installation on RH Elevator**

The elevator nose cap was removed and no signs of visible damage to the torsion bar was noted, Figure 31. The torque stripes on the mounting hardware were present and showed no signs of displacement. After the mounting bolts were removed, a large wrench was placed on the torsion bar mounting plate, the torsion bar could be easily rotated and removed. The bushing between the torsion bar and the closeout rib remained attached to the torsion bar after removal from the elevator.

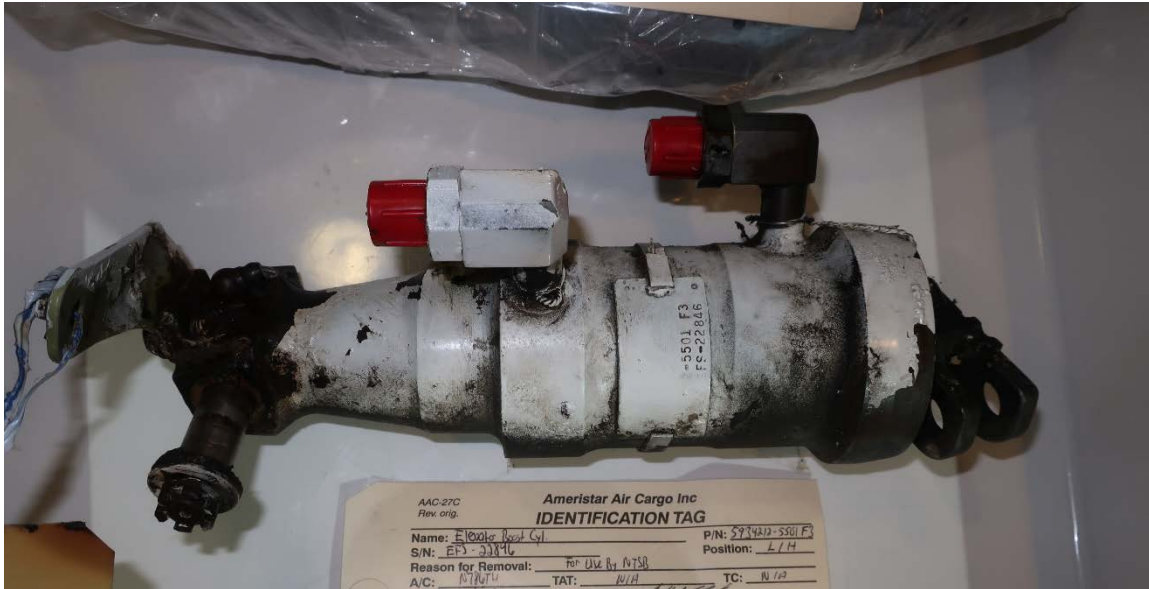
**Figure 38 - LH Elevator boost cylinder prior to bench testing**

The accident aircraft boost cylinders were visually inspected, Figure 38 and Figure 39. No defects were noted in either visual inspection. Prior to the testing, the u-joints on each cylinder were removed to allow for installation in the test fixture.

The overhaul facility performed a functional test of each boost cylinder using their procedure which is based on the component's overhaul manual. The left cylinder passed all tests that were performed. The right cylinder passed all tests except for the relief valve reseal test. The reseal test required a minimum reseal pressure of 2,050 psi and the unit tested at 1,950 psi. The test was repeated an additional three times with results of 1,950 psi, 1,950 psi and 2,000 psi). Test results for both cylinders are included in Attachment 1.

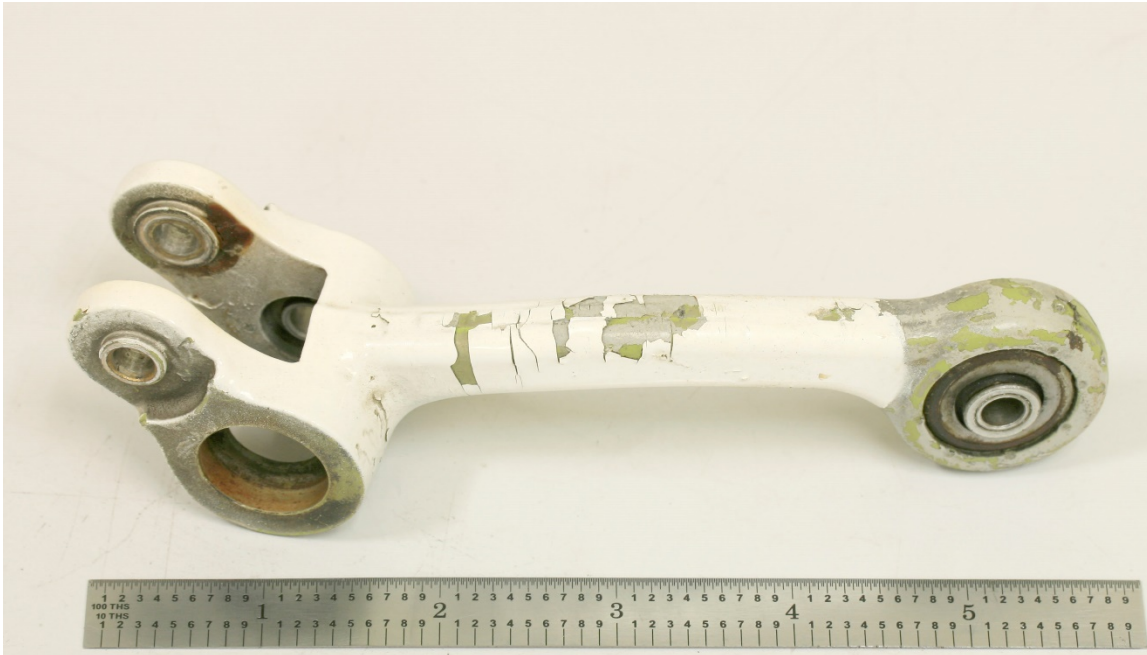
**Figure 40 - Actuating crank prior to hardness and conductivity testing**

The damaged actuating crank and links were inspected by the Boeing Materials Laboratory in Huntington Beach, CA. Two tests, Rockwell Hardness and Conductivity were conducted to check the characteristics of the material of the actuating crank, Figure 40. Only the Rockwell Hardness was conducted to check the characteristics of the material of the links, Figure 41. Each test was conducted using approved Boeing material lab processes. The parts were cleaned, and exterior paint was removed prior to conducting the tests. The test and inspection results were compared to the part requirements stated on the manufacturer's engineering drawings. The parts were consistent with the manufacturer's drawings.

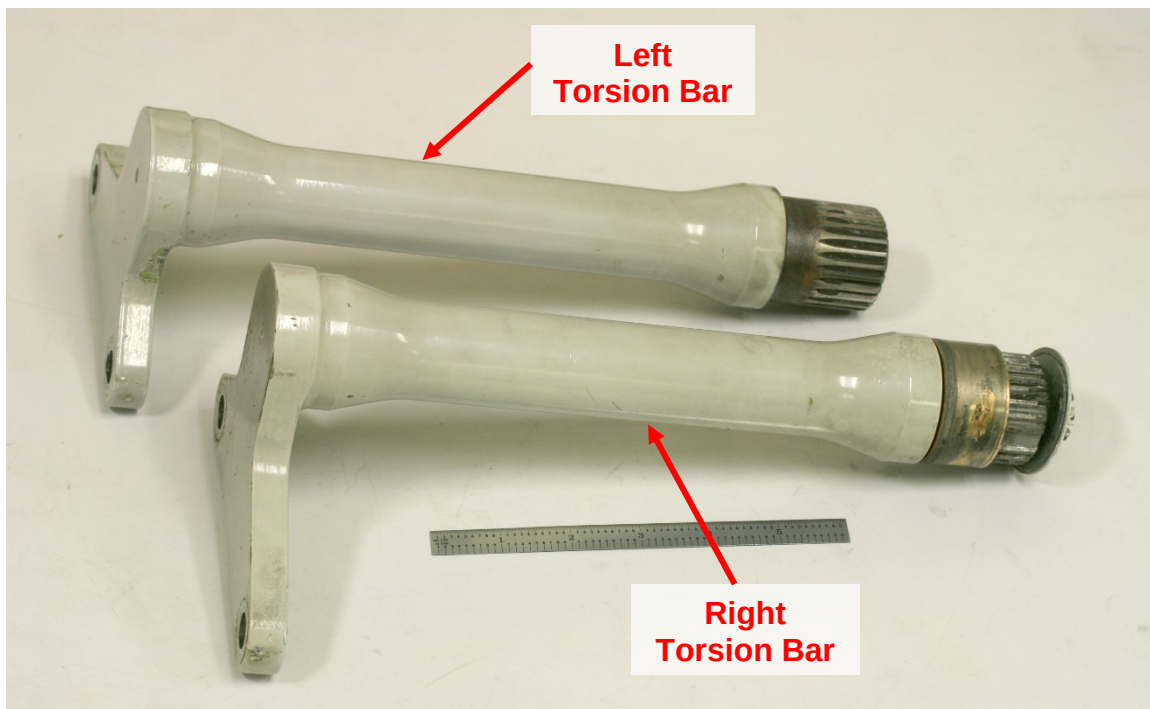
**Figure 42 - Torsion bars prior to hardness testing**

Both torsion bars and stop arms were inspected by the Boeing Materials Laboratory in Huntington Beach, CA. Rockwell Hardness tests were conducted to check the characteristics of the material of each torsion bar, Figure 42. Each test was conducted using approved Boeing material lab processes. Prior to cleaning and paint removal, none of the parts showed any damage to the painted surfaces such as cracking or crazing. The parts were cleaned, and exterior paint was removed prior to conducting the tests. The

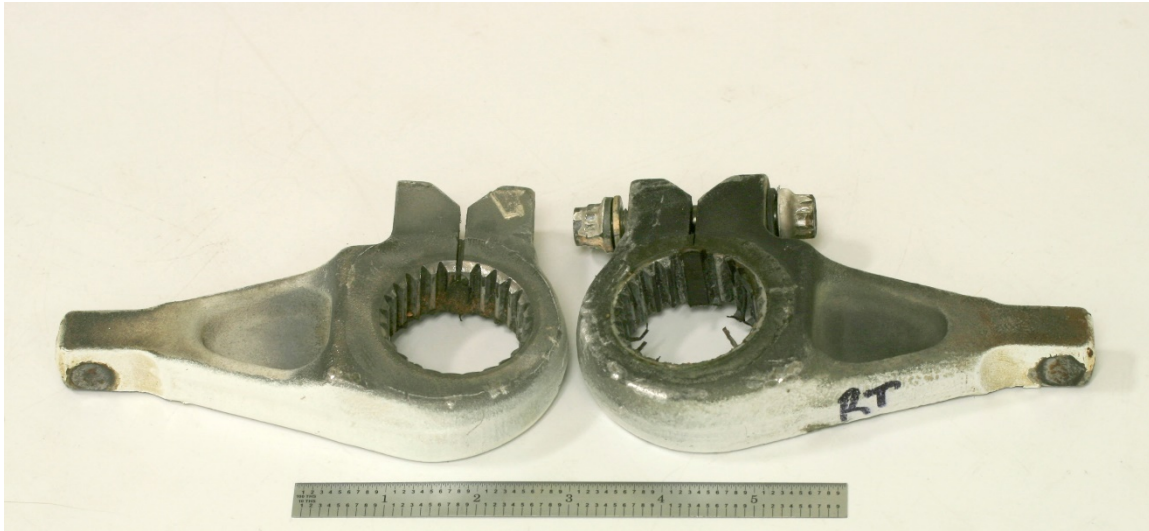
**Figure 43 - Left and right stop arms prior to hardness testing**

Due to fixture issues, hardness testing was not performed on the stop arms, Figure 43. To permit testing, the lab recommended that the stop arms be sectioned, and the sectioned pieces be placed in the test equipment and tested. The group decided against the sectioning of the stop arms, in order to allow use of the arms in the planned elevator testing.

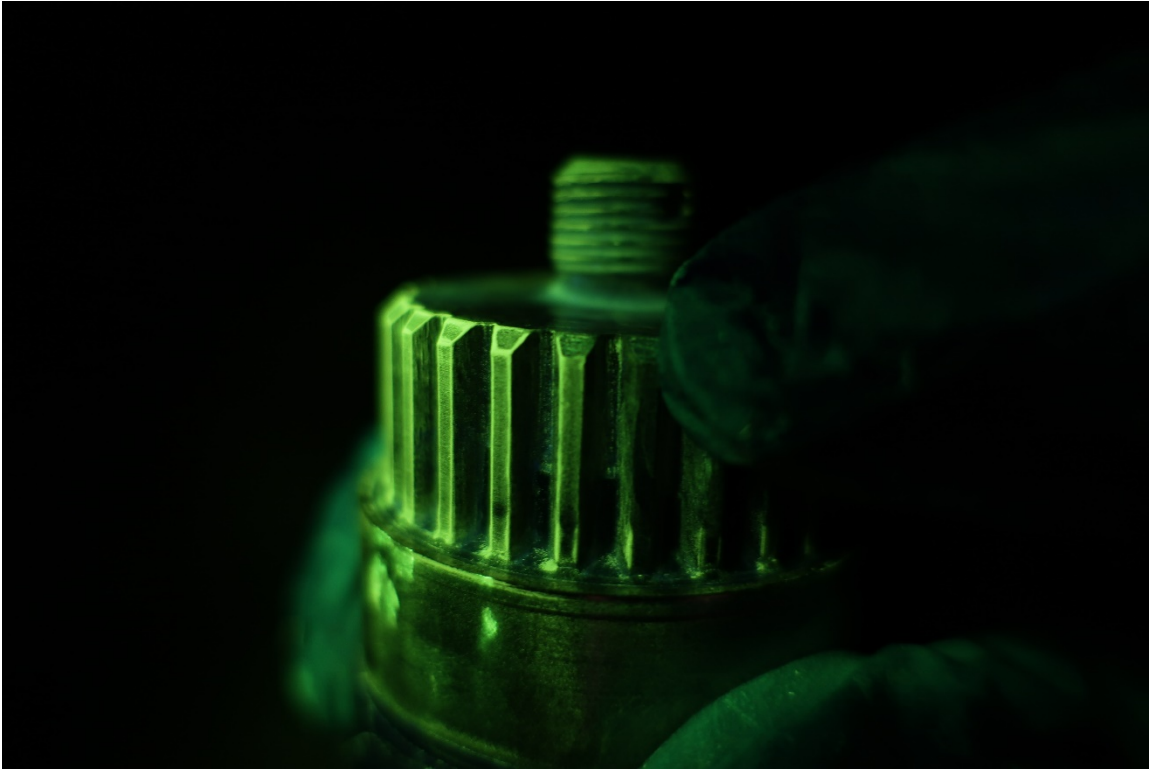
**Figure 44 - Right torsion bar splines during magnetic particle testing**

The torsion bar was then subjected to a 550 A electrical charge to create a magnetic field, Figure 44. A second inspection using a portable yoke type electro magnet was also performed on the torsion bar. During both tests, magnetic particles did not reveal any distinct indications of cracks along the spline valleys or the spline ends.

The testing lab recommended that the cadmium plating be removed to reveal the entire surface of the torque bar splines if additional testing was to be performed. The group did not perform any additional material testing on the torsion bars or stop arms.

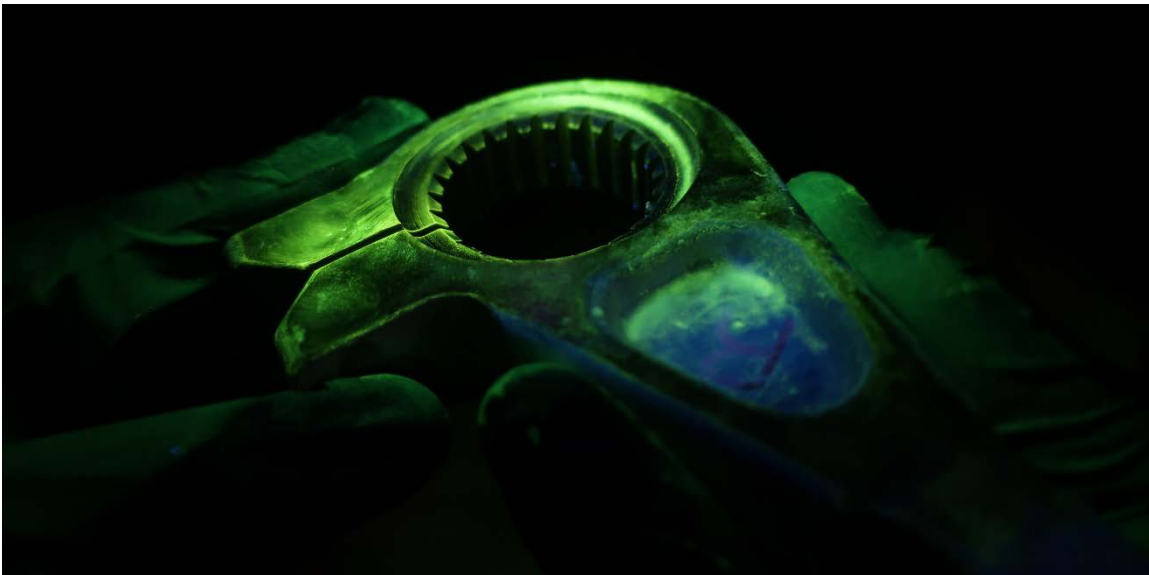
**Figure 45 - Right stop arm splines during magnetic particle testing**

The stop arm was subjected to 970 A to create the magnetic field, Figure 45. A second inspection using a portable yoke type electro magnet was also performed on the stop arm. During both tests, magnetic particles did not reveal any distinct indications of cracks along the spline valleys or the spline ends.

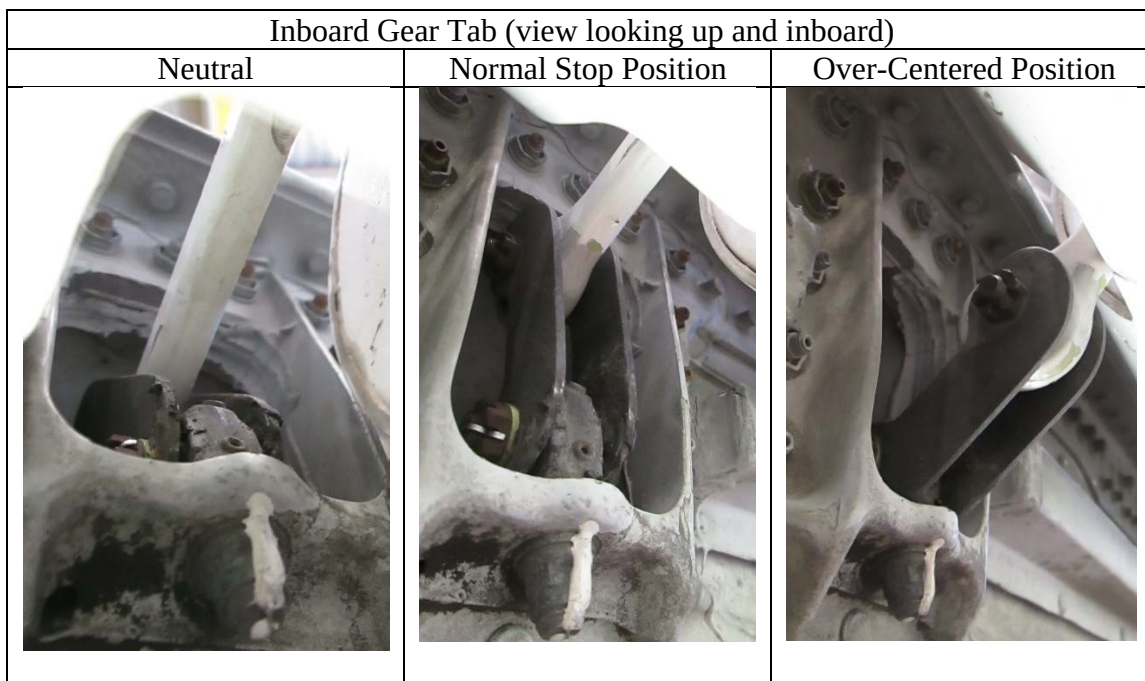
**Figure 47 - Inboard geared tab link and actuating crank position compared to elevator position**

The elevator was placed in a faired position corresponding to elevator neutral. A digital inclinometer was placed on the trailing edge structure between the geared tab and the control tab and zeroed. The elevator was moved in a trailing edge down (TED) direction until the inclinometer read  $16.6^\circ$ , which corresponds to the AMM lower stop position  $16.5^\circ \pm 0.5^\circ$ . The elevator was then moved further in a TED direction until the elevator travel was impeded at  $24.1^\circ$ . After the measurement was taken, the elevator was raised in a TEU direction and then moved abruptly in a TED direction, with a force (applied by hand) also added to the gear tab. The elevator locked in a TED direction and the inboard geared tab links and crank assembly over centered. The elevator surface position in this locked position read  $23.3^\circ$ , the geared tab position read  $20.3^\circ$ . The locked elevator could be released with a quick application of force in a TED direction and in some cases followed by a TEU direction. The test was repeated multiple times and the locked/over-center condition of the inboard geared tab links could be repeated. In all cases of locking/over-centering on the inboard gear tab linkages, the outboard gear tab linkage did not over-center. Figure 47 and Figure 48 show the positions of the links and the actuating crank for various elevator positions.

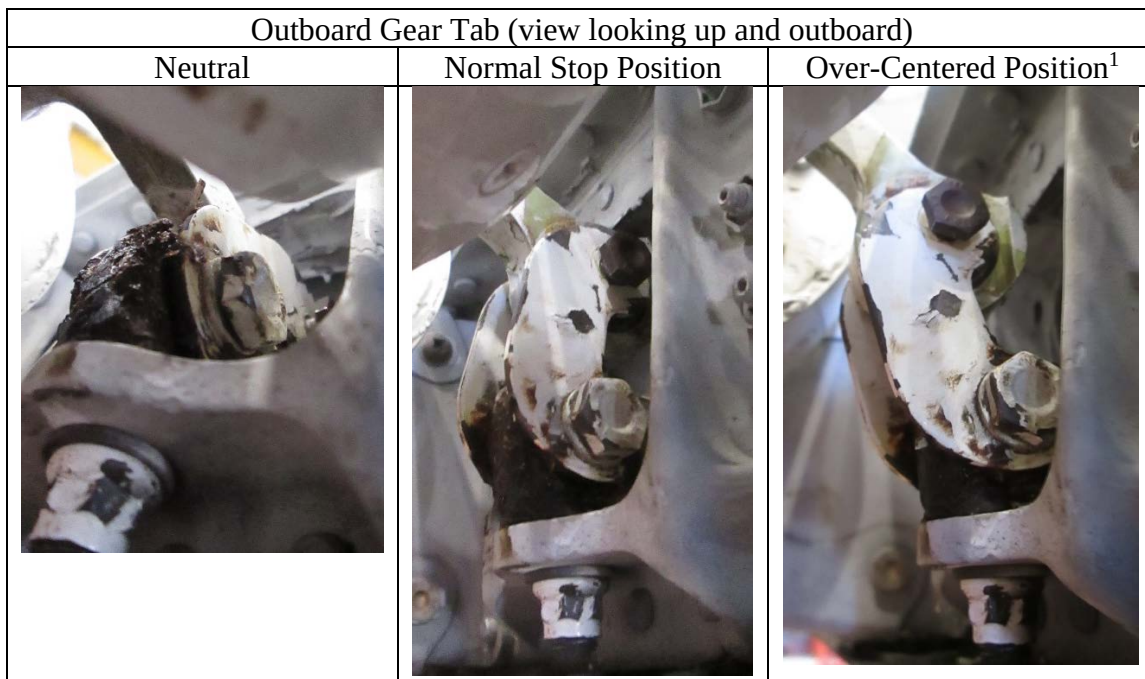
**Figure 48 - Outboard geared tab link and actuating crank position compared to elevator position**

1 – The over-centered position is based on the inboard geared tab link position. The outboard geared tab did not over-center during the testing.

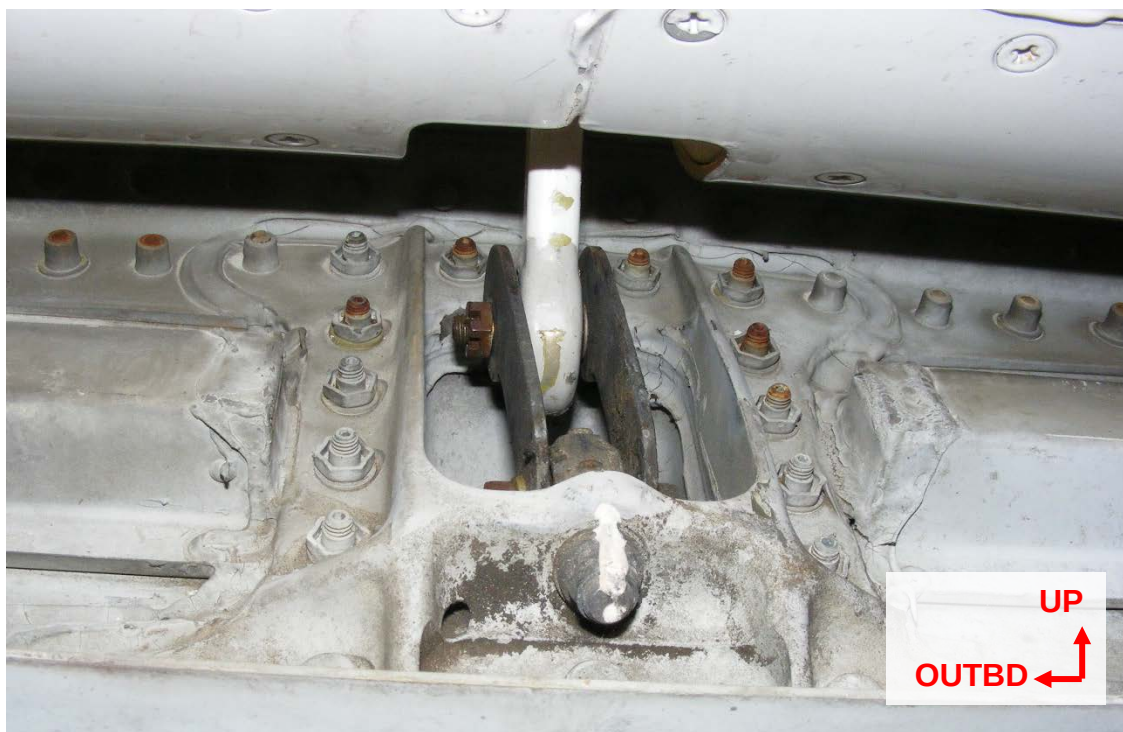
**Figure 52 - Gear Tab Inboard Linkage in nominal condition**

During the 75 kts neutral test, the inboard geared tab linkage over-centered and the elevator remained jammed in a TED position. Figure 52 shows the inboard geared tab linkage in a normal condition when the elevator is at the TED stop. Figure 53 shows the inboard geared tab after an over-centered condition occurs.

Based on these results the group added additional gust conditions at 60, 65 and 70 knots. During the 60 kts TEU test, the inboard geared tab linkage over-centered and the elevator remained jammed in a TED position. The group did not perform TEU tests at 65 and 70 kts due to the 60 kts TEU test result. During the 70 kts neutral test, the inboard geared tab linkage over-centered and the elevator remained jammed in a TED position.

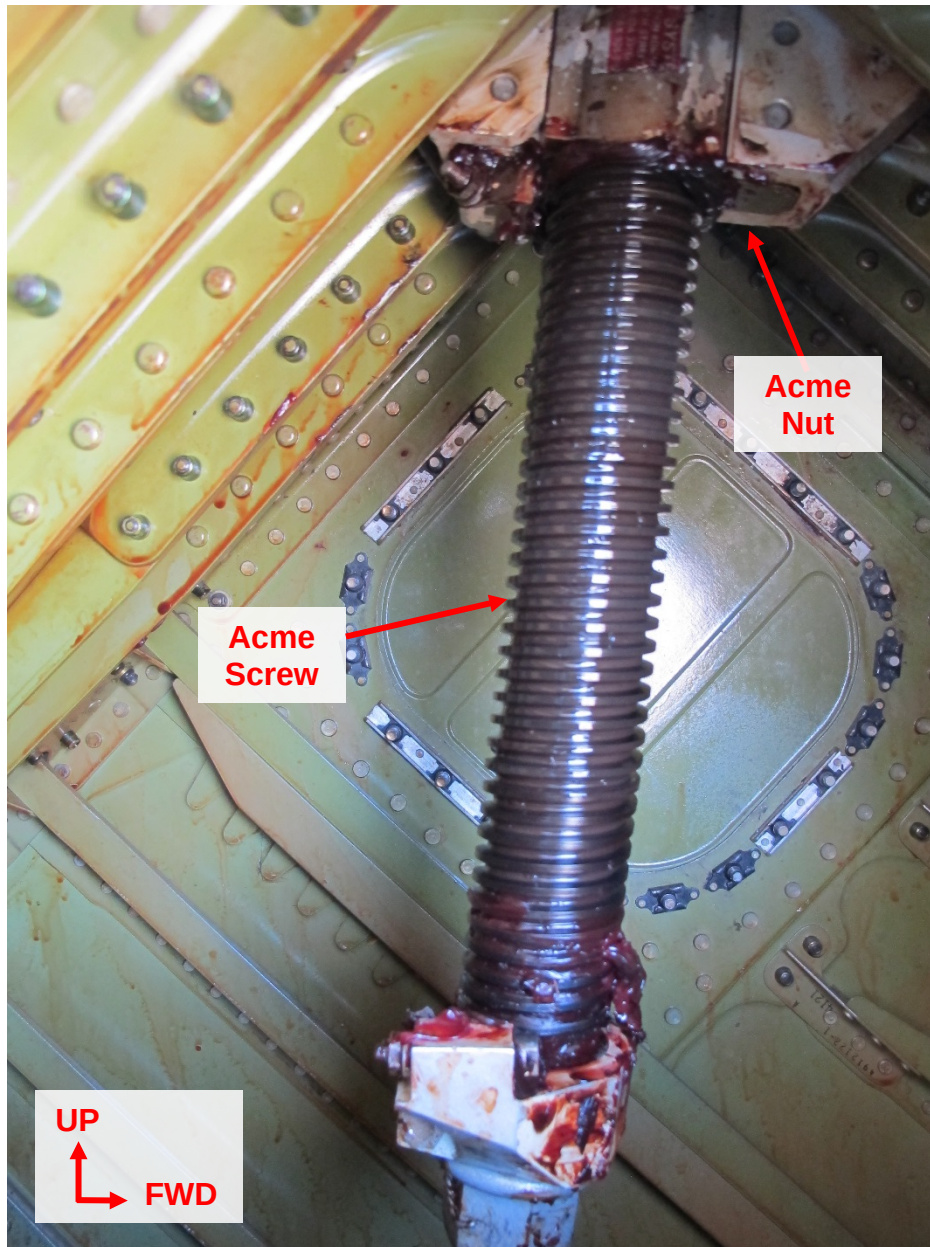
Figure 55 - Horizontal Stabilizer Jack Screw

The horizontal stabilizer trim actuator was inspected through the access panel on the right-hand side of the vertical fin. The jack screw was found to be lubricated, and a measurement was taken to determine the position of the stabilizer. The position of the jack screw was determined by measuring the acme screw protrusion below the acme nut in the stabilizer actuator, the measurement was 9.5 inches. Based on that measurement, the horizontal stabilizer position was determined to be consistent with 8° aircraft nose up. Due to damage to the aircraft electrical system, operation of the trim motors could not be performed.

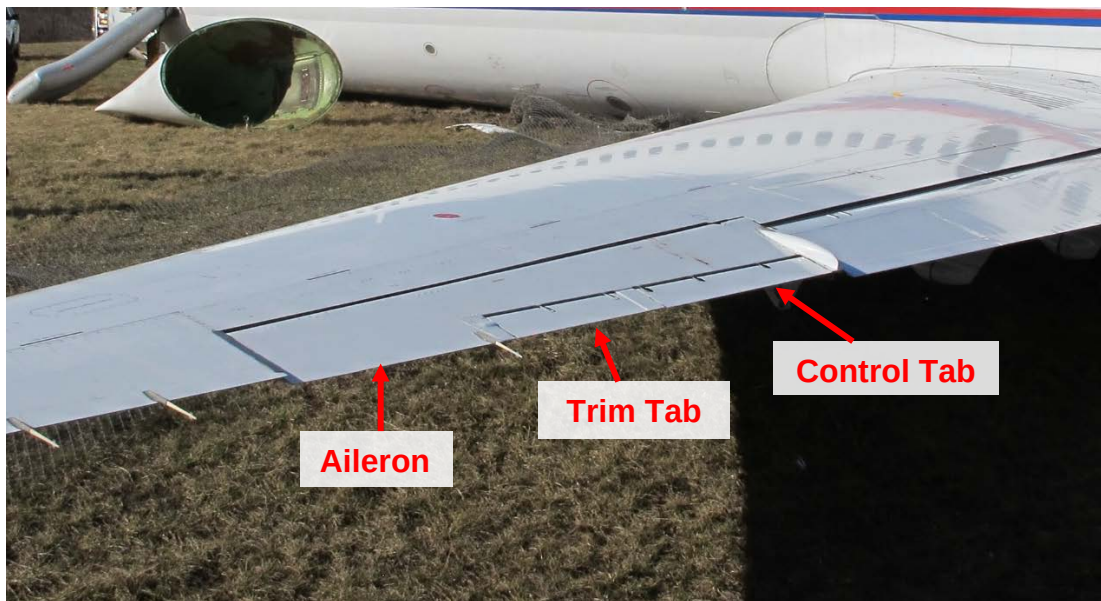
Figure 56 - Left aileron control surfaces (right aileron similar)

The left aileron was found in a trailing edge down position, approximately 1 and 1/8 inches from the wing trailing edge. The trim tab was faired with the aileron and the control tab was slightly trailing edge down from the aileron trailing edge.

The right aileron was found in a trailing edge up position. The trim tab was faired with the aileron and the control tab was slightly trailing edge up from the aileron trailing edge.

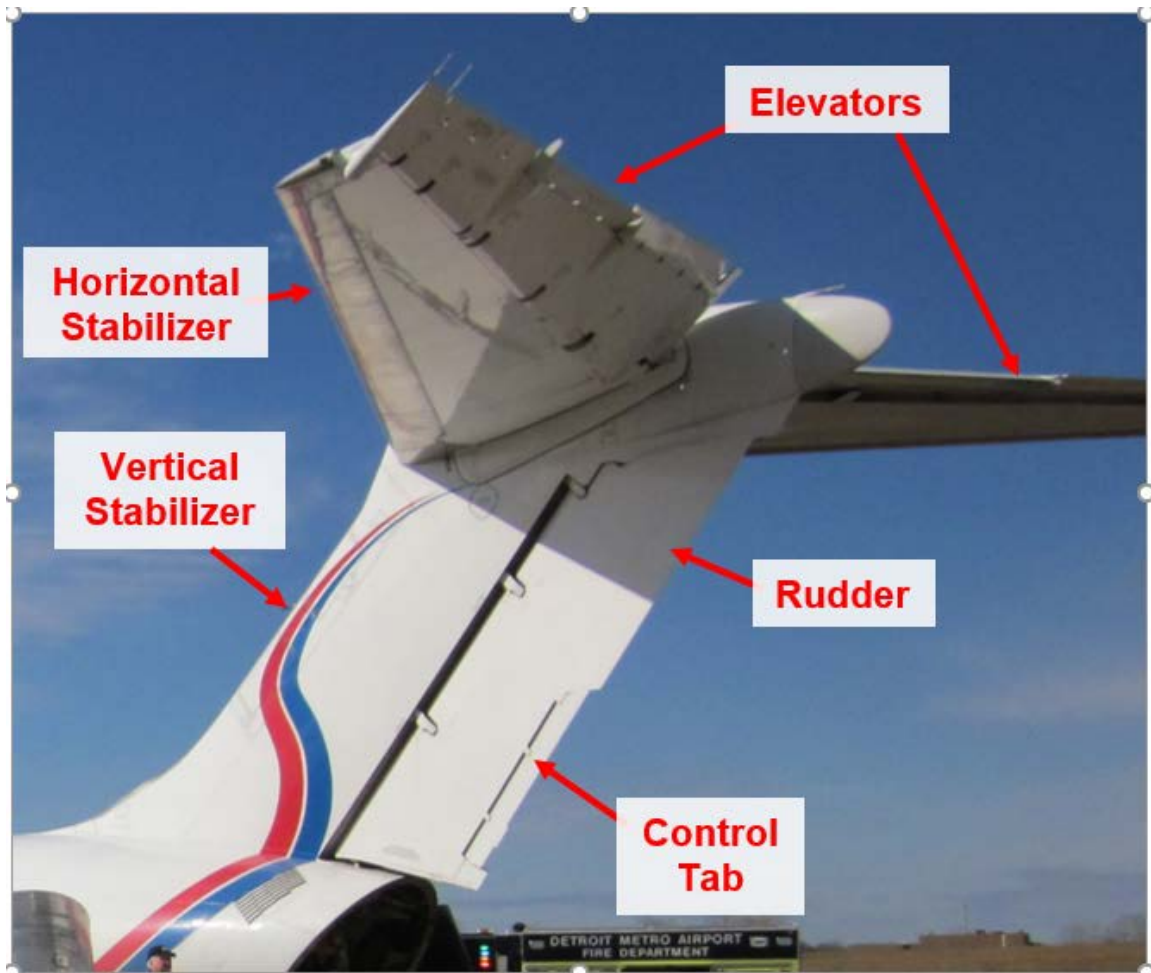
**Figure 57 - Rudder control surfaces, as viewed from aircraft left hand side**

The rudder was found in a trailing edge left position. Flight control continuity for the rudder system was established by exercising the rudder pedals in the cockpit from both the pilot and copilot's side to the stops on both the nose left and nose right positions. The rudder control tab responded with movement in the appropriate directions. The group also noted that when actuating the rudder pedals, the rudder nose left moved freely, and the rudder nose right was heavy from both the captains and first officers position.

The control tab was slightly trailing edge left from the rudder trailing edge, consistent with an aircraft nose right direction. The rudder trim knob in the cockpit was rotated to both extents and the control tab was visually observed responding with movement in the appropriate directions.

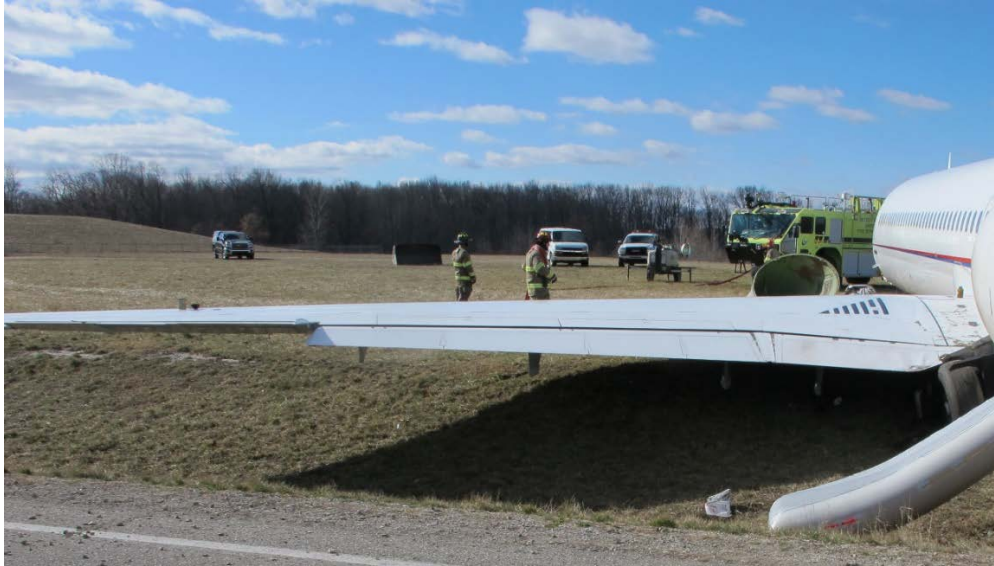
**Figure 58 – Left hand wing flap panels**

The left-hand (LH) side inboard and outboard flaps were found extended and symmetrical along the length of the flaps. The LH inboard flap sustained damage consistent with impacting the LH main gear. The inboard flap was resting on the LH main gear.

The flaps do not contain any visual indications of their position on the wing or flap surface. Position markings exist on the inboard flap track; however, these markings were inaccessible because of the landing gear collapse. In lieu of taking the inboard measurements, a measurement was taken from the left outboard flap hinge stop. The measurement was 1.5 inches, the right outboard flap hinge stop measurement was 4.75 inches.

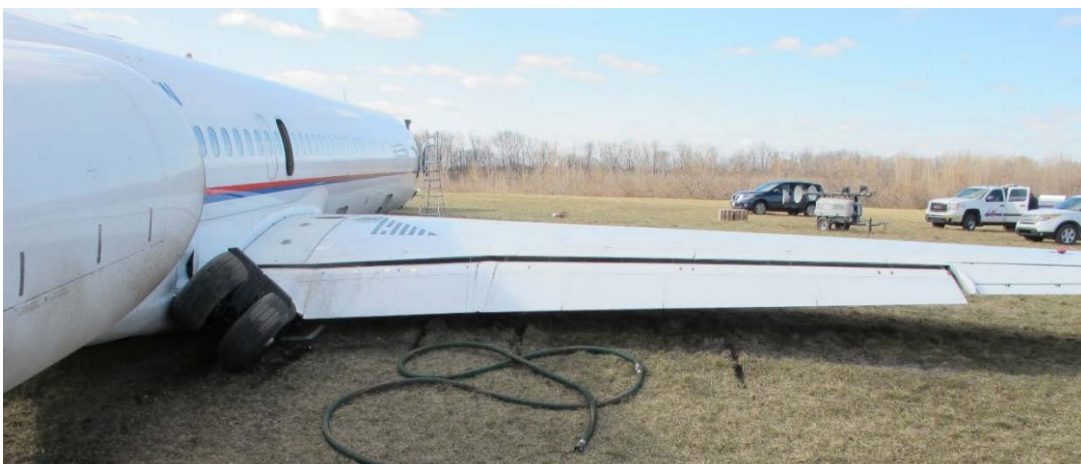
**Figure 59 – Right hand wing flap panels**

The right-hand (RH) inboard and outboard flaps were found extended and symmetrical along the length of the flaps. The RH inboard flap sustained damage consistent with impacting the RH main gear. The inboard flap was resting on the RH main gear. The RH flap hinges impacted the ground just prior to the aircraft coming to rest.

Due to damage from the accident, hydraulic power was not available to check the operation of the flaps. Upon relocation of the wreckage, when the aircraft was raised from the ground, both the left and right flaps extended without any external assistance to a position consistent with full extension. After the access was available due to the aircraft recovery, a bolted flap bus cable fuse connection at a turnbuckle was found separated in the main landing gear wheel well.

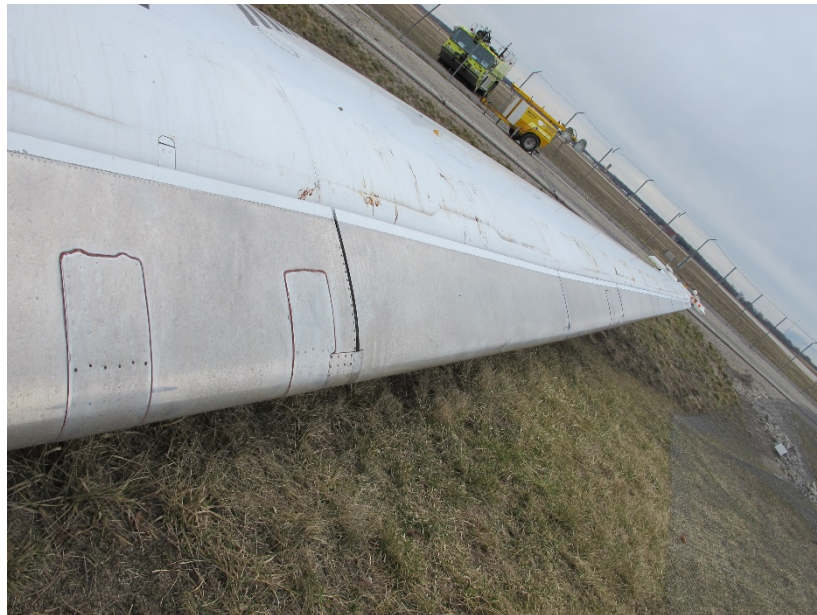
**Figure 60 – Left hand wing slat panels**

All six left hand slats were found extended and symmetrical along the length of the wing. The slat tracks all showed signs of lubrication and grease marks were found on the leading-edge wing skins. The slats did have impact marks consistent with a collision with the airport perimeter fence posts.

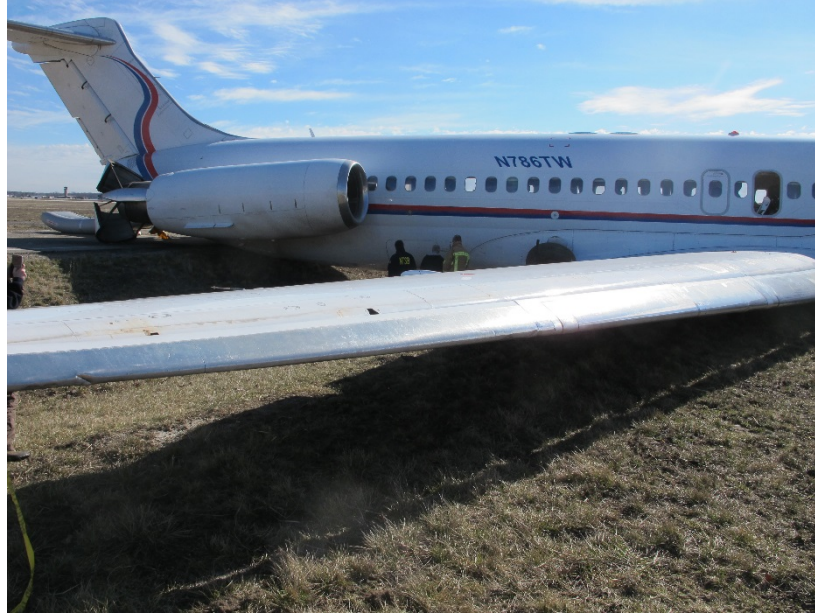
**Figure 61 – Right hand wing slat panels**

All six right-hand slats were found extended and symmetrical along the length of the wing. The slat tracks all showed signs of lubrication and grease marks were found on the leading-edge wing skins.
