Subject: Boeing Submission for Ameristar MD-83 N786TW Runway Overrun  
Following a Rejected Takeoff at Ypsilanti, Michigan – 8 March 2017

**Ameristar Air Cargo MD-83 N786TW  
Runway Overrun Following A  
Rejected Takeoff at  
Ypsilanti, MI  
8 March 2017**

**The Boeing Company  
1 May 2018**

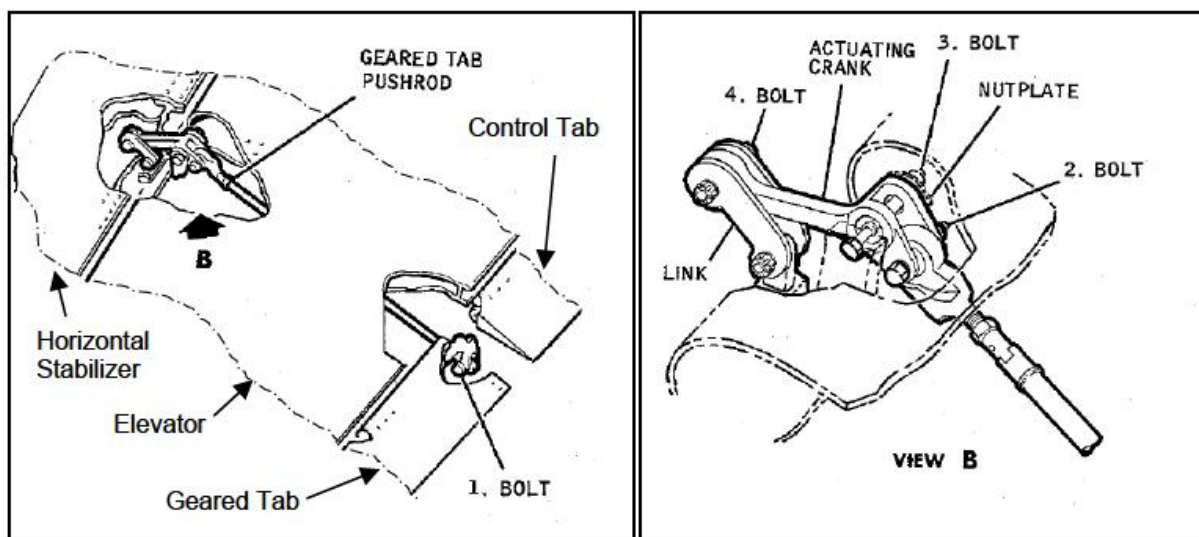
The geared tab provides aerodynamic assistance to the control tab to deflect the elevator. The geared tab drive linkages are directly connected to the horizontal stabilizer rear spar at two places approximately in line with the inboard and outboard ends of the geared tab. The connection to the horizontal stabilizer rear spar consists of an eye bolt, two links, and an actuating crank. Each geared tab pushrod connects to a crank fitting on the geared tab. The geared tab movement directions are identical to the control tab movement but based on elevator surface movement, not control column input.<sup>11</sup>

**Maintenance Manual Excerpt of Gear Tab Components**

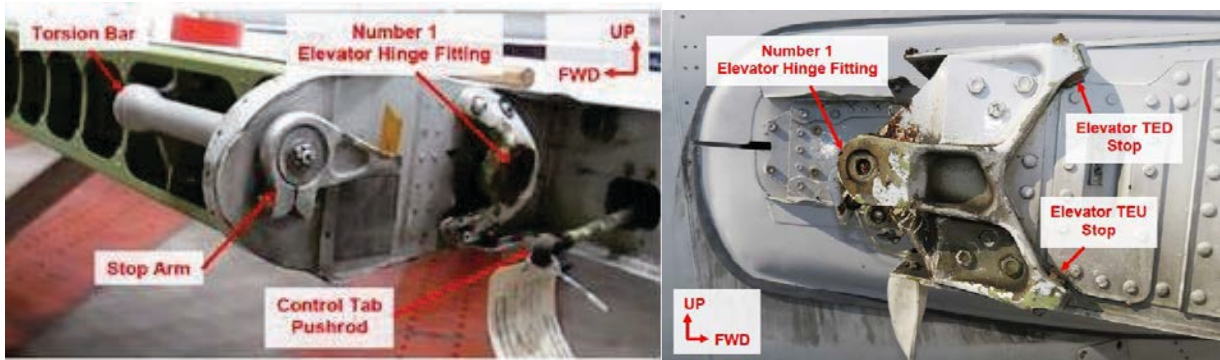
Elevator travel is typically limited to 27° trailing edge up and 16.5° trailing edge down by mechanical stops on the horizontal stabilizer. The elevator contacts the stop via a stop arm and torsion bar arrangement mounted in the leading edge of the elevator near the root. The torsion bar is attached to a structural rib in the elevator to distribute increased loading due to an increase of force on the stop arm when the elevator is in contact with the elevator stops. The torsion bar passes through the closeout rib via a bearing to allow for torsion bar rotation.<sup>14</sup>

One function of the stop arm and torsion bar arrangement is to assist the elevator dampers in preventing damage to the elevator and/or horizontal stabilizer due to high winds while the airplane is on the ground. The spring action of the arrangement is intended to absorb the energy created by a gust driving an elevator to its stops, before airplane damage occurs.

**Elevator Stop, Stop Arm and Torsion Bar**

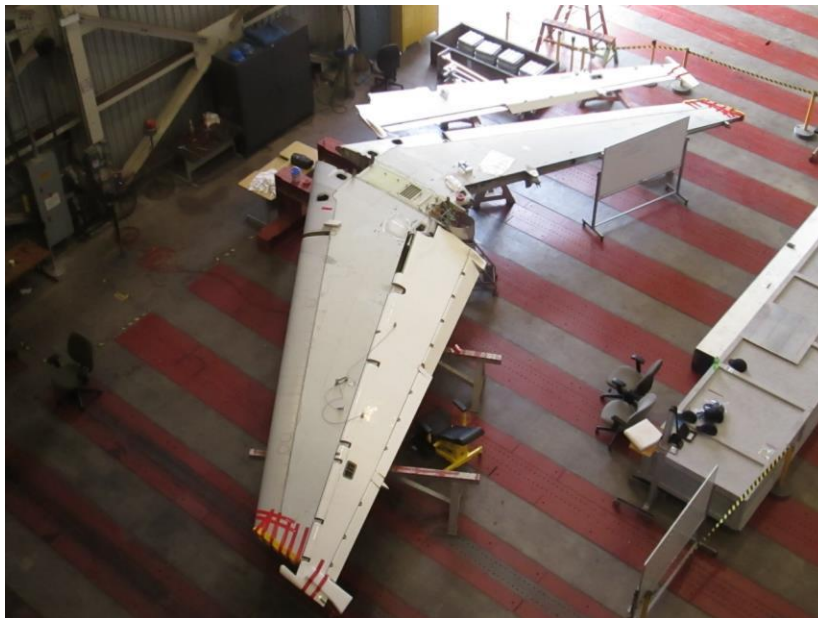
The left and right elevator assemblies, including their tabs, were removed from the accident airplane for laboratory testing. It was found that the right elevator's torsion bar was free to rotate and the left elevator's torsion bar was not free to rotate. If a torsion bar is not free to rotate, its elevator's deflection will be limited to a point where the stop arm contacts a stop, so it cannot deflect far enough to cause a geared tab's links and actuating crank to go to an over-center condition.

**Overview of accident aircraft elevators on test stand at test facility**

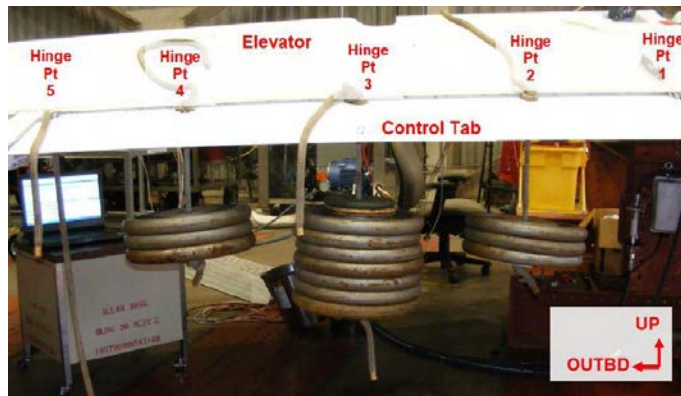
The hinge moment forces corresponding to varying values of horizontal winds impacting an MD-80's elevator were calculated and weights were used to simulate these downward horizontal wind loads impacting the elevator mounted on the horizontal stabilizer in Boeing's test facility.

**Weights Simulating Horizontal Wind Gust Loads**

It was noted during testing that when weights representing gusts of 60 knots and greater were dynamically applied to the elevator, the torsion bar would continue to rotate after the elevator stop arm contacted the elevator stop, and the geared tab's inboard links and actuating crank would travel to an over-center condition. To simulate the dynamic wind conditions, the elevator was positioned full trailing edge up before a simulated downward wind load was applied.
