**NATIONAL TRANSPORTATION SAFETY BOARD  
OFFICE OF AVIATION SAFETY  
WASHINGTON, D.C. 20594**

**POWERPLANT GROUP CHAIRMAN'S FACTUAL REPORT  
NTSB ID: DCA17LA182**

Location: Denver, Colorado  
Date: July 2, 2017  
Time: 1319 local  
Aircraft: CL-0600-2C10 (Regional Jet Series 701), N796SK, S/N 10300

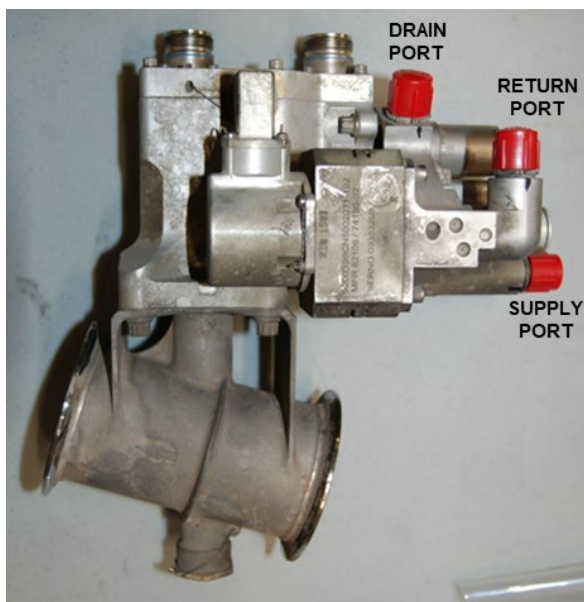
Figure 2. Parker OBV P/N 4123T71P04

The Parker P/N 4123T71P04 OBV is a fuel-actuated, electrically-controlled butterfly valve that increases engine operability margin by unloading the high pressure compressor during engine starts and at higher power settings. The valve opens to bleed stage 10 compressor air into the fan bypass air stream. Three rosan expander fittings are installed in the OBV upper housing (housing cap). Fuel from the engine high pressure pump is routed to the supply port and returned to the pump inlet through a return port.<sup>5</sup> See Figures 2 and 3.

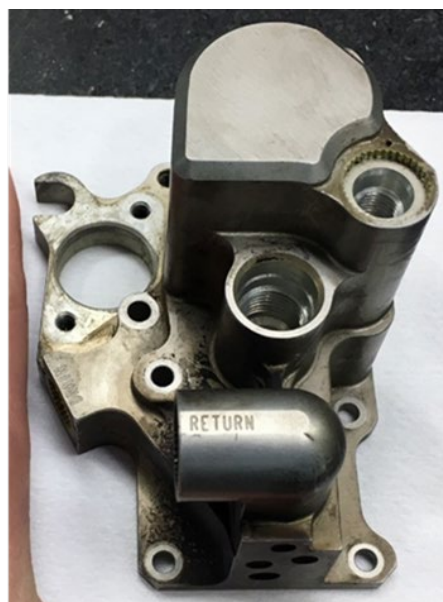
Figure 3. P04 housing cap

The P04 OBV housing cap material is 6061T6 aluminum and the fittings are A286 corrosion-resistant steel. Both the supply and the return fittings are rosan -05 to -06 expander-type fittings, having 9/16-inch diameter tube ends with a 270-300 lb-in installation torque range and 3/8-inch diameter port ends with a 100-120 lb-in installation torque range. See Figure 4.

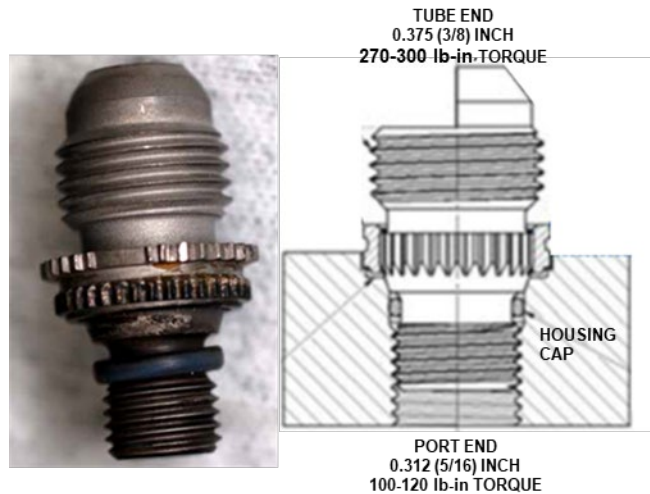
Figure 4. Parker OBV supply rosan (expander) fitting. Fitting threads engage the aluminum housing to develop a preload between the threads and the conical seat

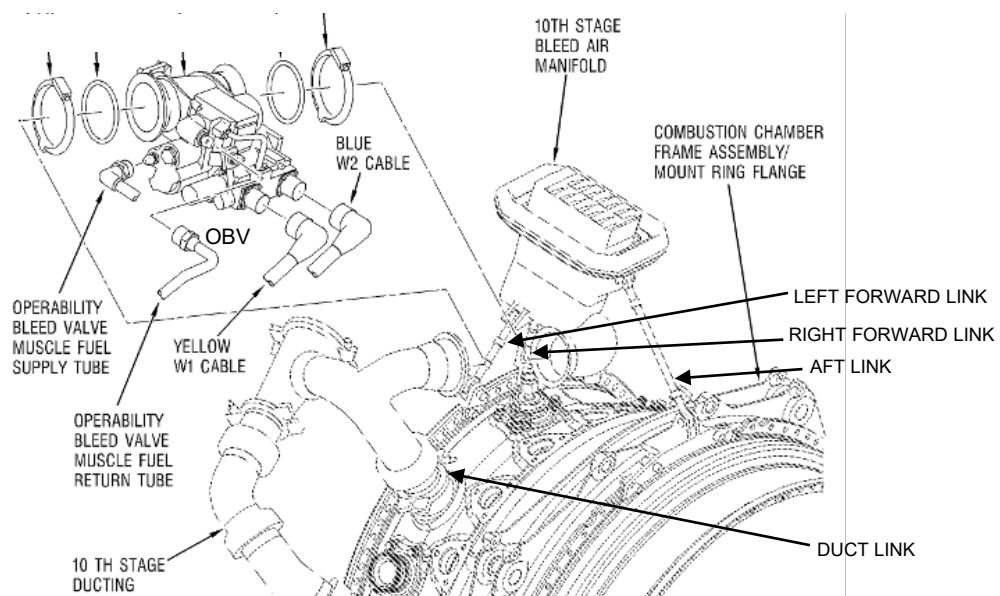
Figure 5. CF34-8C ECS showing OBV installation

The CF34-8C OBV is clamped between the 10<sup>th</sup> stage duct and the 10<sup>th</sup> stage bleed air manifold at 12 o'clock <sup>6</sup> and is not directly attached to the engine. It is part of the engine ECS and extends away from the engine core to mate with an air exhaust port in the forward upper core cowl. The assembly is stabilized by four adjustable link rod assemblies (ECS links). The ECS links are installed between the S10 duct and manifold and the engine combustion chamber frame flanges. See Figure 5.

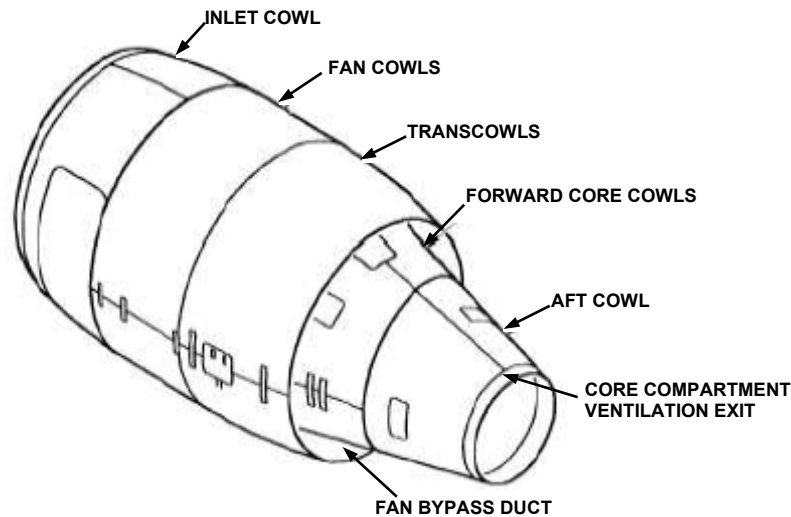
Figure 6. CRJ 700 nacelle, showing the engine forward core cowls, which enclose the engine core section (core compartment)

The engine core is enclosed by the forward core cowls (core compartment). See Figure 6. The core compartment is a designated fire zone. High rates of ventilation through the core compartment cool the engine and remove flammable fluids and gases to prevent hot surface ignition due to contact with hot engine surfaces. Core compartment drainage is assisted by gravity drains as ventilation rates decrease.

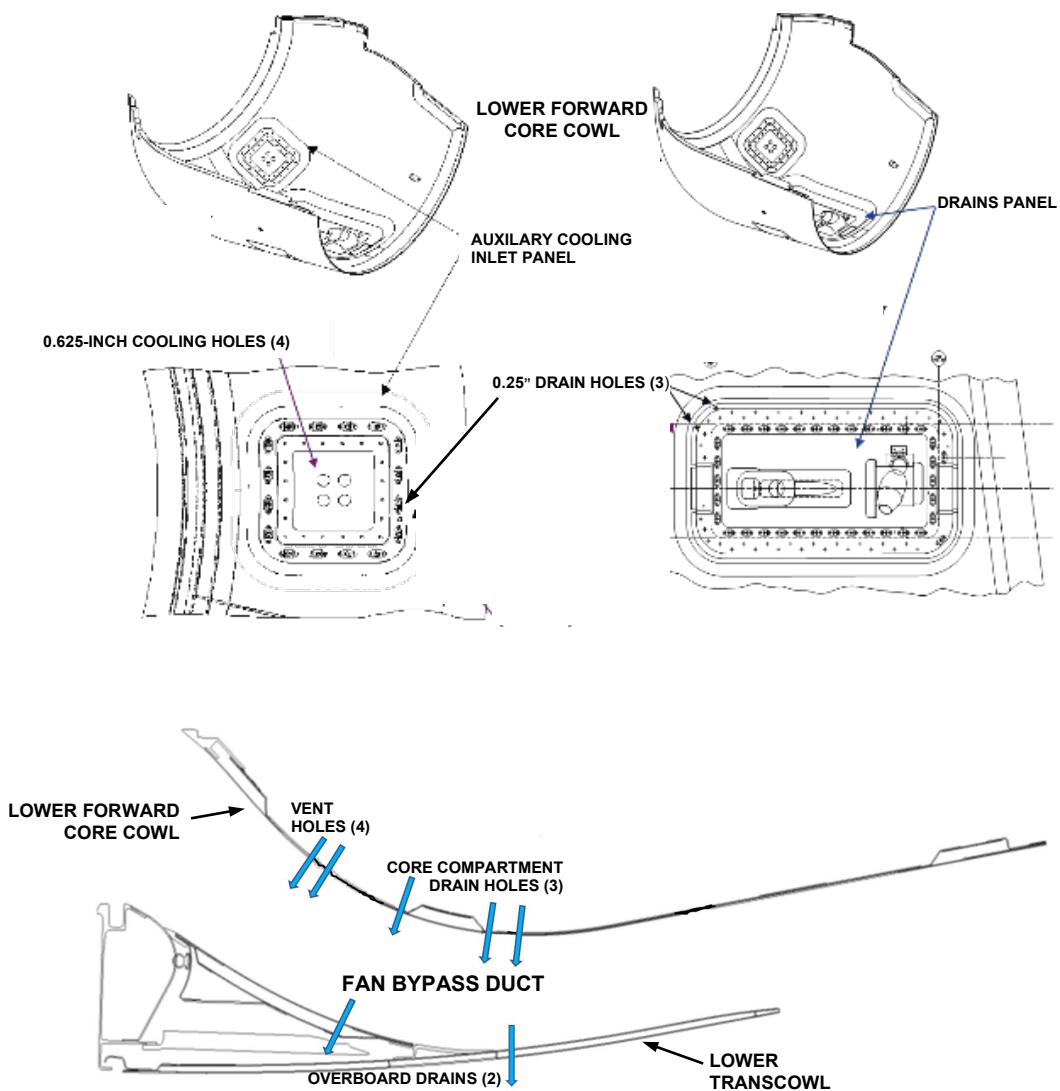
Figure 7. Engine fire zone drainage

Fluids not removed by the ventilation airflow collect at the bottom of the core compartment and drain into the fan bypass duct (fan duct) through three 0.25-inch diameter holes, two located in the drain panel near the bottom of the lower forward core cowl and the third hole at the auxiliary cooling inlet panel in the lower forward core cowl. Drained fluids are removed from the fan duct with the fan discharge airstream. With the engine shut down, any fuel draining from the core compartment is no longer removed by fan exhaust and will accumulate in the fan duct. This fuel is routed overboard through two transcowl fluid drains.

Four 0.625-inch diameter vent openings to the fan duct are located in the auxiliary cooling inlet panel. The forward lower core cowl includes a pressure relief door (PRD). See Figure 7.

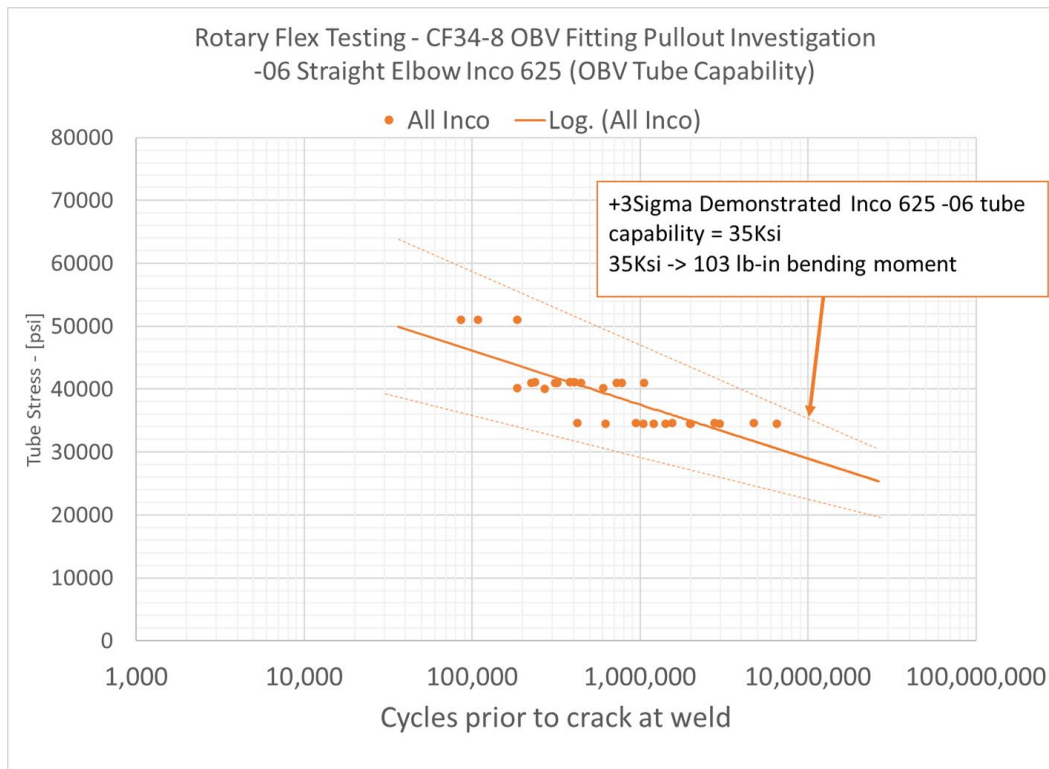
GE used the Inconel 625 tube +Sigma high cycle fatigue (HCF) data from the rotary flex tests to characterize the load capability of the OBV tubes. The Inconel 625 -06 return tube +3 Sigma capability was defined as 35 ksi, or a value greater than or equal to 103 lb-in bending moment. See Figure 30.

Figure 30. +3 Sigma HCF CF34-8 OBV tube (Inconel 625 -06 90° elbow) capability

Given that GE CF34-8 reliability data showed no in-service OBV tube failures, the load that a +3 Sigma HCF CF34-8 OBV return tube could input into a fitting was designated the worst possible tube-induced vibration loading that OBV fitting joints would experience, and 35 ksi /  $\geq 103$  lb-in bending force was made the upper load threshold for fitting capability. Rotary flex tests using 35 ksi  $\geq 103$  lb-in bending force as the upper tube load limit and knowledge gained from the torque tension tests were performed to confirm P04 test findings and to verify P05 OBV capability.
