ENGINEERING DOCUMENT NUMBER 4865

INVESTIGATION REPORT

World Atlantic Airlines MD80 Forward Slide Deployment Failure  
Public Docket

Slide Evacuation System D29982-121  
Serial number 1091

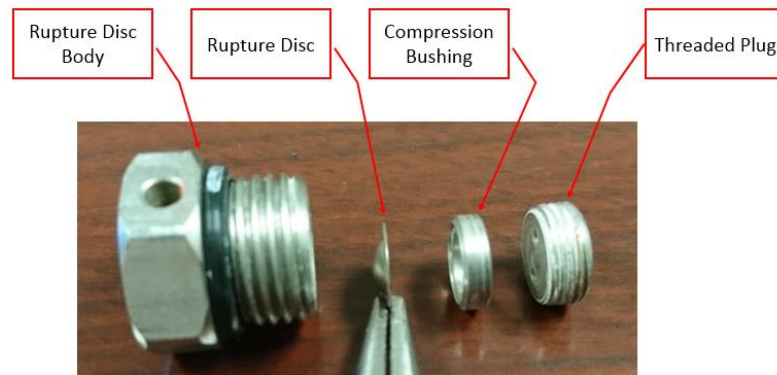
Figure 13  
Exploded View of the Rupture Disk Assembly

An exploded view of the Rupture Disk Assembly is shown in Figure 13. The interior rupture disk is seated against the body of the Assembly by a compression bushing, which is secured in place by a threaded plug. The rupture disk is securely held against the compression bushing by a matching V-shaped edge around both components. This V-shaped edge maintains the pressure seal and limits movement of the rupture disk within the Assembly.
