# Metallurgical Investigation Final Report

**Subject:** Metallurgical Investigation of Fan Blades No. 11 and No. 10 from PW4077 Engine 777049

**Date:** October 9, 2018

# PW4077 P777049 Fan Blade Fracture Investigation

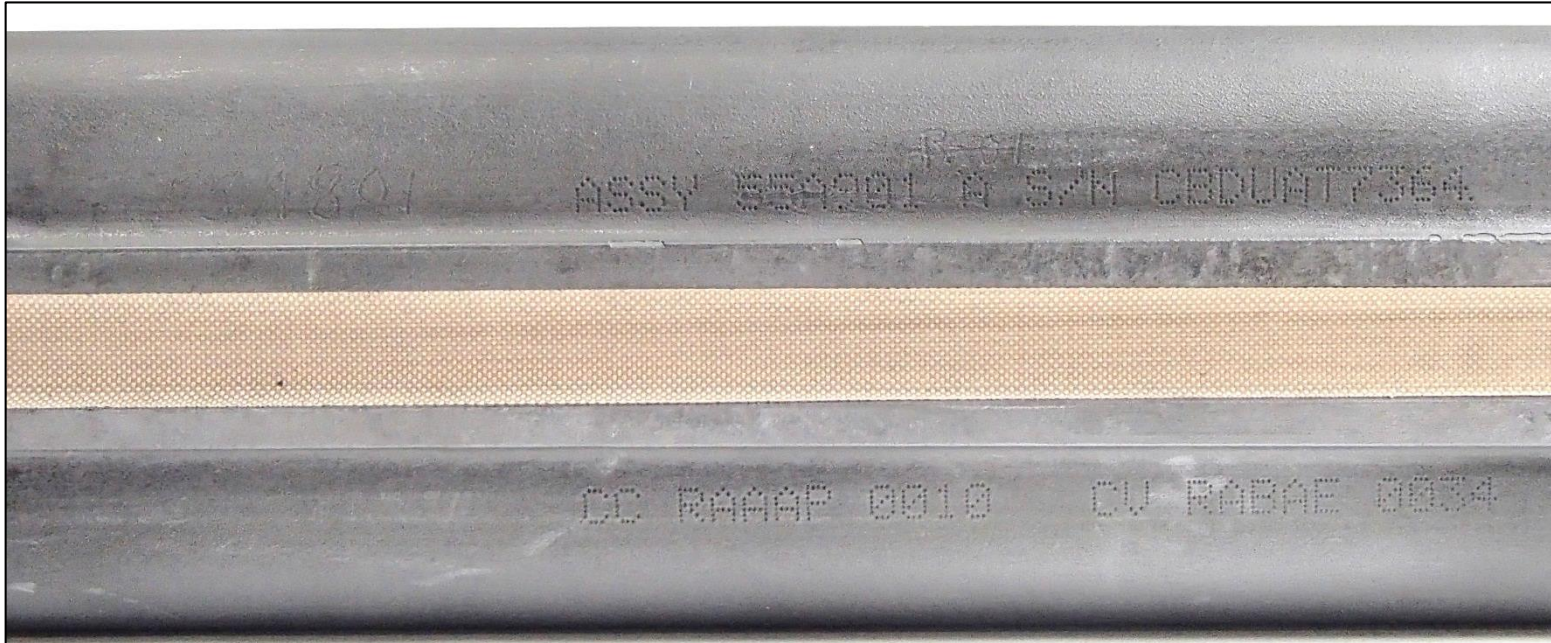
## Blade #11 Part Markings

The part manufacture and repair identification markings located on the root bottom are shown in **Figure 9**.

ASSY 55A901-A S/N CBDUAT7364

55A801 (Vibropeened marking)

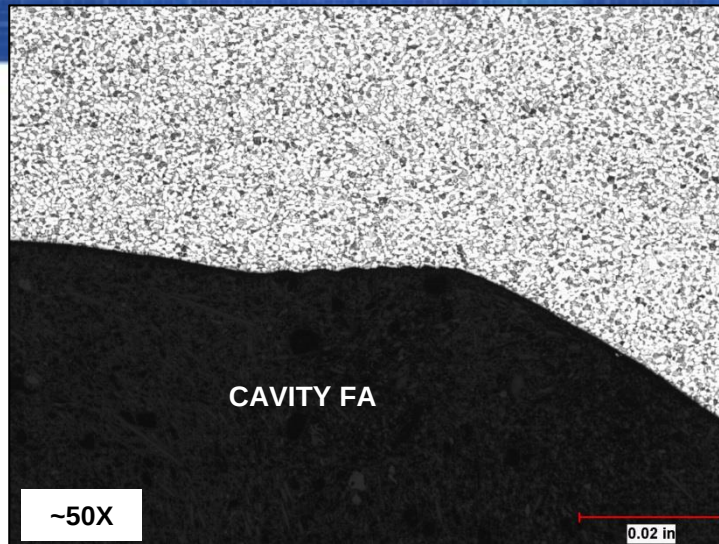
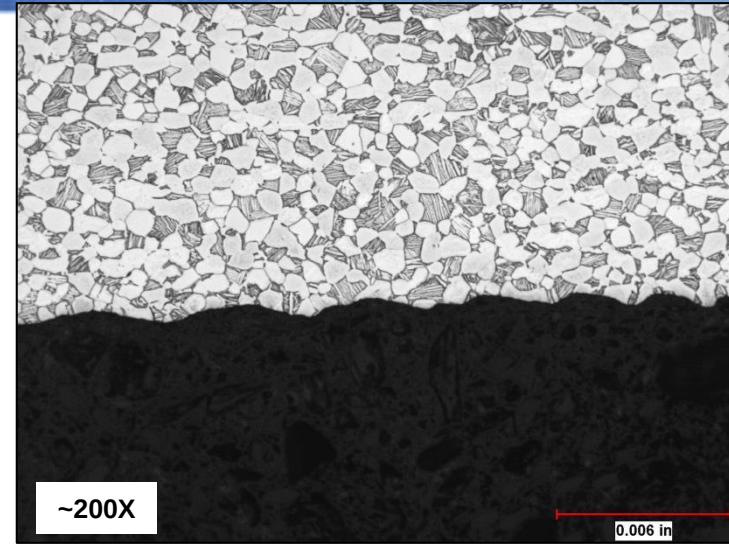
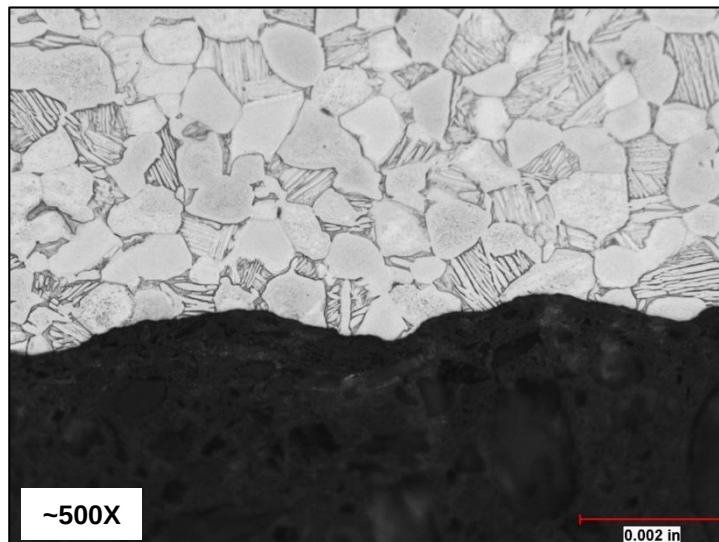
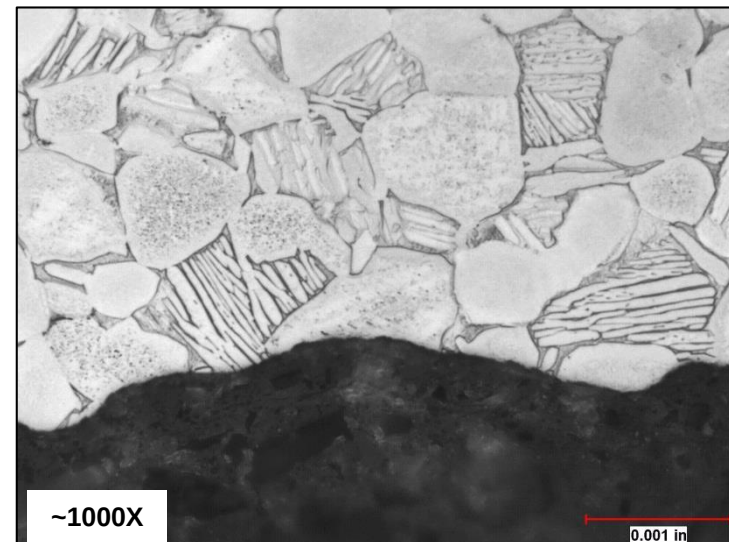
In tandem with the FESEM evaluations of the fracture surface, a metallographic section was prepared  $\sim 1 - 1.5''$  inboard of the fracture plane for evaluation of the internal cavity surface, wall-to-rib transition geometry corresponding to the fatigue origin area, and bulk microstructure. The section was oriented chordwise (but at the same angle as the fracture plane) and contained both convex and concave side walls within the forward end of cavity FA, and the aft end of cavity EA, and the adjoining spanwise rib (**Figure 28**). Step height of the machining mismatch in the section measured  $0.004'' - 0.005''$ , which met the requirement. Machining mark height and spacing within the mismatch measured up to  $\sim 0.0005''$  and  $0.005''$ , respectively. The size of the transition radii on either side of the mismatch were also approximated via best-fit circles and appeared to meet the requirements (**Figure 29**). A similar transition geometry with a machining mismatch was also observed within the transition radius on the opposite side of the rib, at the aft end of cavity EA (**Figure 30**). Examination of the section after etching to reveal microstructure showed no microstructural deformation along the as-machined internal cavity surfaces, including at the mismatch associated with the origin area (**Figure 31**). No alpha case was observed along the internal cavity surfaces (**Figure 32**). Bulk microstructure in the section was acceptable to the material specification requirements (**Figure 33**).

Figure 31 - Examination of the section after etching revealed no microstructural deformation along the as-machined internal cavity surface. Attachment 1

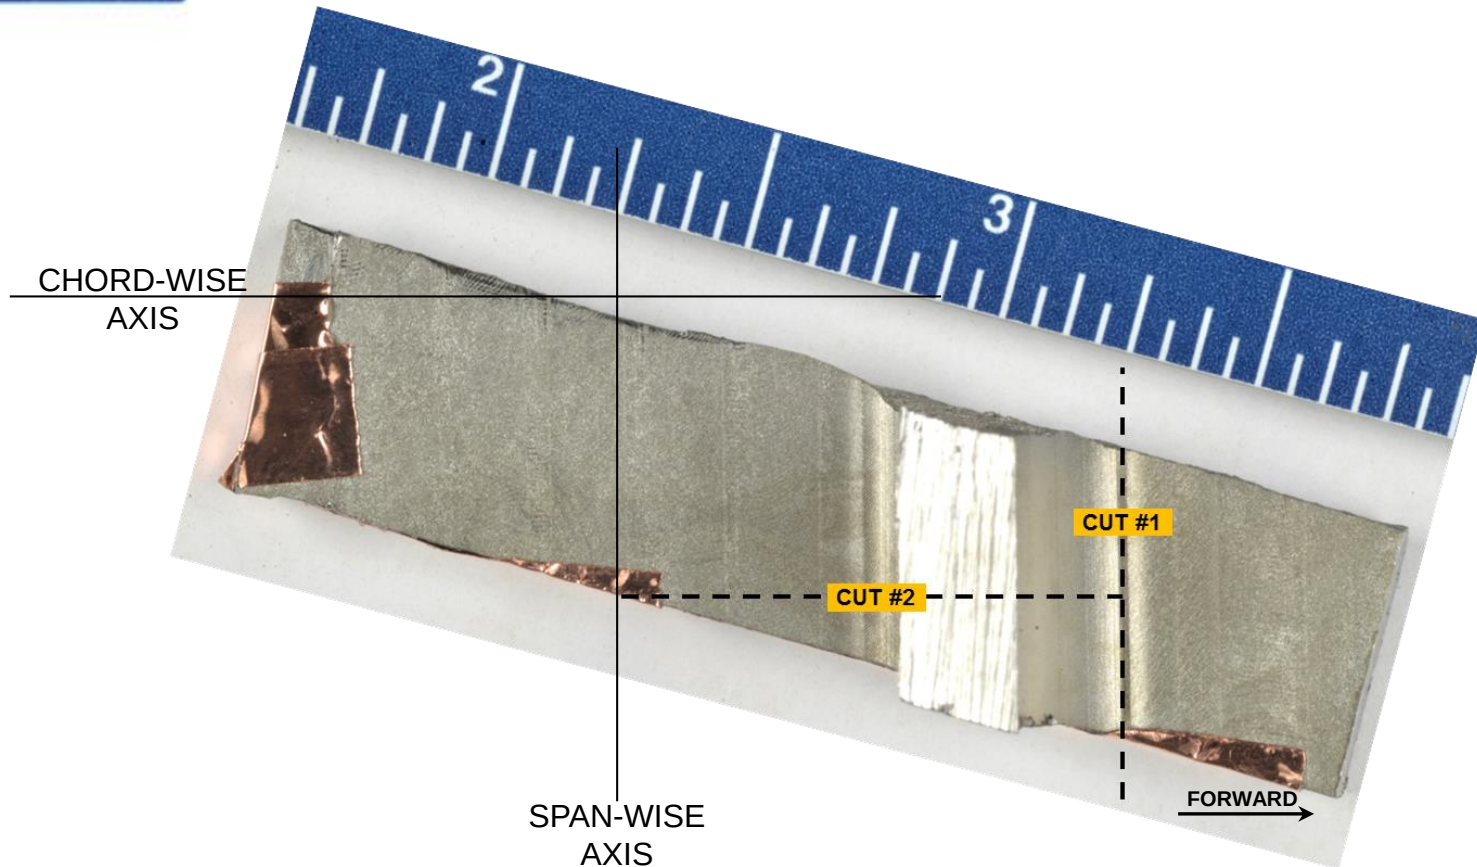
Figure 34 - Two transverse cuts were made through the CV wall where shown (cut #1 & #2) to square-up the piece of interest to be mounted using machining passes as guides for approximate span-wise axis. The portion of the fracture forward of cut #1 was preserved.

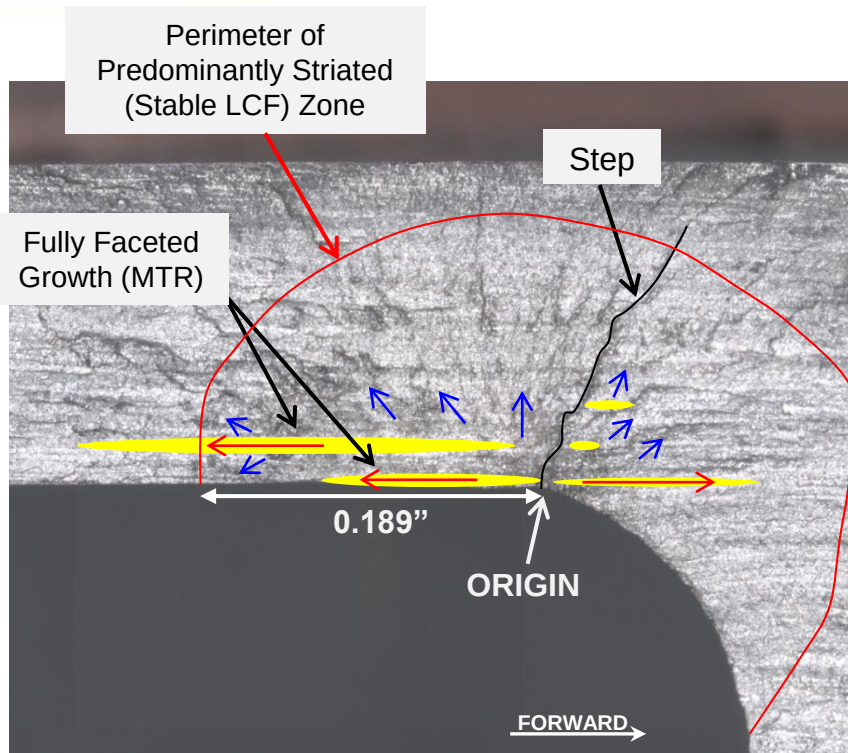
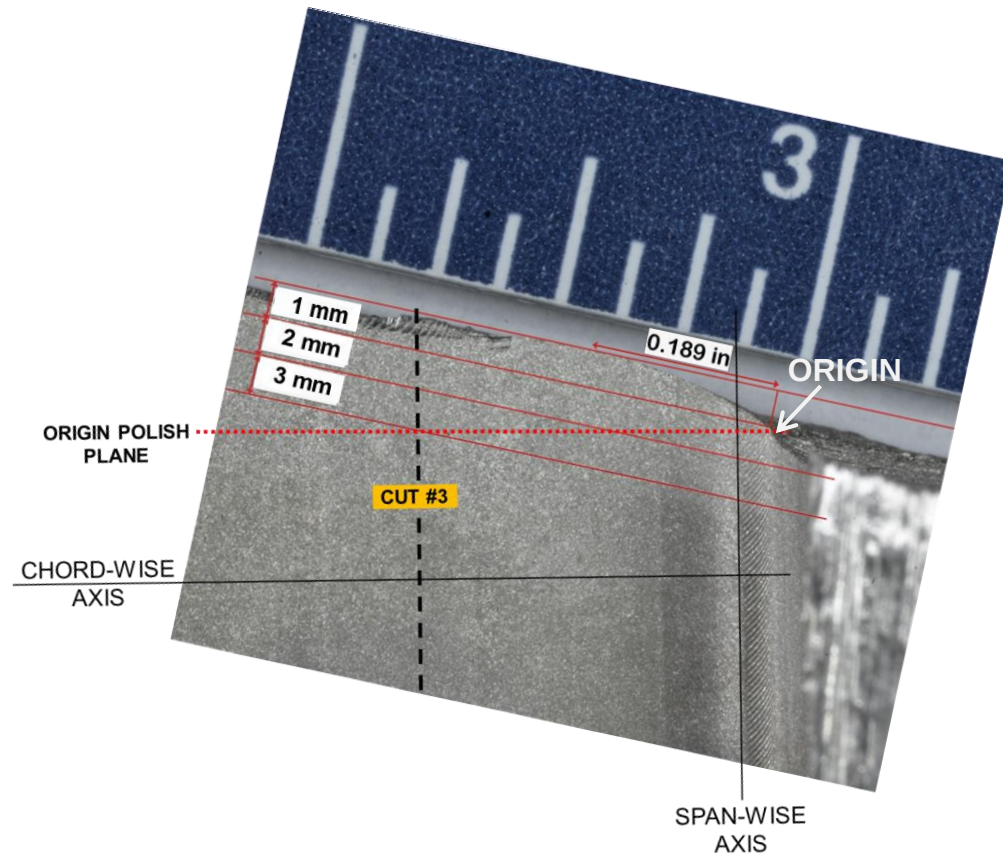
Figure 35 - A transverse cut was made through the CV wall where shown (cut #3). The portion of the fracture surface aft of the cut line was preserved.

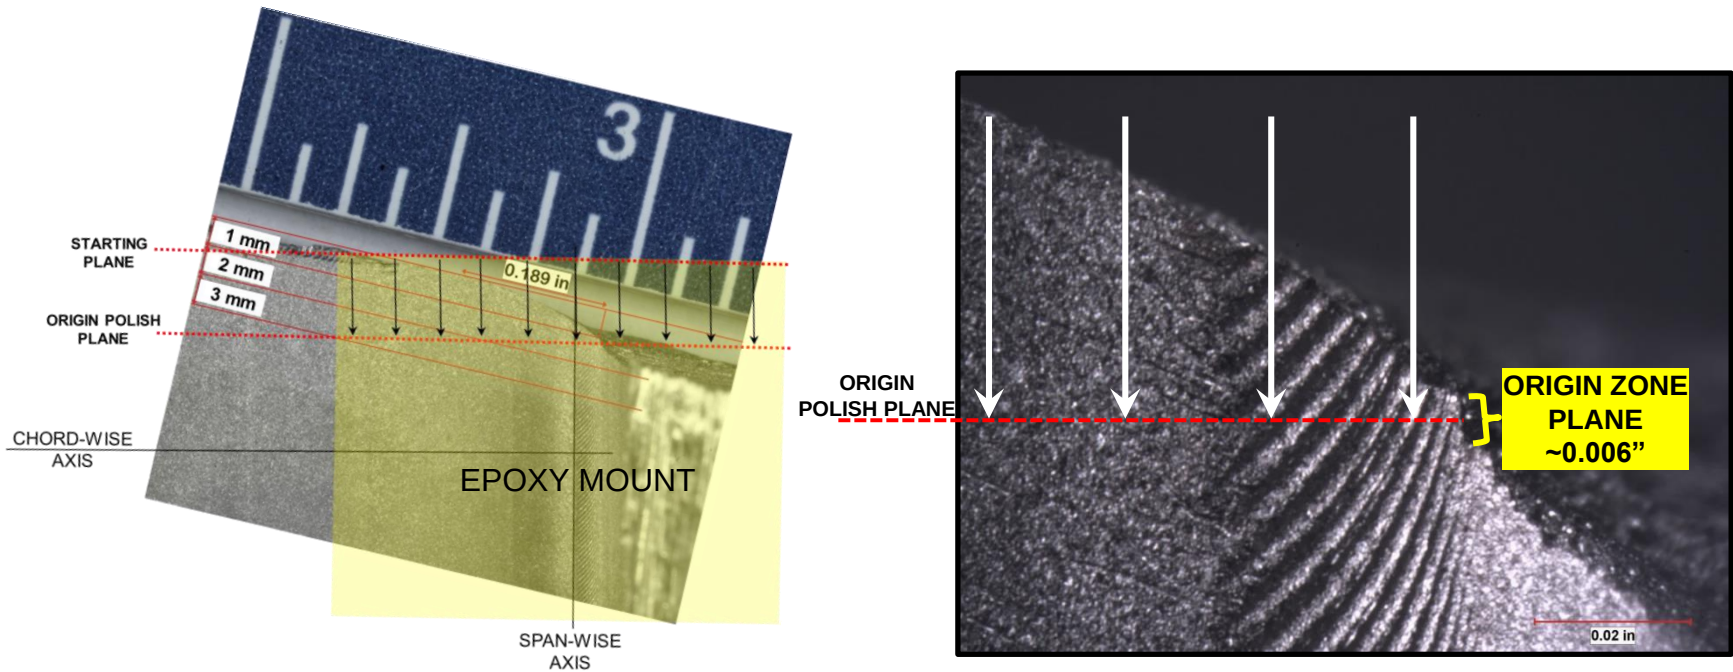
Figure 36 - The fracture surface was mounted down at an angle in clear epoxy. The mount was ground and polished in the direction of the arrows to the plane intersecting the origin, as perpendicular to origin as possible (a near-chordwise plane). The origin plane was a  $\sim 0.006$ " target.

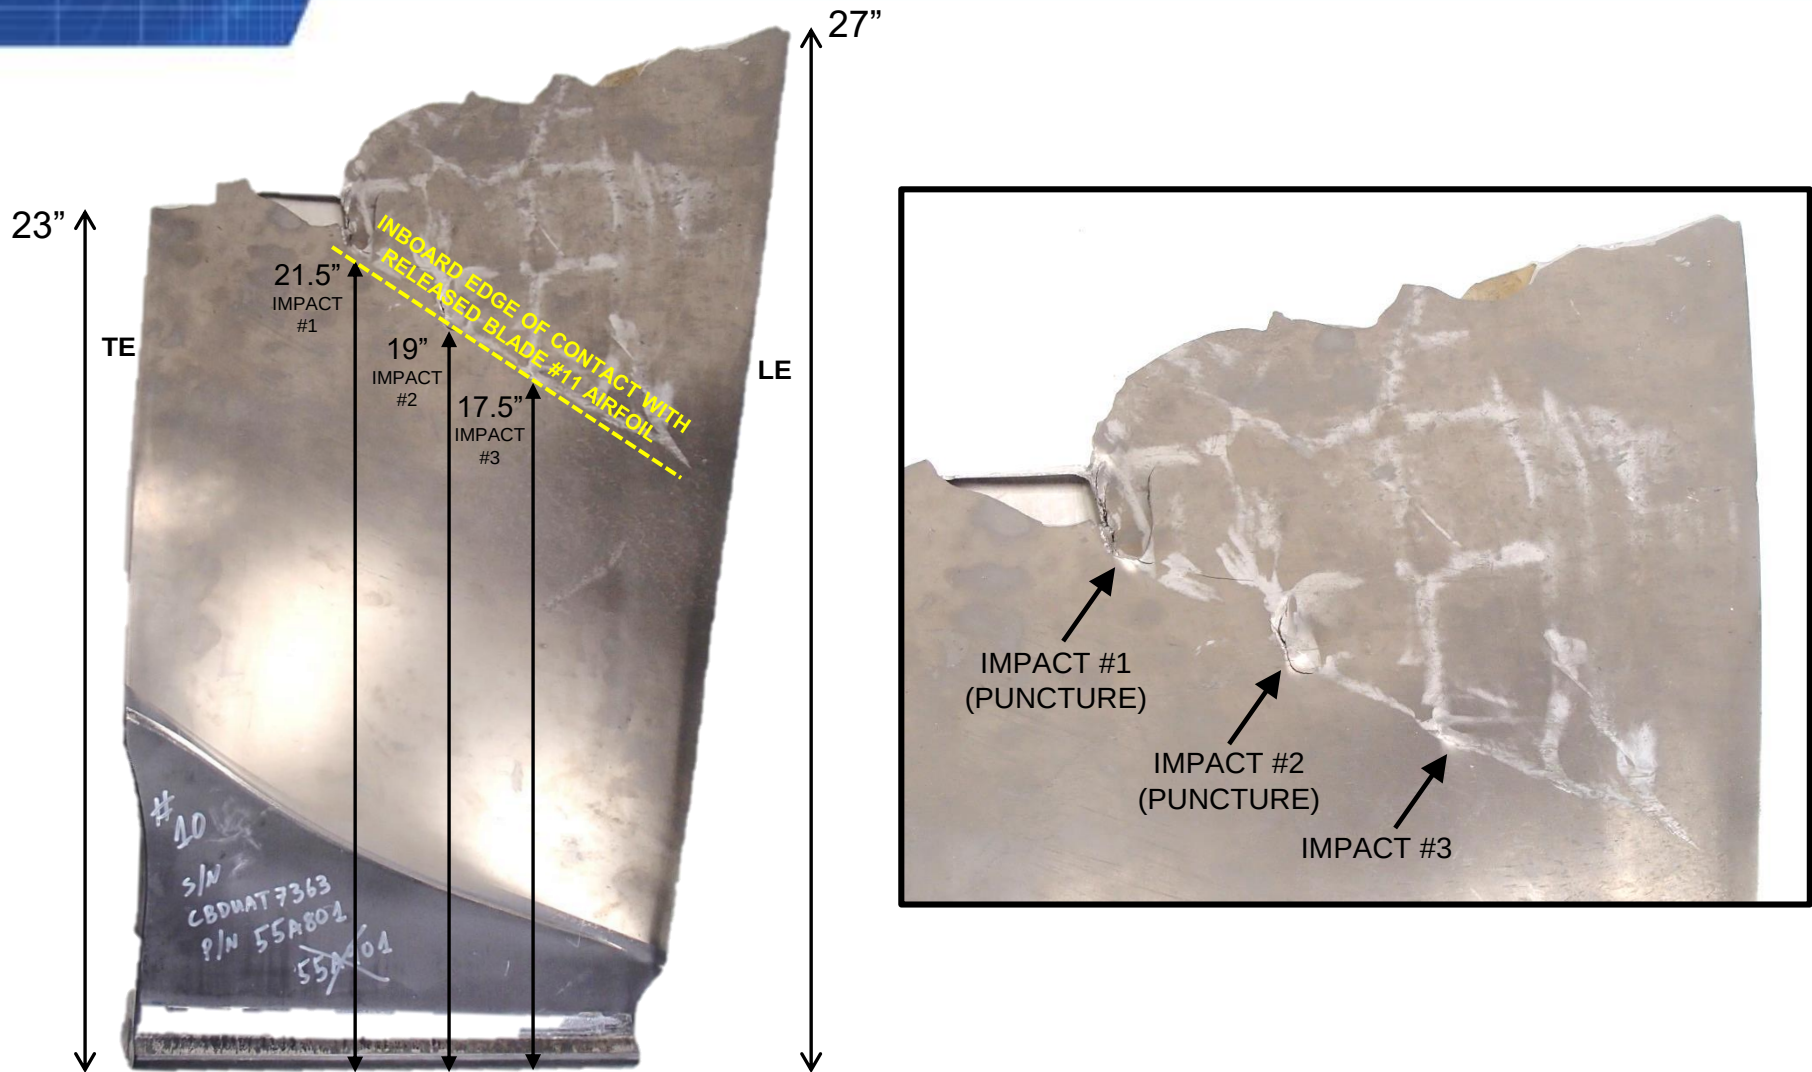
Visual examination of Blade #10, the following fan blade in the fan hub, revealed a transverse fracture through the airfoil ~23” – 27” outboard of the root bottom as measured from trailing edge to leading edge. An incomplete portion of the released airfoil containing the leading edge and the mating fracture half was also recovered from the engine. This portion, which exhibited heavy secondary damage, weighed 4.1 lbs. The inboard portion of the blade weighed 24.6 lbs. The fracture was due to shear/tensile overstress; no evidence of fatigue progression was observed. Directionality of overstress features observed during a binocular microscope examination of the fracture surface indicated that the fracture had initiated primarily from a puncture in the concave side wall ~21.5” outboard of root bottom and ~5.5” forward of the trailing edge. Two additional punctures in the concave side, ~19” and ~17.5” outboard of root bottom, were aligned with the first. The damage was consistent with having been induced by the inboard edge of the released portion of Blade #11 airfoil (**Figures 41 – 44**). The part manufacture and repair identification markings located on the root bottom are shown in **Figure 45**.

Figure 42 - Overall view of Blade #10, inboard portion, concave side.

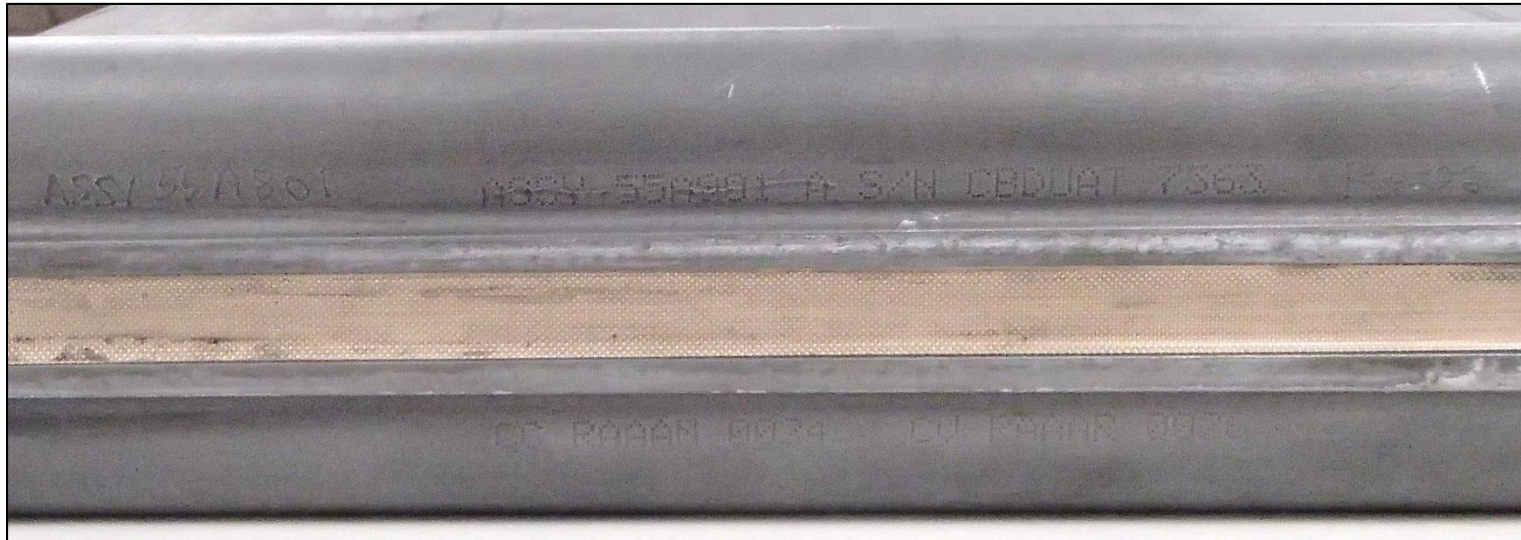
ASSY 55A901-A S/N CBDUAT7363  
55A801 (Vibropeened marking)  
Convex Skin H/C: RAAAR0026  
Concave Skin H/C: RAAAN0024  
R-01, R-02, A72 286 (Vibropeened markings)

Figure 45 – Close-up views of Blade #10 part markings on root bottom.

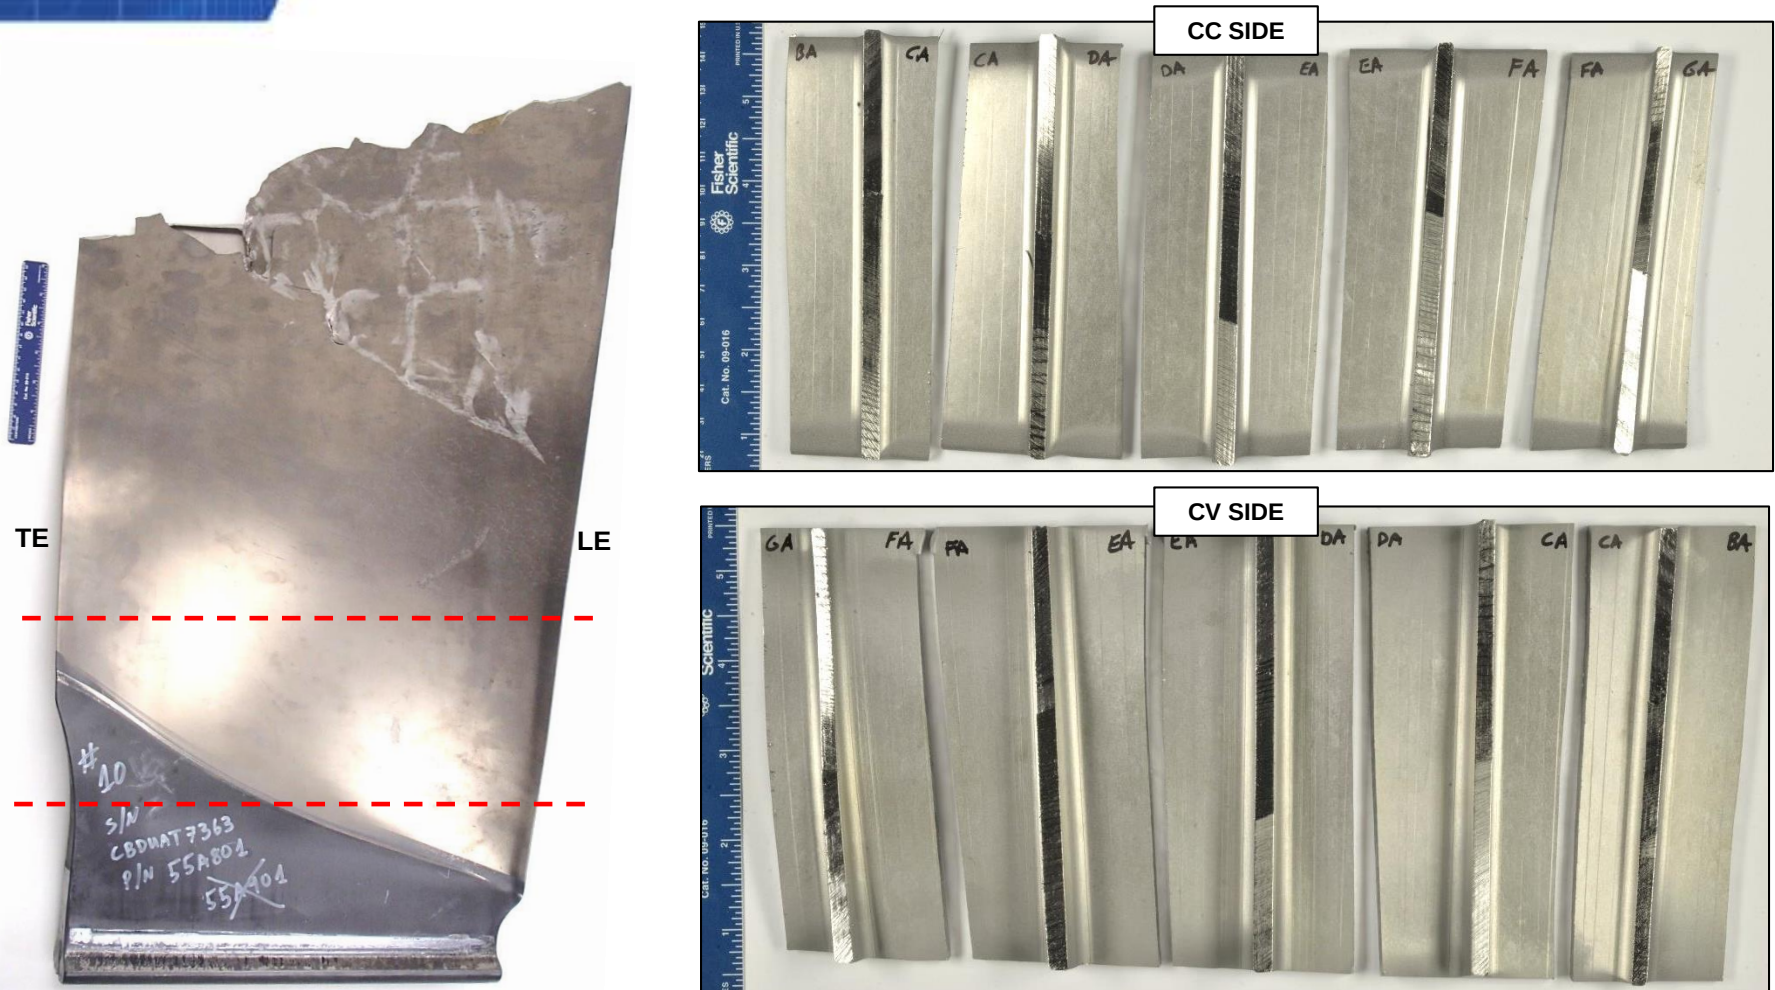
The blade was sectioned chordwise where shown in **Figure 46** (bounding the area corresponding to the fracture origin location on Blade #11) and each internal cavity was filleted open to examine the as-machined features in comparison to Blade #11. Examination typically revealed machining mismatches/cusps at the wall-to-rib transitions that were less prominent than what was observed on Blade #11 (**Figure 47**).

Figure 46 - Blade #10 was sectioned chordwise where shown (bounding the area corresponding to the fracture origin location on Blade #11) and each internal cavity was filleted open to examine the as-machined features in comparison to Blade #11 Attachment 1
