**NATIONAL TRANSPORTATION SAFETY BOARD**

**Attachment 4 –Eaton Hydraulic Engine Driven Pumps Investigation Report**

**DCA18LA163**

# LEVEL 1 INVESTIGATION REPORT

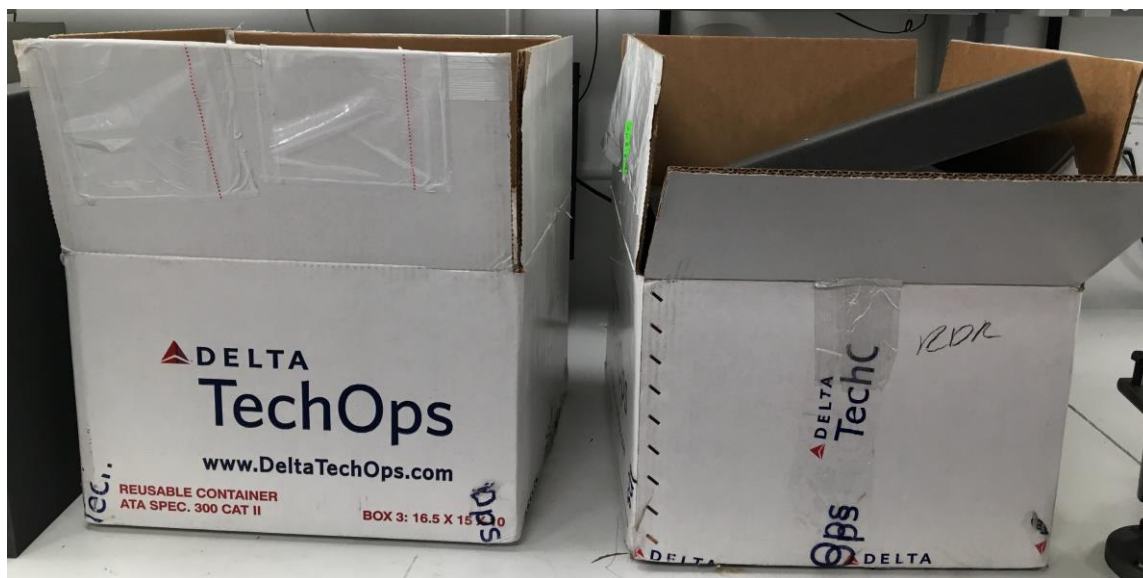
The EDP was delivered and booked in on 28<sup>th</sup> Dec 2018 in two separate Delta TechOps cardboard boxes. There was no external identification on the boxes stating that the contents were subject to an investigation or must not be opened. The boxes were opened and the paperwork inside the box clearly stated it must not be worked on without authorization from NTSB. Both boxes were retrieved from stores, quarantined and remained untouched until the arrival of the AAIB representation (AAIB was acting as an agent of the NTSB).

**Photo No 1: EDP Packaging Boxes**

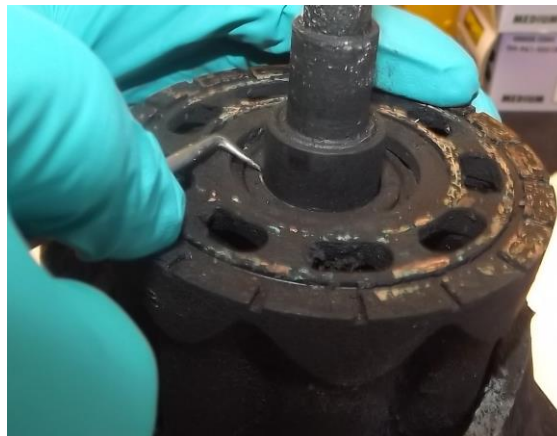
A record of the cylinder block position relative to the drive shaft was made by scribing a mark on the drive shaft in line with the lift limiter shim as shown in the photograph below.

**Photo No 7 : Alignment Mark Cylinder Block to Driveshaft**

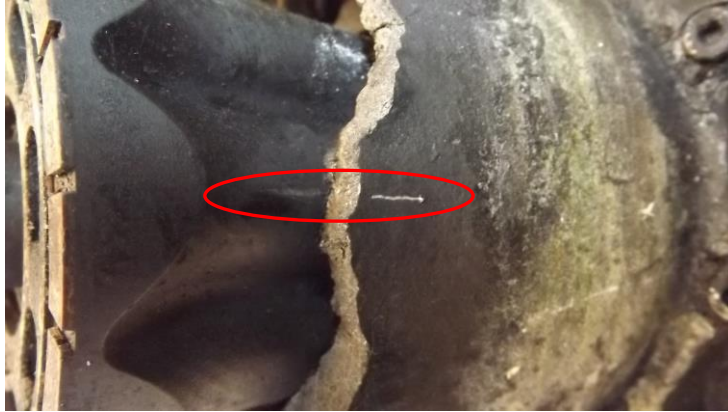
The alignment of the cylinder block to the housing was recorded by etching lines on the external surfaces.

**Photo No 8 : Alignment Mark Cylinder Block to Housing**

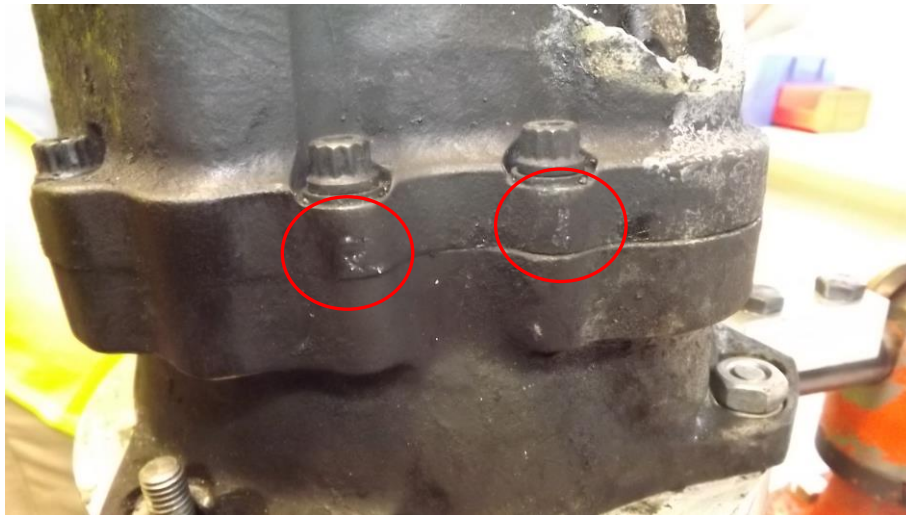
The housing screw positions were etched onto the housing, upon removal all screws were placed in a separate bag labelled with their corresponding number.

**Photo No 9 : Housing Screw Positions**
